Derwent Valley Mills World Heritage Site

Monitoring Views 2017

Appendix 9

Images from North to South

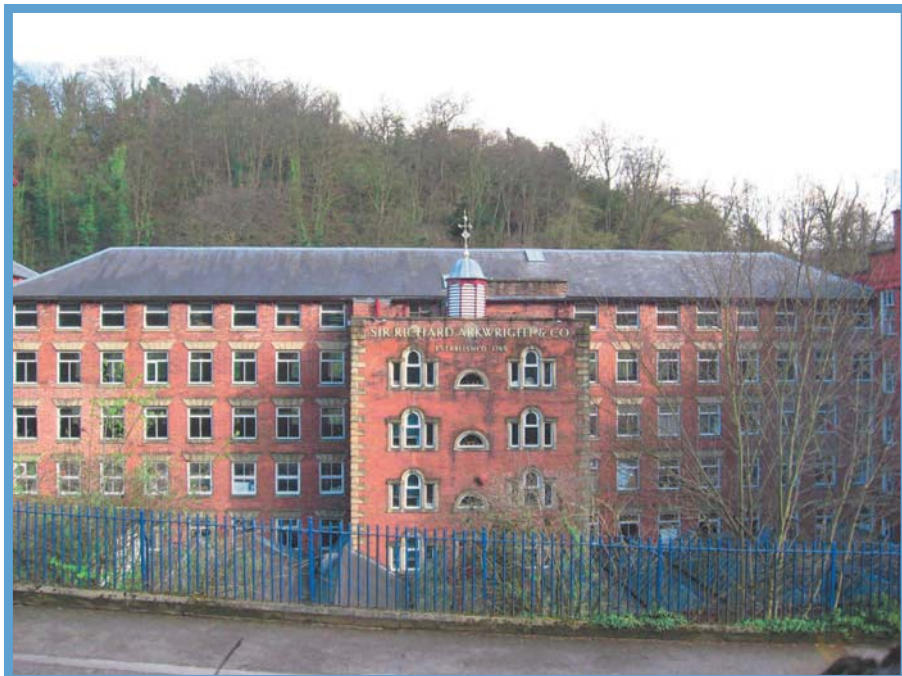
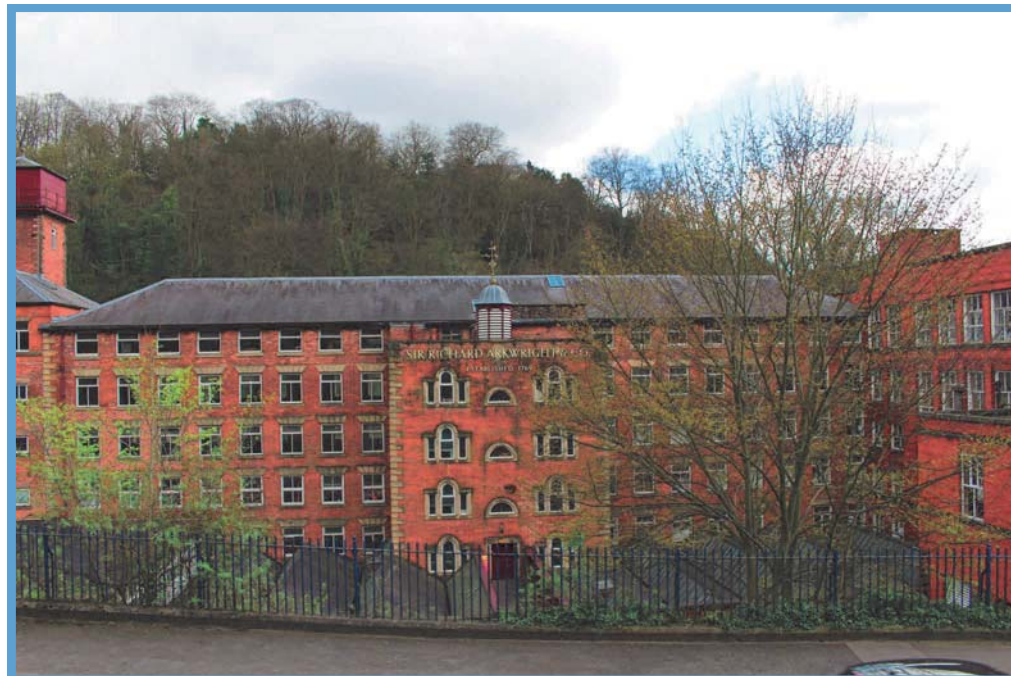
01 Masson Mills from the west

Recent change to view (2017): Some growth in vegetation but not sufficient to screen the view further.

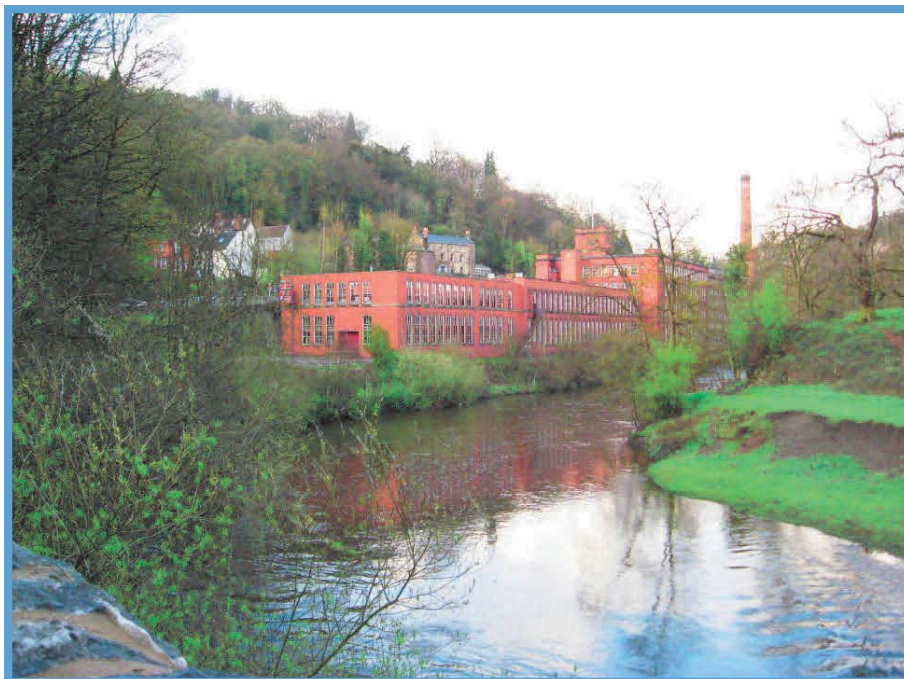
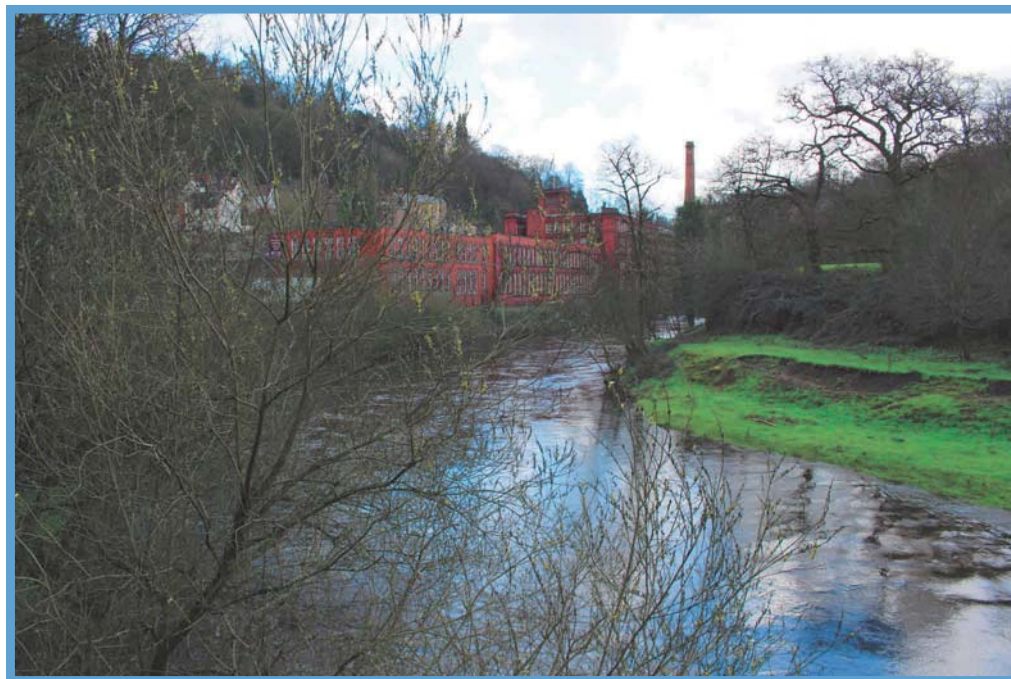
02 Masson Mills from the south

Recent change to view (2017): Vegetation is now beginning to block the view and is in need of attention.

It is desirable that the vegetation on both banks does not increase to the point that the viewpoint is further affected

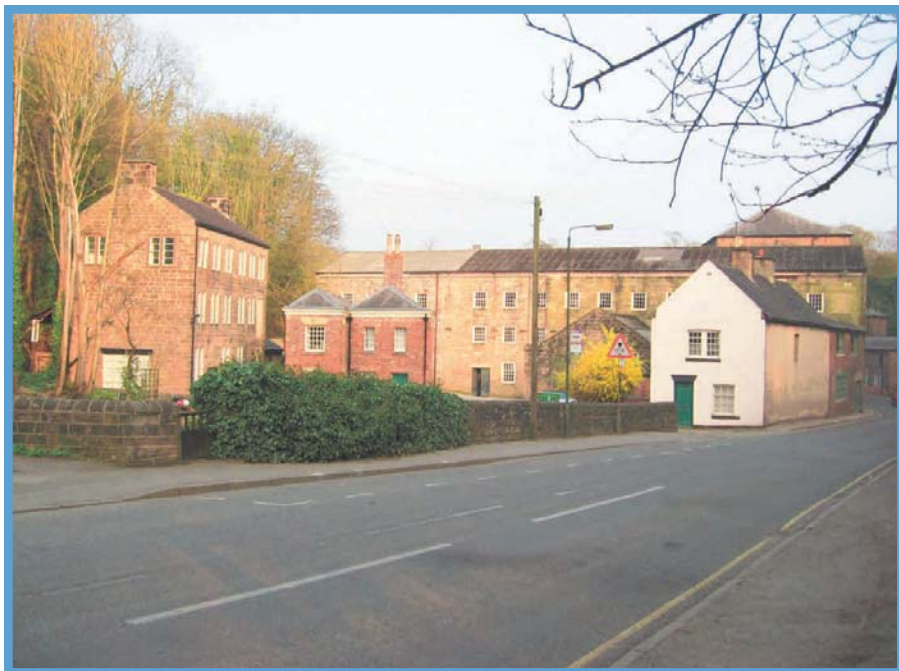
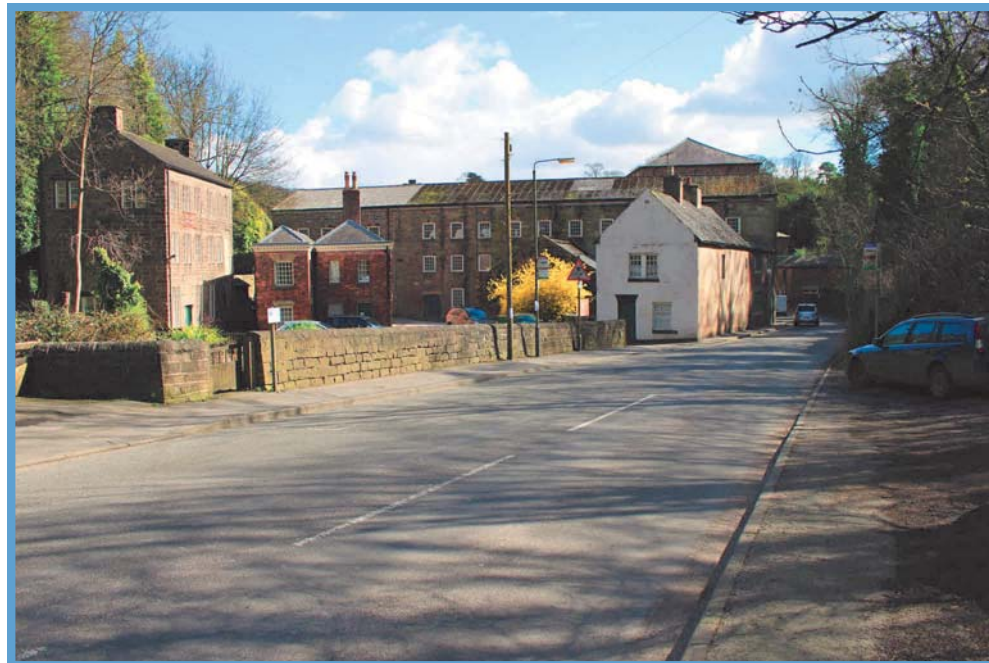
04 Cromford Mill from Mill Road

Not in the view, because it was very badly damaged in a road traffic collision in 2002 is the cast iron conduit of 1821 which spanned the road and which needs to be repaired and reinstated.

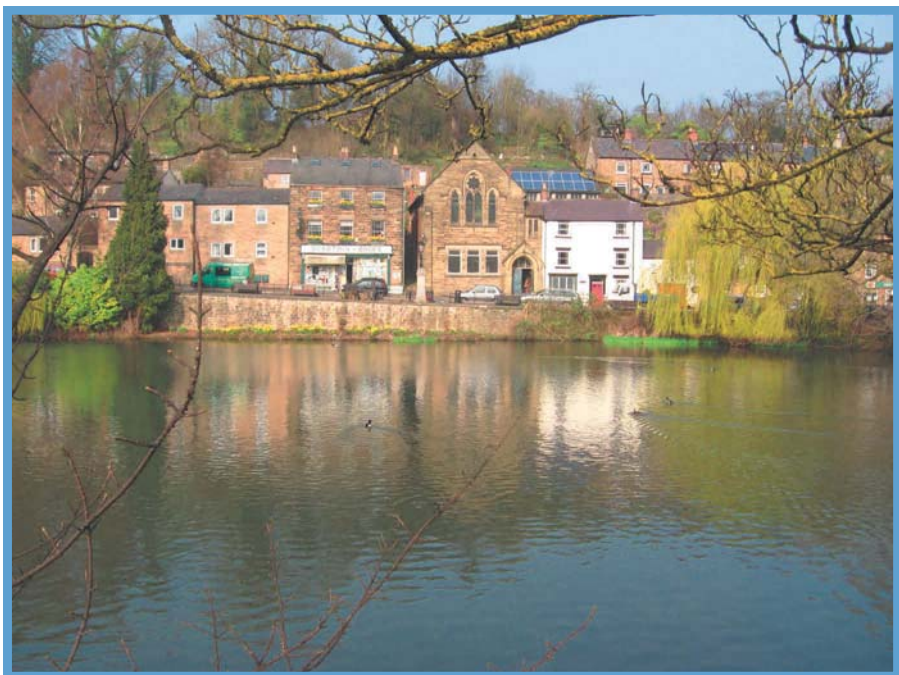
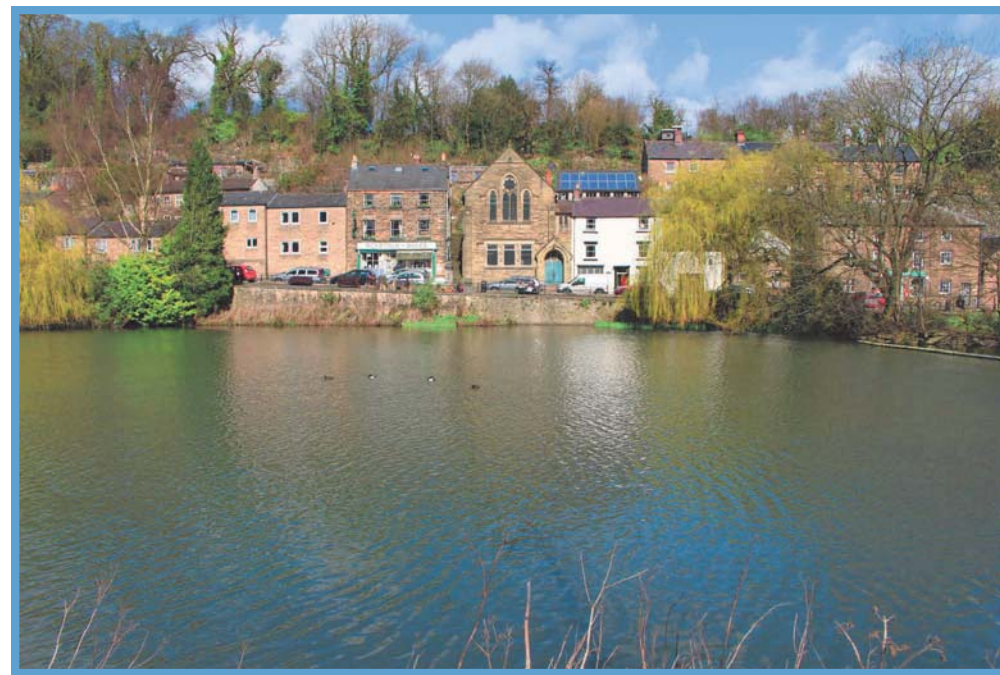
09 Cromford Mill Pond and Scarthin

2012 – Solar panels have appeared—highly prominent in this view.

Description (2008): The Mill Pond behind the Greyhound Inn is an important feature. It needs to be regularly managed to avoid the build up of sediment. The frontage to Scarthin is an important backdrop to the pond. The terrace of Mount Pleasant perched high up on the hillside is even more prominent when seen from Cromford Hill. Its houses have all lost their original joinery and it is desirable that this lost detail should be reinstated.

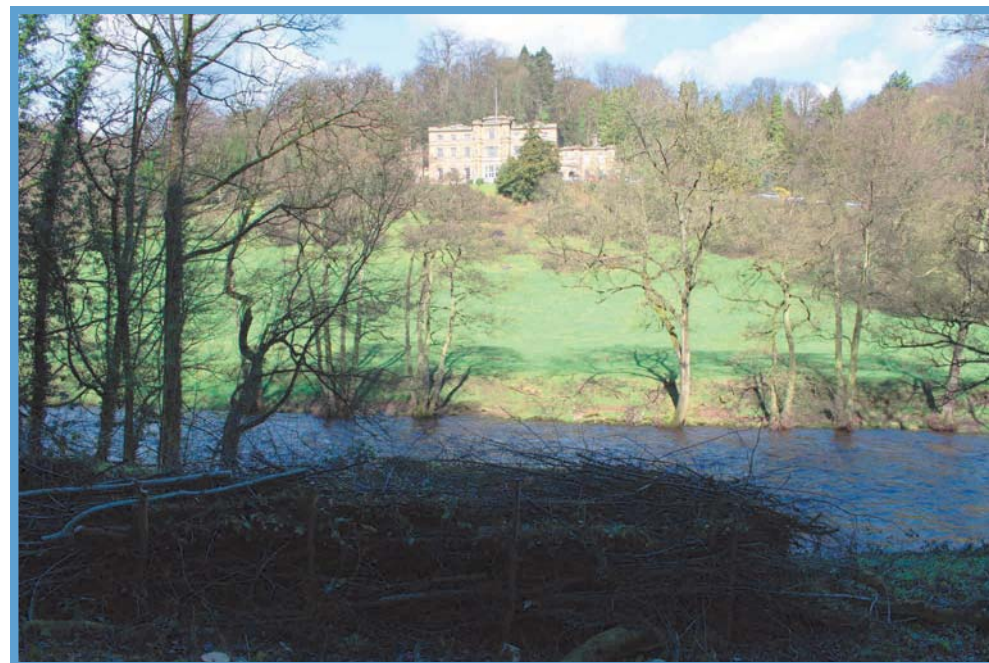
14 Willersley Castle and Park from the south bank of the River Derwent

Description (2008): The damaging effect of unmanaged riverbank tree encroachment into the designed landscape of Willersley Park is very obvious in this view. In the summer the castle is completely screened from view.

2012 – Vegetation incrementally increasing and impacting on view.

Recent change to view (2017): Removal of some trees is helping to restore this lost view

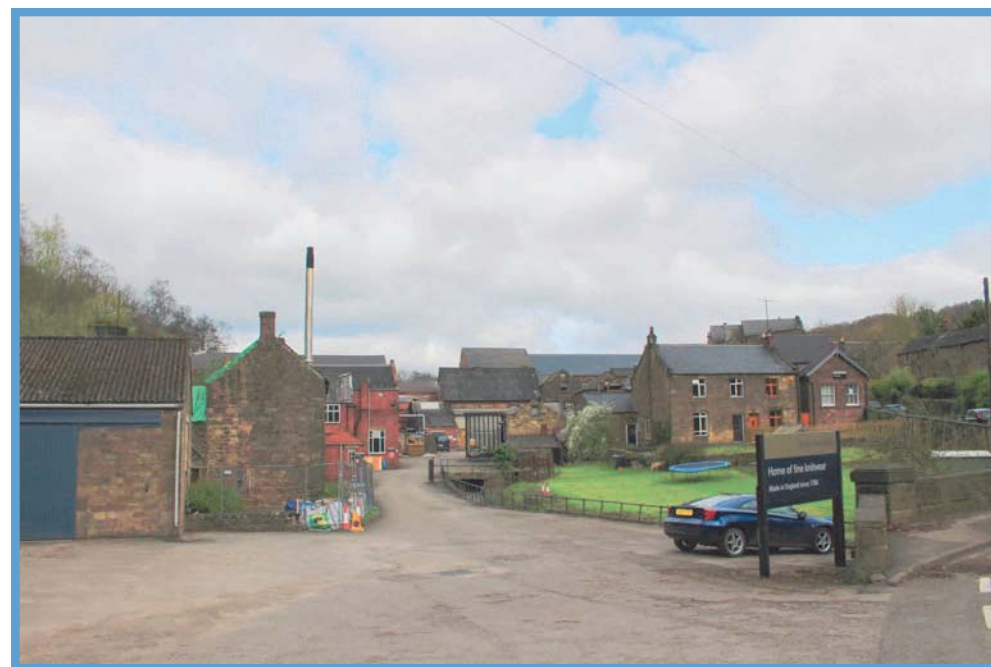
18 The Smedley Mills at Lea

Recent change to view (2017): Reroofing of the original 1783 mill has been completed successfully.

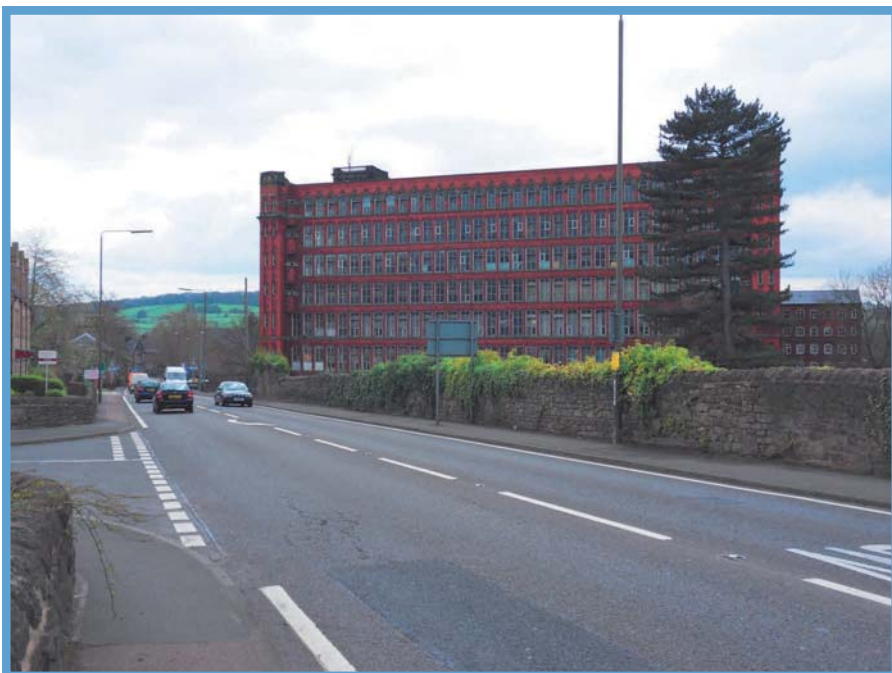
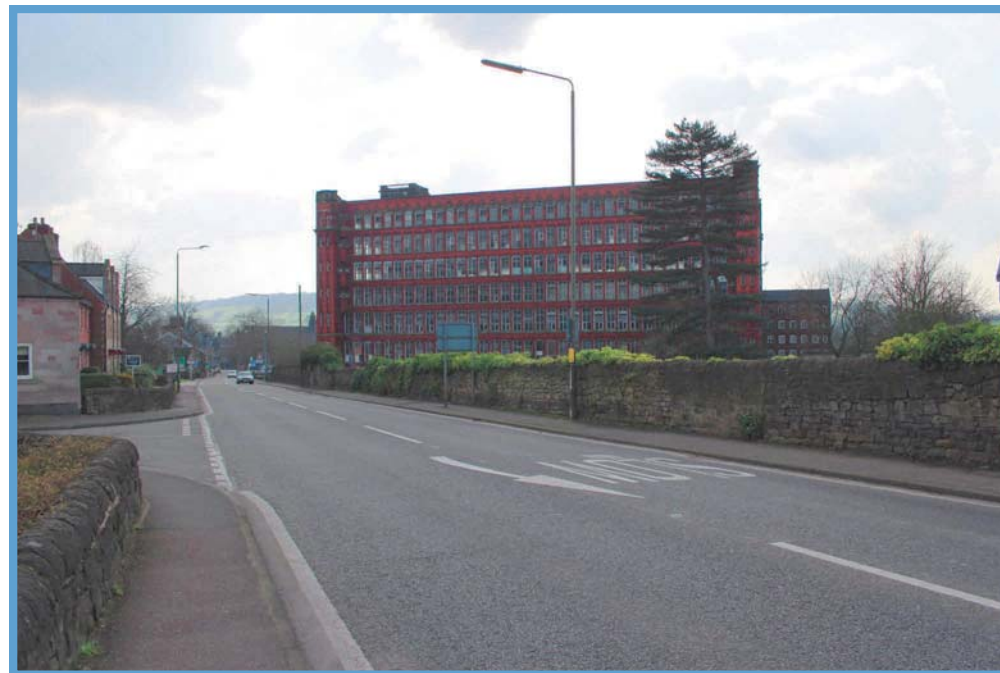
22 Belper's East Mill from the A6 looking south

Description (2008): The East Mill is a major landmark within the World Heritage Site. Its present condition is a matter of great concern. From this viewpoint its setting is largely as it was when built. The wall predates the mill and forms the boundary of the River Gardens. It was raised in the winter of 1905/6 to reduce the risk of falling for onlookers leaning over the wall. Vegetation has penetrated and damaged this wall.

2010 – Although no significant change is visible to this landmark mill it continues to deteriorate. Removal of trees as part of the River Gardens renovations has improved the view of the East Mill.

Recent change to view (2017): The building continues to deteriorate with an increase in vegetation growth.

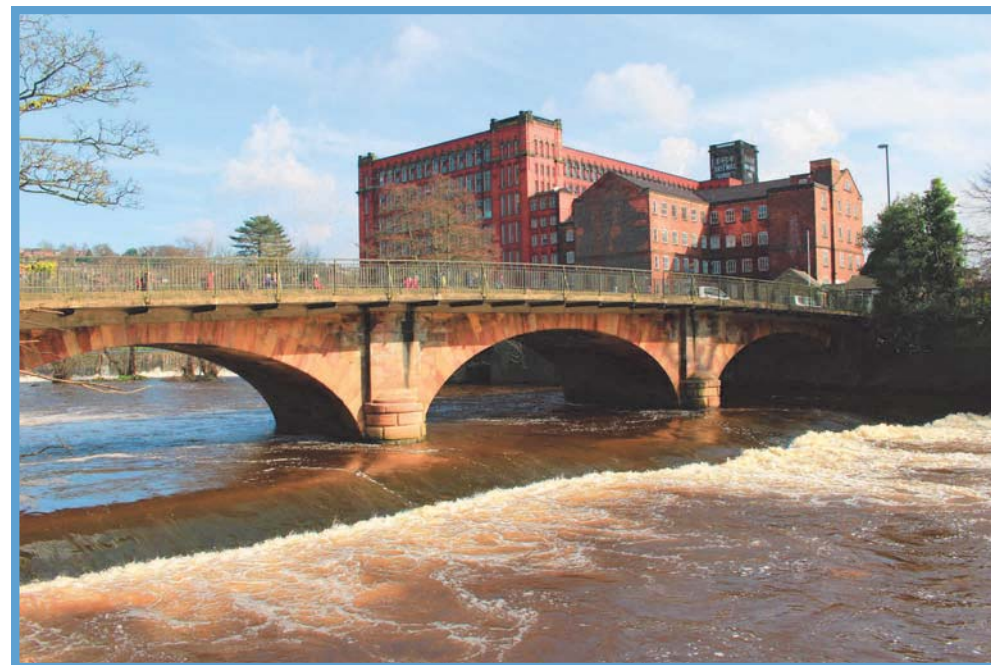
The poor condition of both mills and the weir are causes for concern.

Recent change to view (2017): No visible significant changes but the rock weir continues to deteriorate and may collapse in a future flooding event.

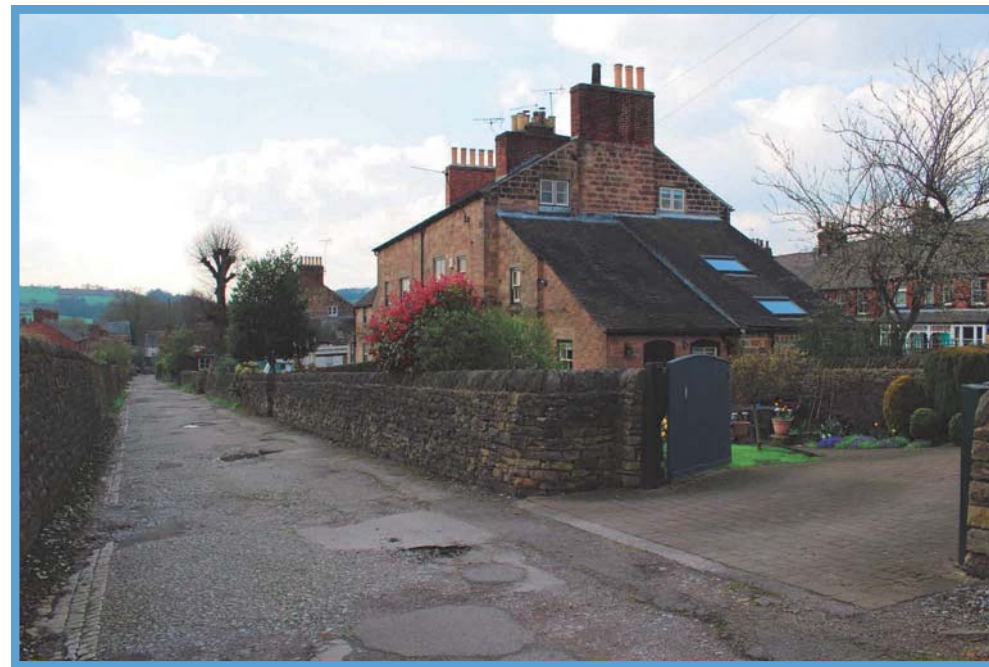
Description (2008): The historic setting of these distinctive houses of 1805 is important, namely stone boundary walls and a Telford like road construction. The latter is in a poor state and is vulnerable to further deterioration. A World Heritage objective is the repair of the best surviving areas of road surface and the restoration of the remainder. An important characteristic of this historic scene is the absence of kerbs, street signs and other modern street clutter.

Recent change to view (2017): No significant change but the road continues to deteriorate.
