Derwent Valley Mills World Heritage Site Monitoring Views 2017

Appendix 20

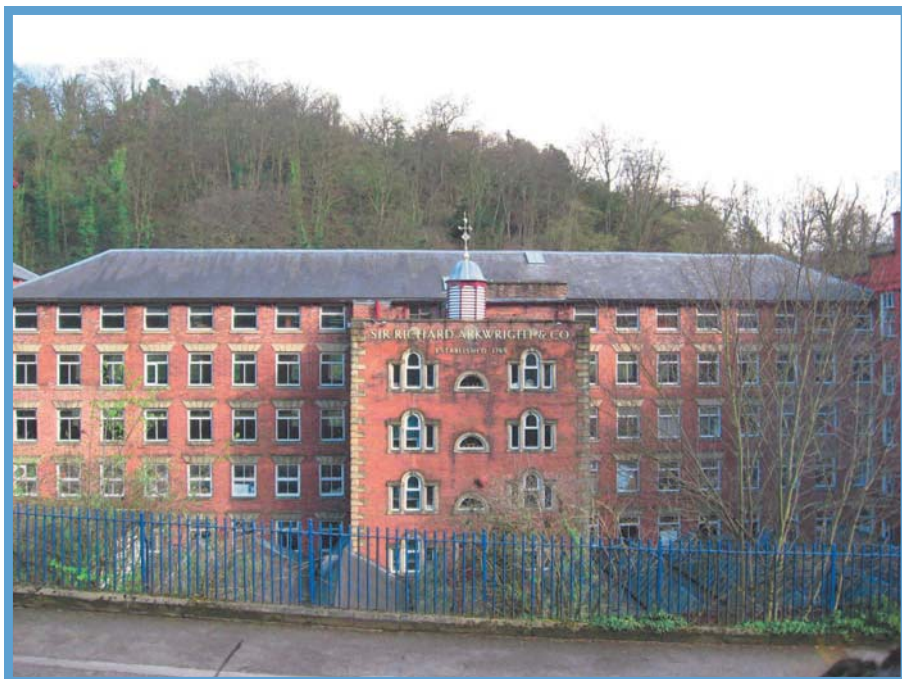
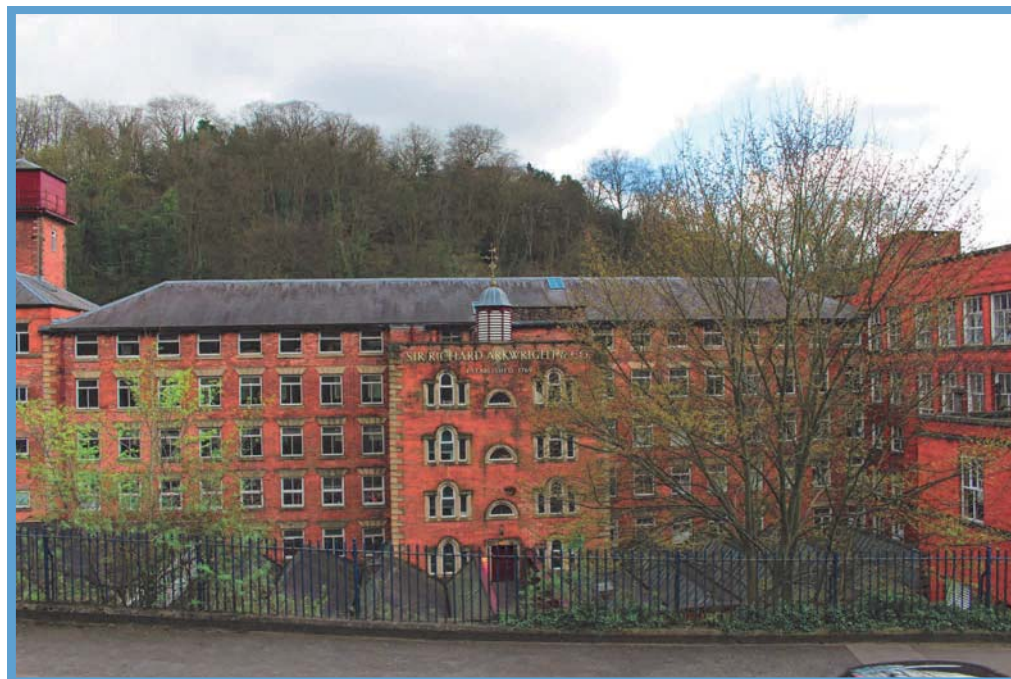
01 Masson Mills from the west

Recent change to view (2017): Some growth in vegetation but not sufficient to screen the view further.

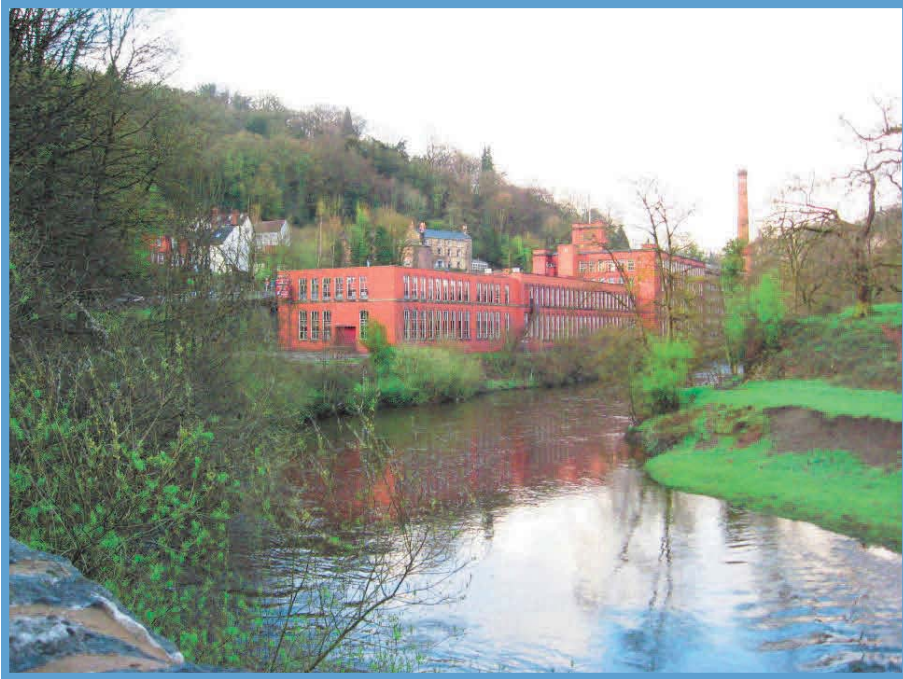
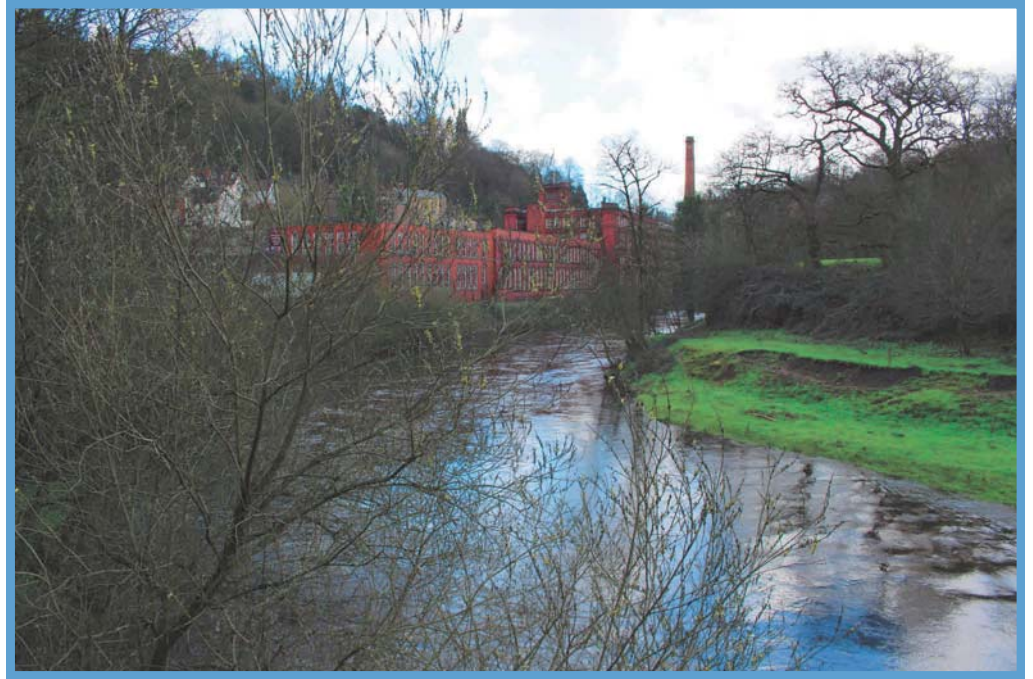
02 Masson Mills from the south

Recent change to view (2017): Vegetation is now beginning to block the view and is in need of attention.

It is desirable that the vegetation on both banks does not increase to the point that the viewpoint is further affected

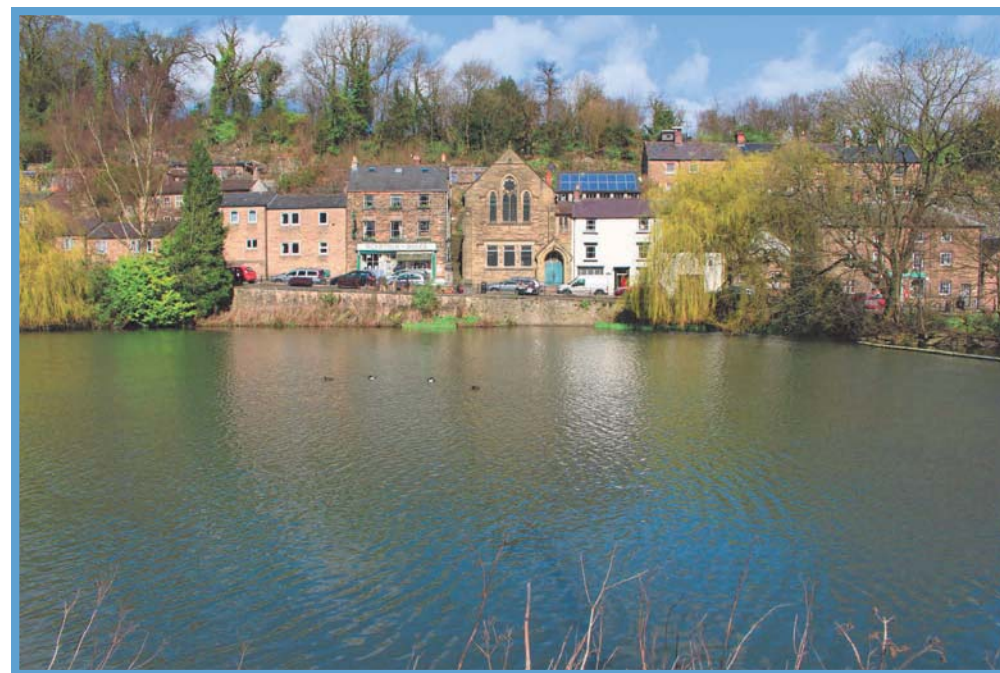
09 Cromford Mill Pond and Scarthin

Description (2008): The Mill Pond behind the Greyhound Inn is an important feature. It needs to be regularly managed to avoid the build up of sediment. The frontage to Scarthin is an important backdrop to the pond. The terrace of Mount Pleasant perched high up on the hillside is even more prominent when seen from Cromford Hill. Its houses have all lost their original joinery and it is desirable that this lost detail should be reinstated.

2012 – Solar panels have appeared—highly prominent in this view.

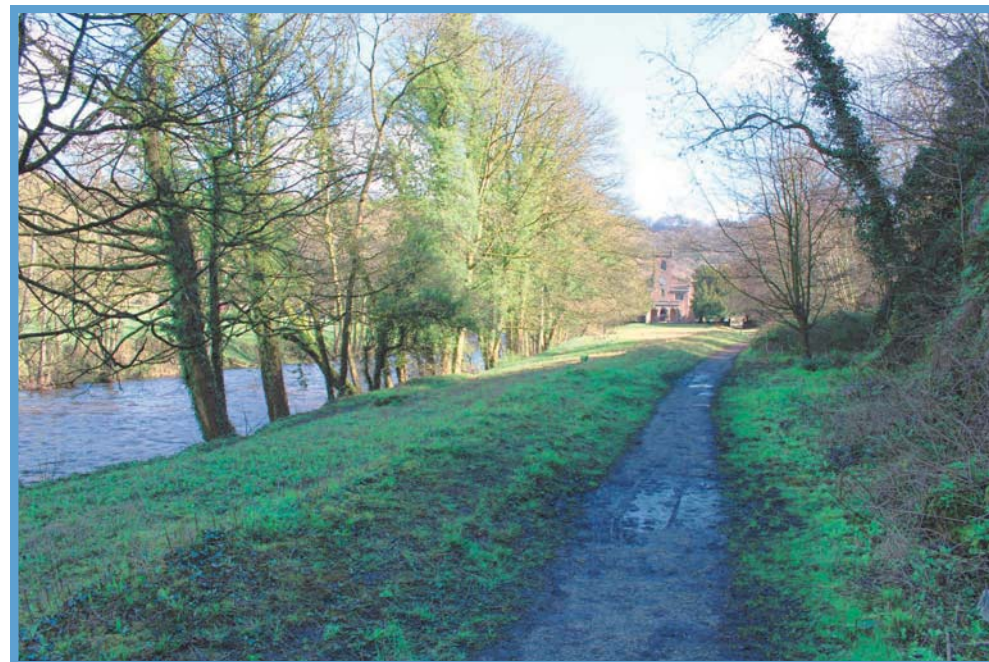
13 The Derwent riverbank looking towards St Mary's Church

Recent change to view (2017): Tree growth is beginning to obscure the view of the church.

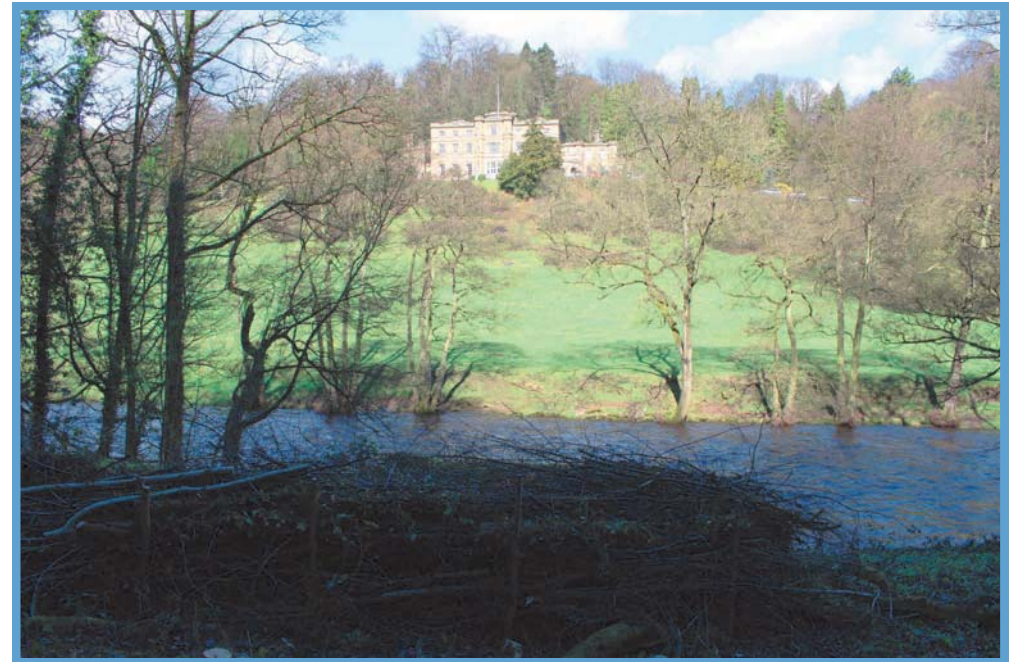
14 Willersley Castle and Park from the south bank of the River Derwent

Description (2008): The damaging effect of unmanaged riverbank tree encroachment into the designed landscape of Willersley Park is very obvious in this view. In the summer the castle is completely screened from view.

2012 – Vegetation incrementally increasing and impacting on view.

Recent change to view (2017): Removal of some trees is helping to restore this lost view

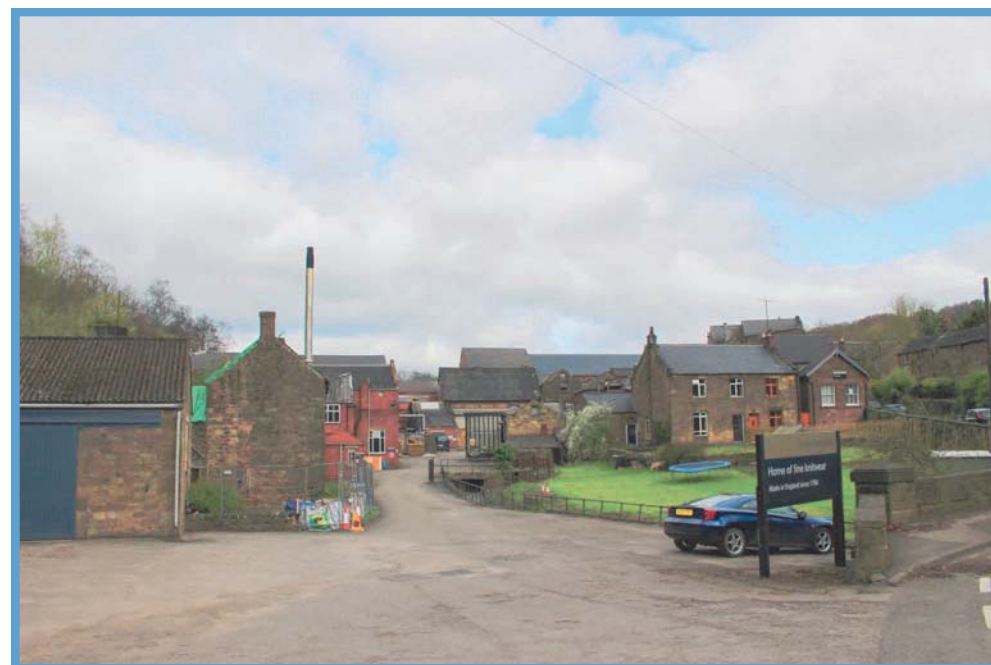
18 The Smedley Mills at Lea

Recent change to view (2017): Reroofing of the original 1783 mill has been completed successfully.

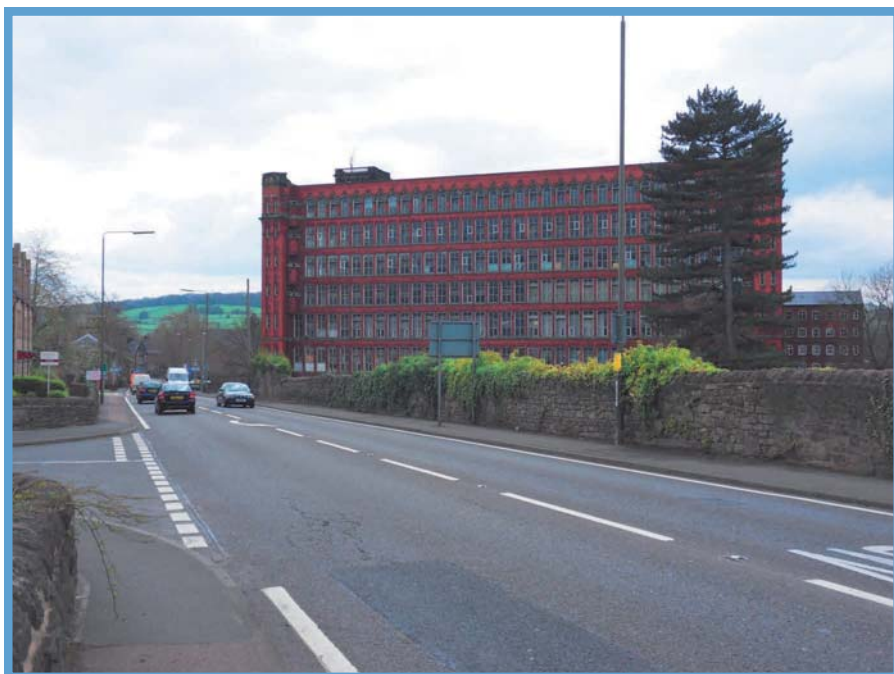
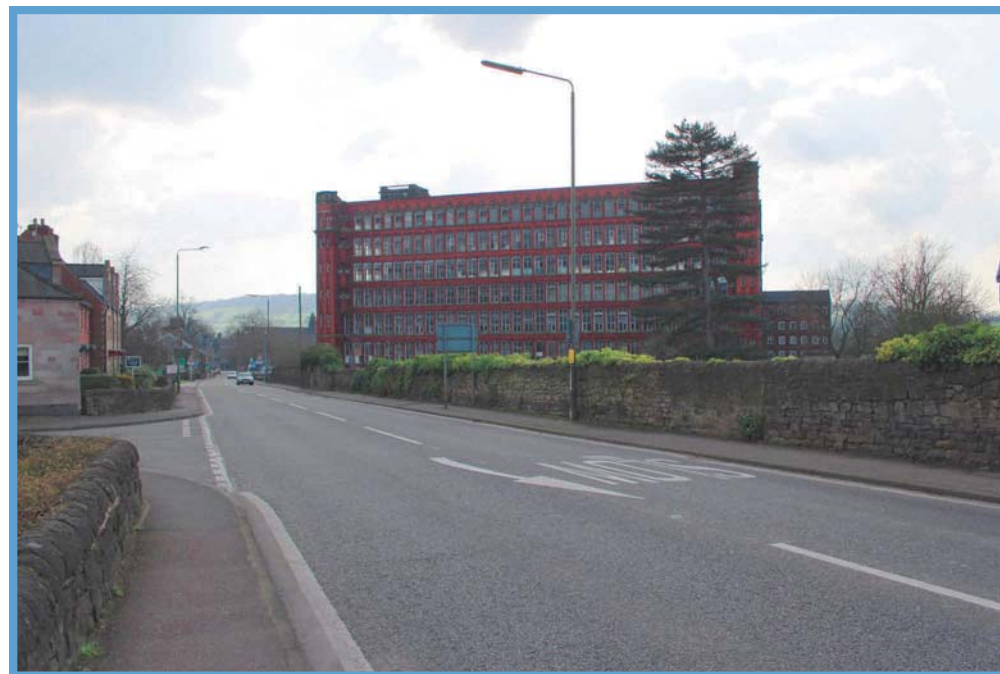
22 Belper's East Mill from the A6 looking south

Description (2008): The East Mill is a major landmark within the World Heritage Site. Its present condition is a matter of great concern. From this viewpoint its setting is largely as it was when built. The wall predates the mill and forms the boundary of the River Gardens. It was raised in the winter of 1905/6 to reduce the risk of falling for onlookers leaning over the wall. Vegetation has penetrated and damaged this wall.

2010 – Although no significant change is visible to this landmark mill it continues to deteriorate. Removal of trees as part of the River Gardens renovations has improved the view of the East Mill.

Recent change to view (2017): The building continues to deteriorate with an increase in vegetation growth.

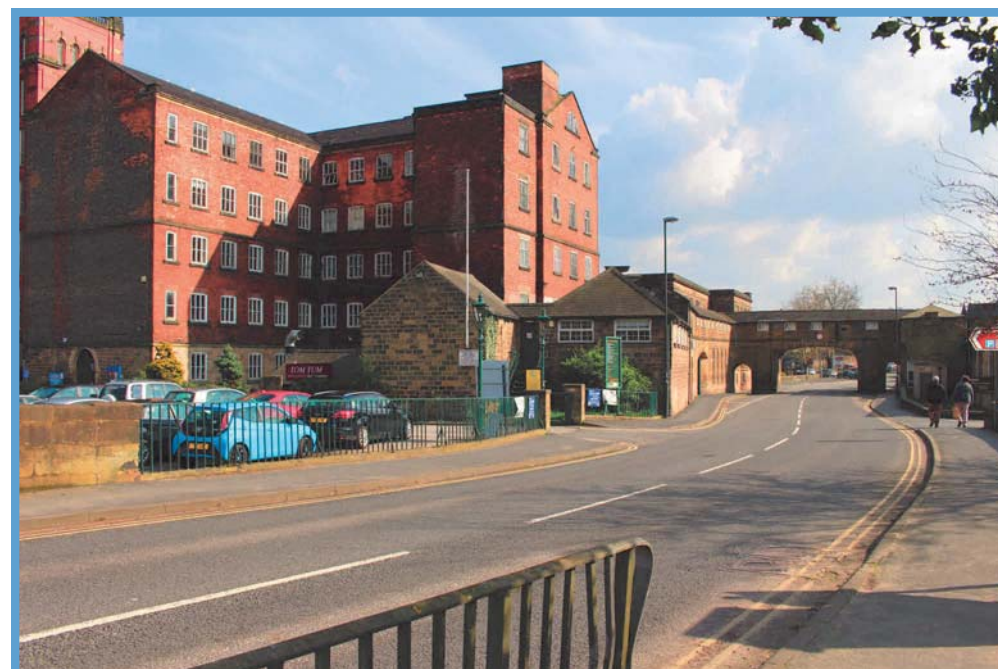
Description (2008): From this viewpoint the Gangway (footbridge) of c 1795 and the North Mill of 1804 are seen well together. Their setting is damaged by undistinguished 20th century industrial buildings and plant just out of sight on the right. The footbridge has suffered extensive damage from tall vehicles. Bridge collision warning signs were installed in 2007 to reduce the risk of further damage, but whilst a busy A-road continues to go under the bridge, the risk remains.

2010 – The scaffolding facilitated some very limited repairs, but the need for major repairs remain a Management Plan priority.

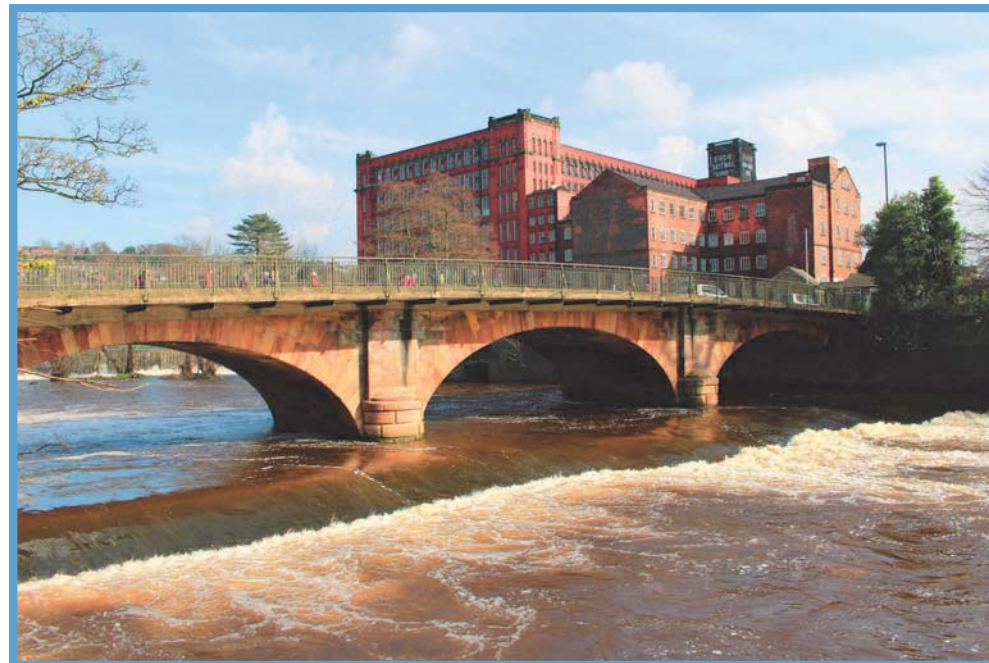
The poor condition of both mills and the weir are causes for concern.

Recent change to view (2017): No visible significant changes but the rock weir continues to deteriorate and may collapse in a future flooding event.

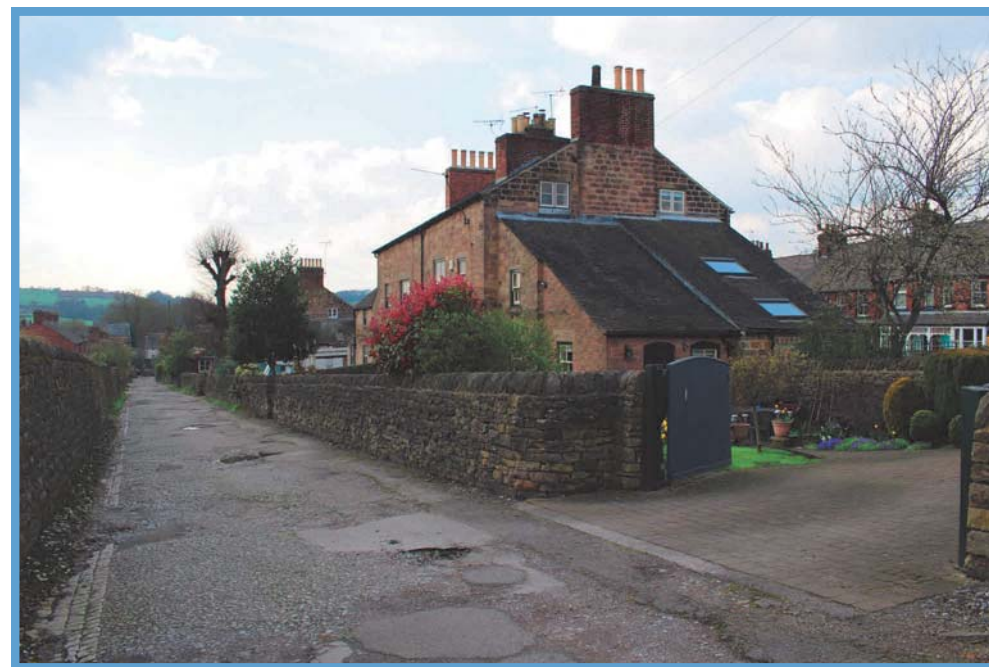
Description (2008): The historic setting of these distinctive houses of 1805 is important, namely stone boundary walls and a Telford like road construction. The latter is in a poor state and is vulnerable to further deterioration. A World Heritage objective is the repair of the best surviving areas of road surface and the restoration of the remainder. An important characteristic of this historic scene is the absence of kerbs, street signs and other modern street clutter.

Recent change to view (2017): No significant change but the road continues to deteriorate.
