Derwent Valley Mills World Heritage Site Monitoring Views 2022

Appendix 20

Images from North to South

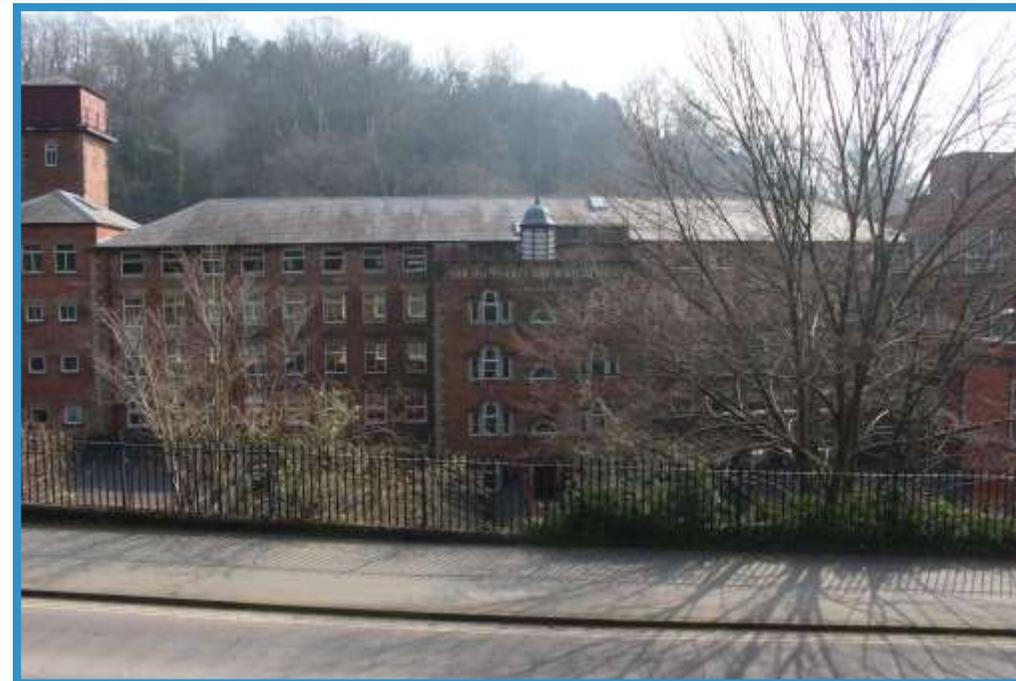
01 Masson Mills from the west

Vegetation growth continues, with removal or management now clearly needed. Closure of the museum and neighbouring retail site in Spring 2020 increases the need to monitor this unused structure.

It is desirable that the vegetation in the foreground does not increase to the extent that this view is screened further from view.

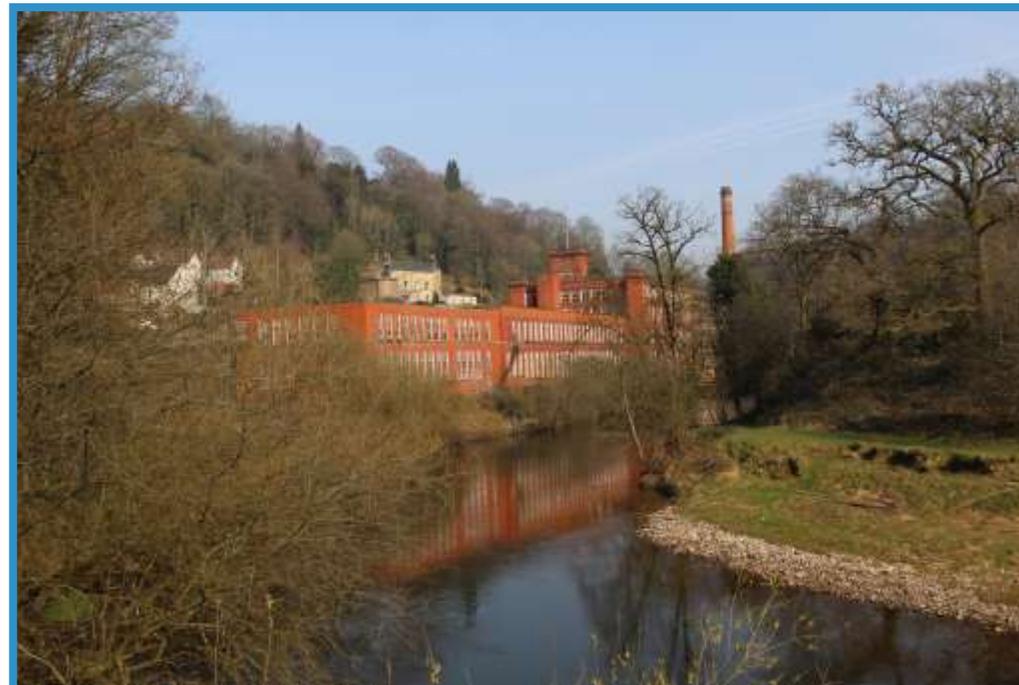
02 Masson Mills from the south

- 2009 – No significant change.
- 2010 – No significant change.
- 2012 – No significant change.
- 2017 – Vegetation is now beginning to block the view and is in need of attention.

Vegetation growth continues, with no perceivable management on either bank.

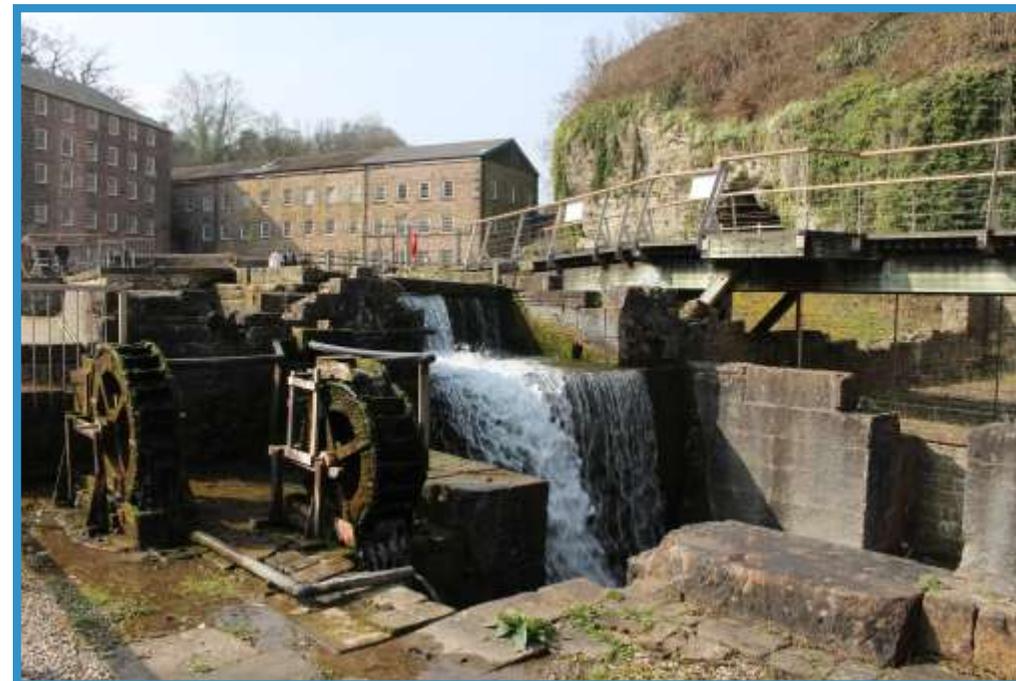
06 Cromford Mill - the first mill from the second mill wheelpit

Waterwheel models have been added, to better interpret and explain the different types used for power generation in the early factories.

The Arkwright Society is investigating the possibility of generating waterpower here again, which will need careful consideration as to how this will impact on the surviving historic fabric.

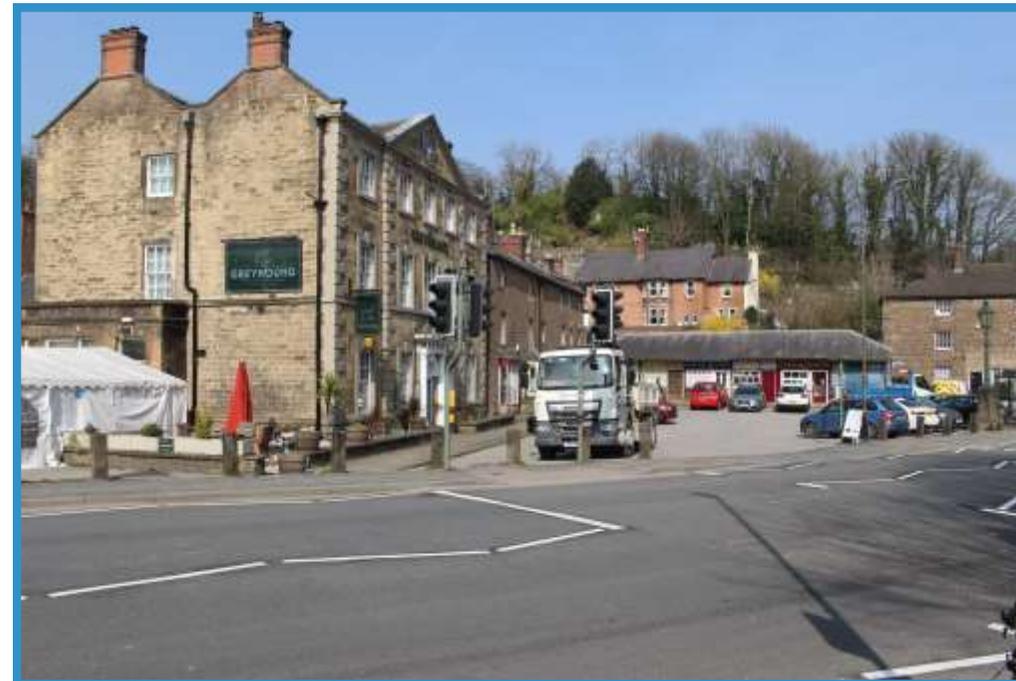
08 Cromford Market Place

Additional signage has been added to the side wall of the Greyhound Hotel. Additional outside seating provision has been introduced to meet measures to reduce Covid-19 transmission.

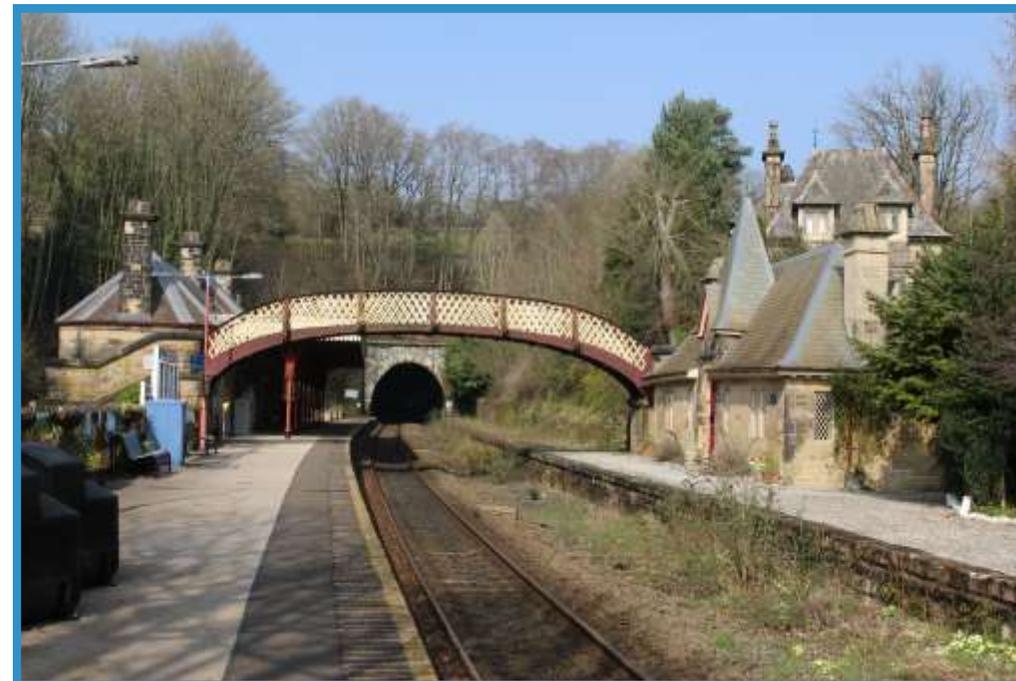
15 Cromford Station with stationmaster's house

The fact that the extravagantly designed 19th century railway buildings and footbridge at Cromford have survived is very important, but for many years the platform buildings have been empty, unused and falling into disrepair. Their repair with the reinstatement of lost architectural detail and their reuse as a holiday let (upside) and office suite/World Heritage Portal (downside) in 2008-9 is a major achievement.

2010 – The repair of the two platform buildings during 2009 delivered major objectives of the Management Plan with regard to 'buildings at risk' and economic development. The down platform building, restored by the Arkwright Society, is let as a suite of offices and the up-platform building, restored by Mr Tim Collis and Mr Ryan Phelps, is a holiday home.

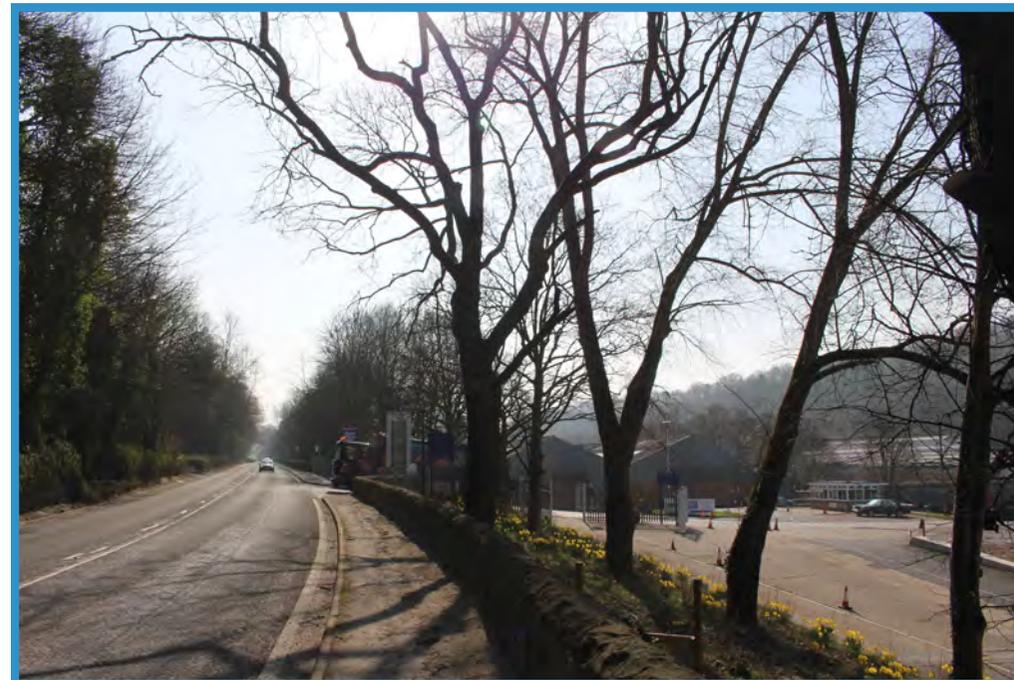
The re-use of buildings for a motor museum has improved the site overall. The modern building on the right has been removed, creating a more open space at the museum entrance, with no loss to historic fabric. A section of the stone wall on the south side of the main entrance has been removed and replaced with steel fencing to improve visibility for vehicle drivers, with no WHS consultation.

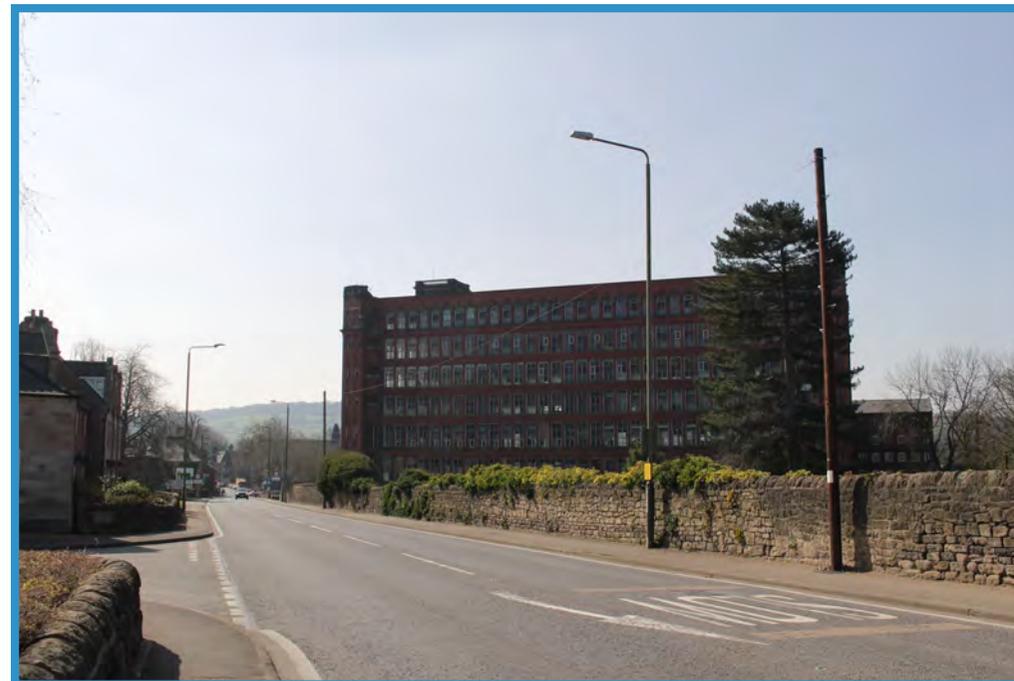
22 Belper's East Mill from the A6 looking south

The East Mill is a major landmark within the World Heritage Site. Its present condition is a matter of great concern. From this viewpoint its setting is largely as it was when built. The wall predates the mill and forms the boundary of the River Gardens. It was raised in the winter of 1905/6 to reduce the risk of falling for onlookers leaning over the wall. Vegetation has penetrated and damaged this wall.

2017 – The building continues to deteriorate with an increase in vegetation growth.

The empty building continues to deteriorate, with more vegetation growth and no reparation work evident.

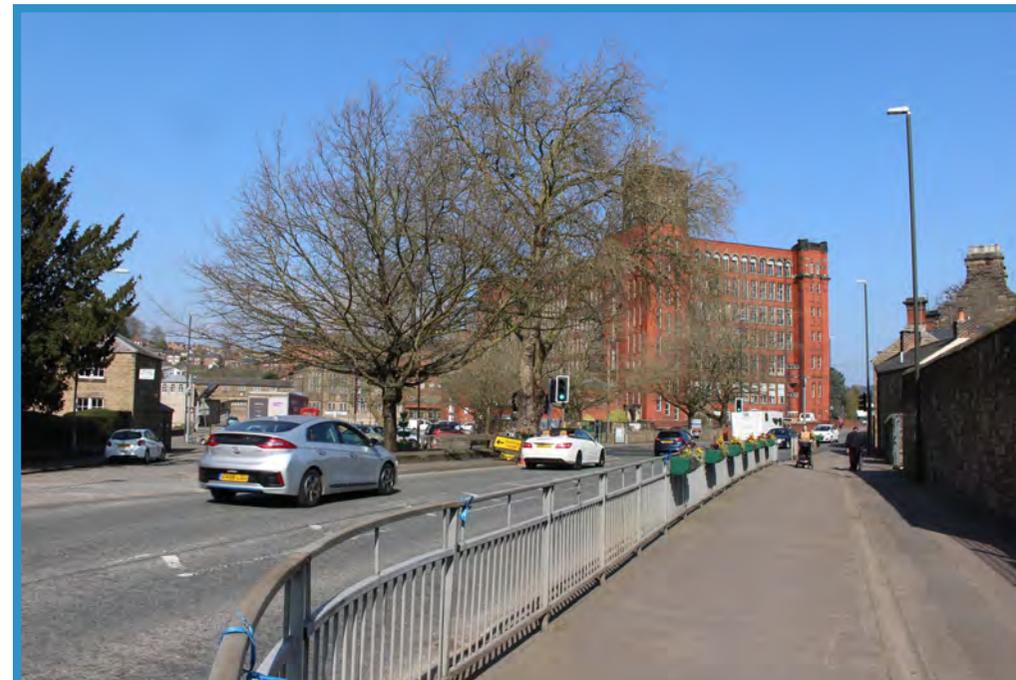
The empty building continues to deteriorate, with more vegetation growth and no noticeable care of the building evident.

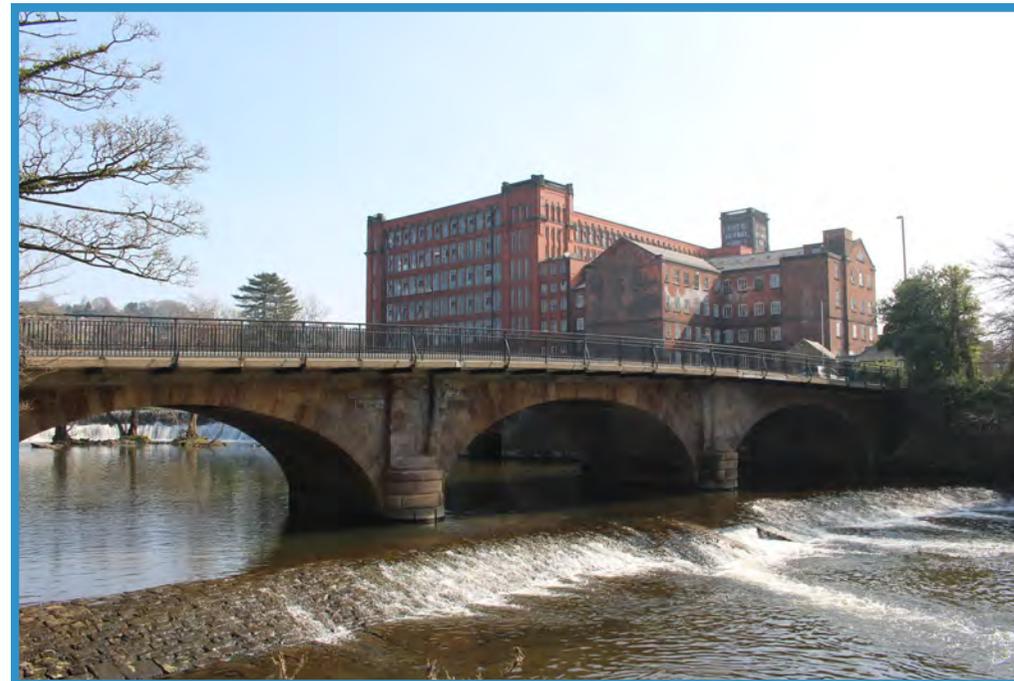
From this viewpoint the river bridge of 1797, the weir of 1797, North Mill of 1804 and the East Mill of 1912 are seen together. The poor condition of both mills and the weir are causes for concern.

2017 – No visible significant changes but the rock weir continues to deteriorate and may collapse in a future flooding event.

The scale of efflorescence on the upper floors of the Listed Grade One North Mill are also noticeable from here. Despite several significant flooding events the rock weir has not yet collapsed, but no repair work has taken place and it continues to deteriorate. Collapse could significantly change this important view.

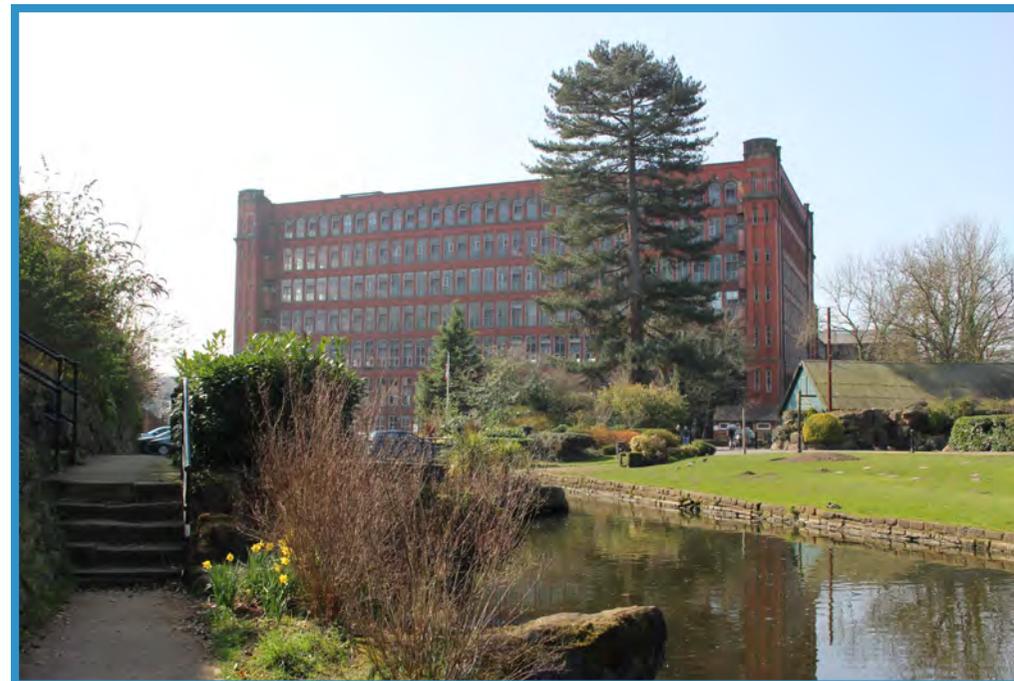
27 East Mill from River Gardens

Some management of the vegetation in the gardens has restored a clearer view of the mill building. The mill itself continues to deteriorate.

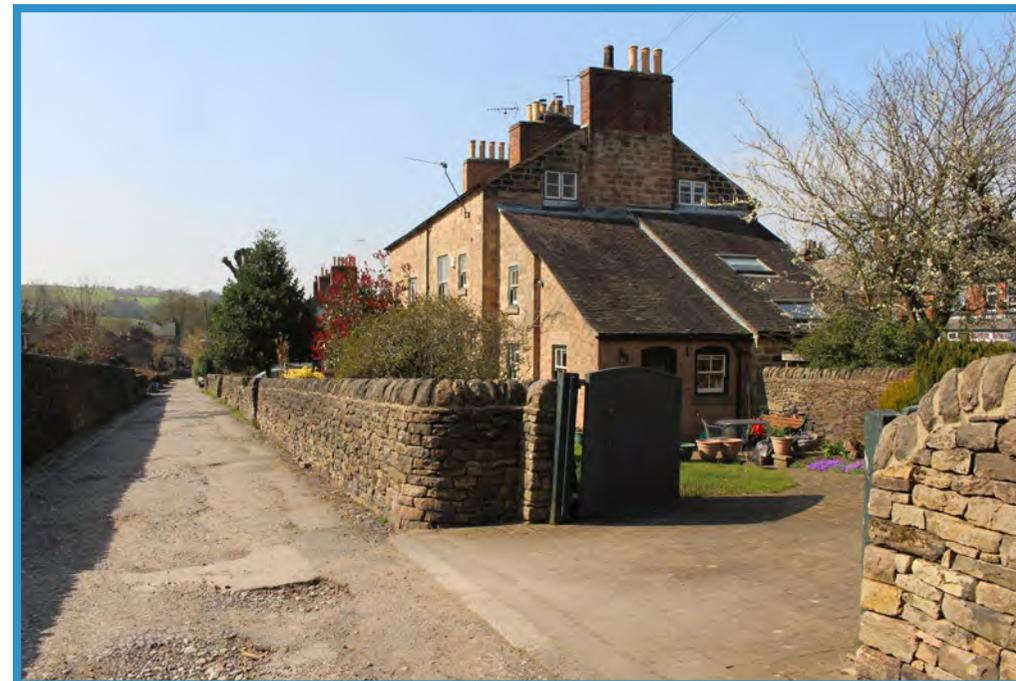
31 Cluster Houses on Joseph Street, Belper

The historic setting of these distinctive houses of 1805 is important, namely stone boundary walls and a Telford-like road construction. The latter is in a poor state and is vulnerable to further deterioration. A World Heritage objective is the repair of the best surviving areas of road surface and the restoration of the remainder. An important characteristic of this historic scene is the absence of kerbs, street signs and other modern street clutter.

- 2009 – No significant change.
- 2010 – No significant change.
- 2012 – No significant change.
- 2017 – No significant change but the road continues to deteriorate.

The road continues to deteriorate, but residents have cleared out the gutters along the northern edge of the road, aiding drainage.
