ROCK HOUSE, CROMFORD

SUMMARY

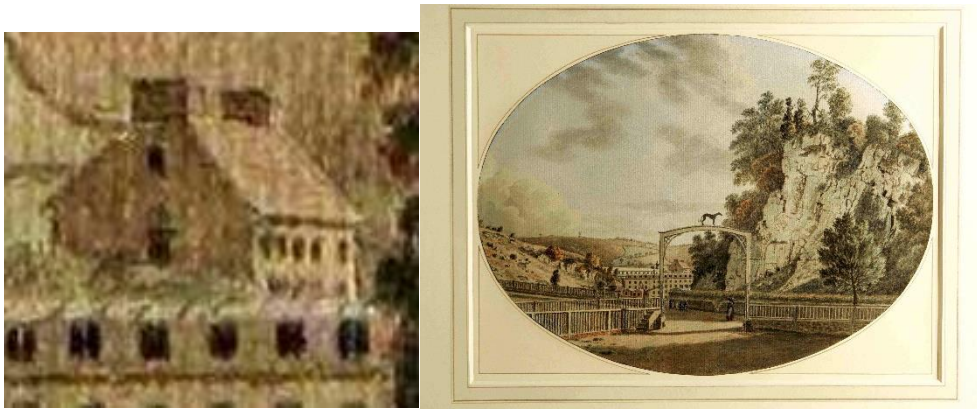
An undated watercolour of c.1785-1790 shows, from the vantage point of the yard in front of the Greyhound Inn, a large house with a single, broad spanned gabled roof.³⁵ It is in the right position for Rock House. The house is shown having five windows in its western elevation with eccentric spacing³⁶, namely four regularly spaced and the easternmost fifth one set further apart. Only the top floor and part of the floor below is visible over the roof of the six storey First Mill, but even taking into account the elevation of the rock on which it sits, the house shown is likely to be three storey in height.

Although clearly a relatively large dwelling its appearance is not obviously that of a 'gentry house'. It is conceivable that the shadow line at the eaves represents the underside of a projecting stone cornice and another less marked shadow line, parallel with the far verge of the roof, may indicate the roof had coped gables. If this is the case they would have most probably terminated in the Derbyshire vernacular 'kneeler' detail. The contrast between the colour of the (gable top) chimney stacks and the walls suggests the artist may have been depicting brick stacks. The gable end has no three-storey double pile building against it, as today's stone house has. Within the gable end is a small attic window, centrally placed immediately under the chimney stack. A dark shape below it may represent a slightly larger window to the floor below, but it is too indistinct to be sure and a second floor window in such a position is not characteristic of the period. The house shown must have been two rooms deep. The presence of only two chimney stacks, one at each gable end, suggests each floor is likely to have had only four heated rooms on each floor. The location of the eastern chimney stack does not accord with the arrangement of stacks in the Rock House of today.

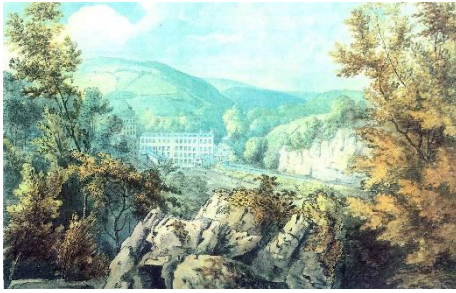
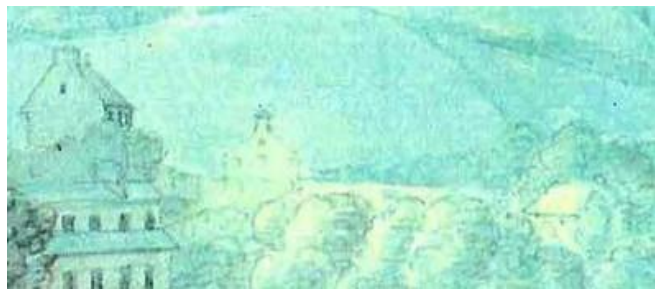
From a similar but slightly different viewpoint William Day's watercolour of 1789 shows Rock House above the roof of the second mill. As with the Greyhound yard view the house is shown as having a wide gable end, with an attic window centrally placed under the gable top chimney stack. The roof pitch is steeper. An overhanging detail at eaves level suggests either projecting kneelers or a projecting eaves cornice or perhaps both. Day's watercolour shows the building known today as The Mews, with its bell-cote/cupola clearly delineated. The relative heights of the two buildings make it clear that Rock House is three storeys. It is possible that the building to the far right in the detail is the building which became the Derby Road Lodge.

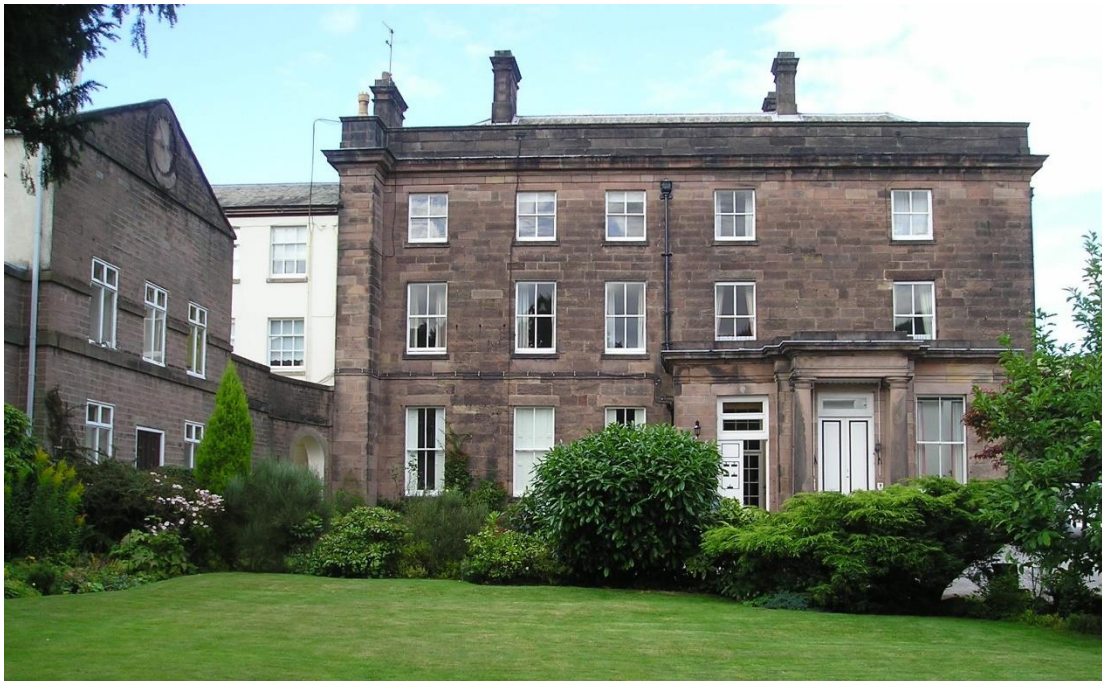
ROCK HOUSE Listed grade 2

The house as we see it today has the appearance of a Victorian structure. The big question is “to what extent is it a modification of the house depicted in the 18th century”.

The degree of weathering which the tooled external face of the gritstone masonry exhibits does not suggest exposure to the elements since the 18th century. The ashlar walls, and the proportions of the window openings within them, are in fact consistent with a date of 1867. They might even be consistent with a date 40 years earlier, but it is difficult to believe they could be consistent with the second half of

the 18th century. It may be significant that the vertical furrow tooling of the east wall and the chimney stacks is quite different to the herringbone tooling of the remainder of the exterior, but the degree of weathering between the masonry of the two tooling types is not marked.

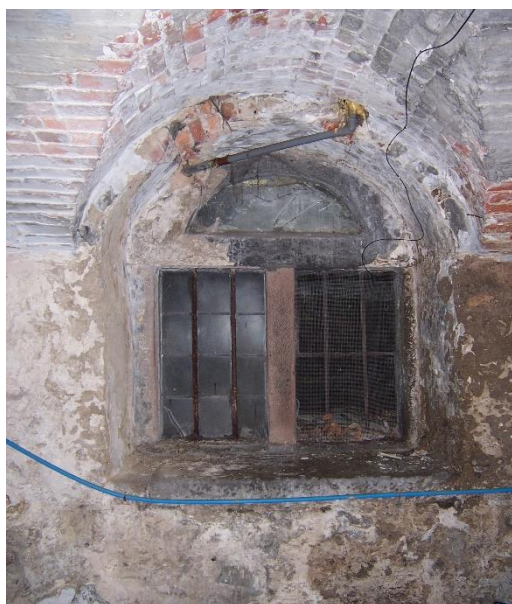
The windows coincide with the three westernmost bays of the present house. They are each made up of rectangular leaded quarries either side of stone mullions and are given distinction by having over them lunettes glazed with single sheets of early glass. These lunette heads echo the lunette windows of Masson Mill built in 1783. The windows could however date from anytime between 1770 and 1800, or even as late as the 1820s. It is likely that the lunette lights were originally 'meshed' rather than glazed, allowing permanent ventilation. Half height iron casement windows, on one side of the mullion, allowed further ventilation.

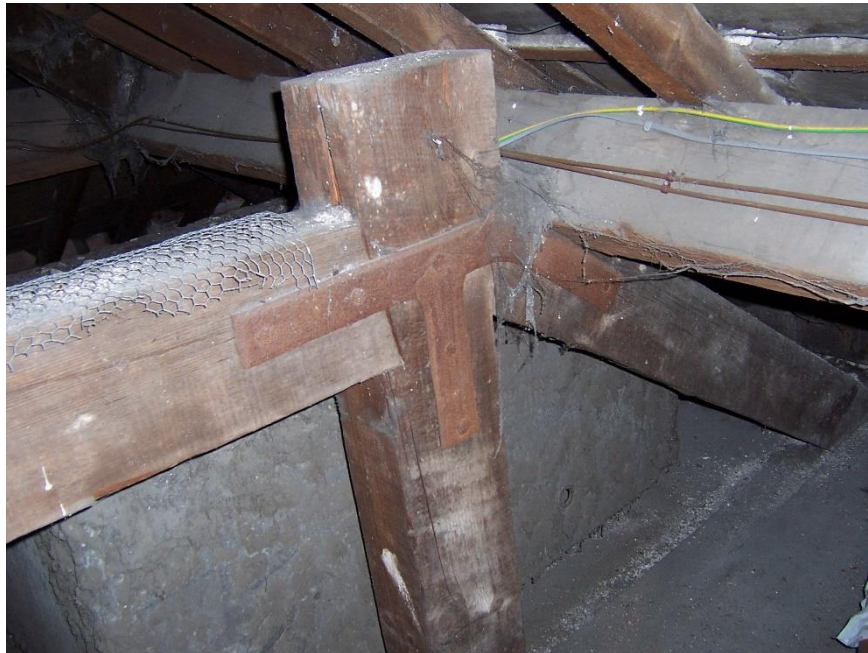
up of queen post trusses, with purlins and rafters. All is in pine. The trusses are reinforced with iron brackets.

The construction methods and materials are consistent with a date of 1867. The floor is lime ash. There is no evidence of the survival of tie beams from the original roof. The roof is partly covered with Westmorland slates and partly with Welsh slates.

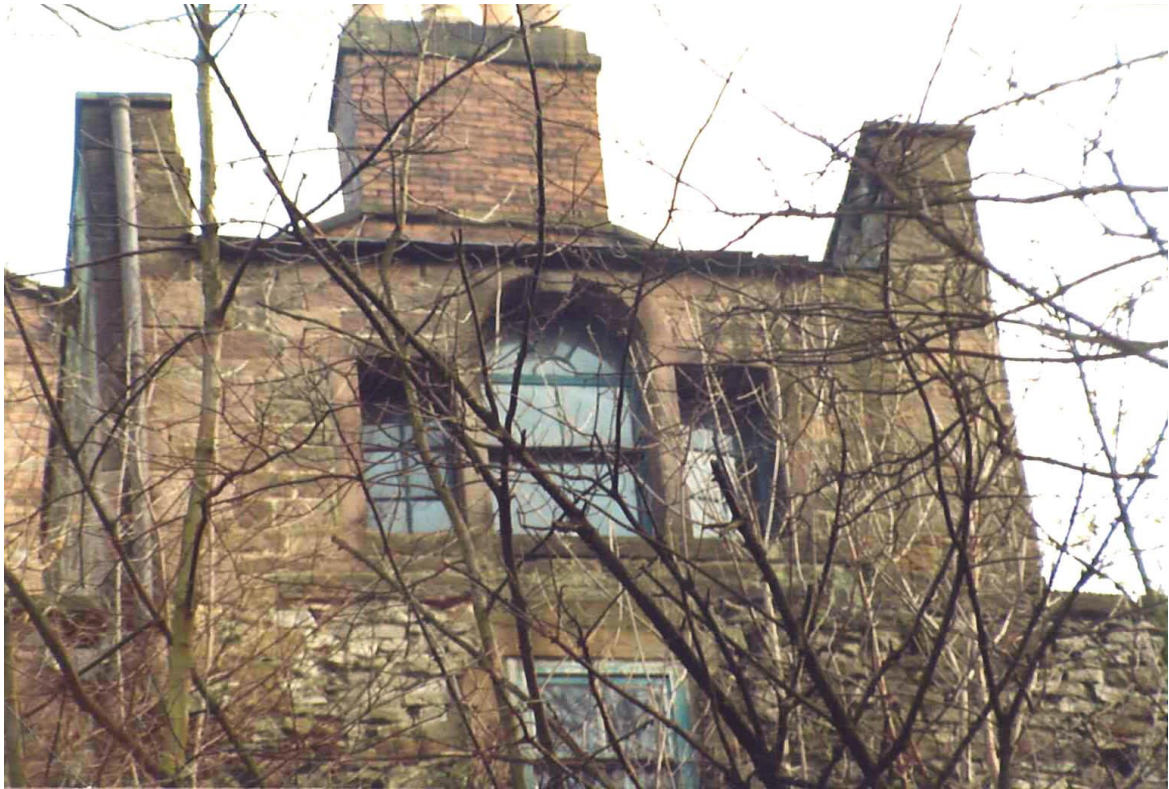
This photograph of 1982 shows the building before it was extended.

It may be seen that the joinery of the Venetian window is deeply set back at the rear face of the stone reveals. The position of the joinery at the back face of the stone window dressings is unusual and appears particularly strange here because of the small scale of the building within which the rather grand window sits. The result is that the openings are given deep shadows and appear almost as if they are unglazed. Was this perhaps a deliberate intention, giving the structure the look of a decorative garden gazebo perhaps?

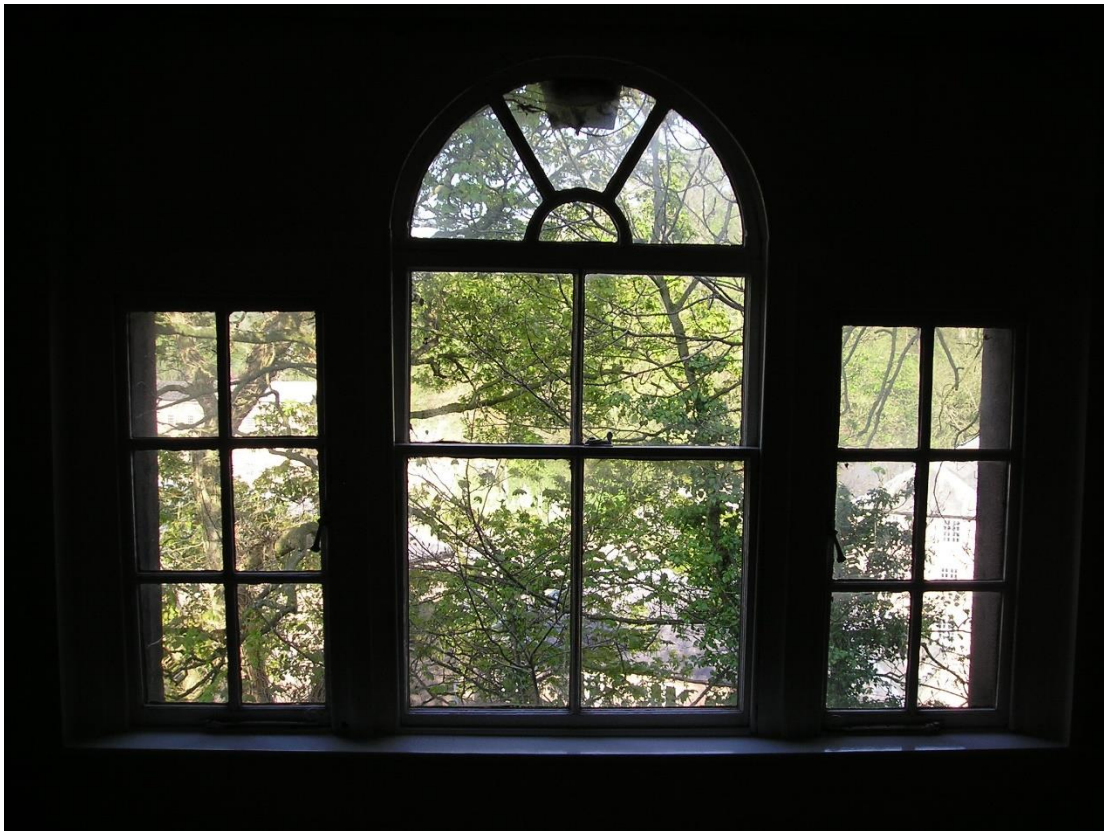
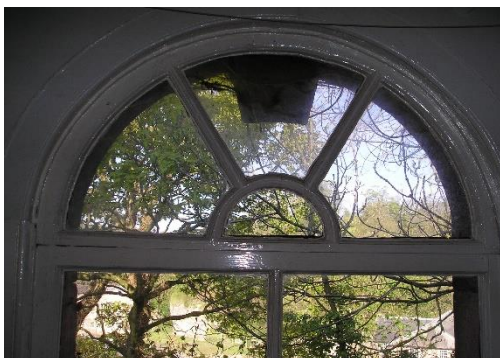
The shaped window stones are set within gritstone ashlar walling, sitting on uncoursed limestone rubble walling, which comes right off the cliff face. Below the Venetian window there is a smaller sash window, set into the limestone rubble wall. This is a modern (20th century) insertion. The building is now largely obscured from sight, from Mill Road, as a result of tree and scrub growth, but at the time it was constructed the rockface would probably have been bare of vegetation and the view through the Venetian window would have been unobscured, providing a panorama of the whole of the mill yard and encompassing the entrance point to the yard off Mill Road, opposite the Mill Manager's house.

The fanlight and side opening casements of the Venetian window are probably the original joinery. The sash window beneath the fanlight appears to be an alteration. The larger glass pane sizes and the slightly thinner glazing bar profile suggest a 19th century date, although the absence of 'horns' indicates it is probably dates from the first half of the century.

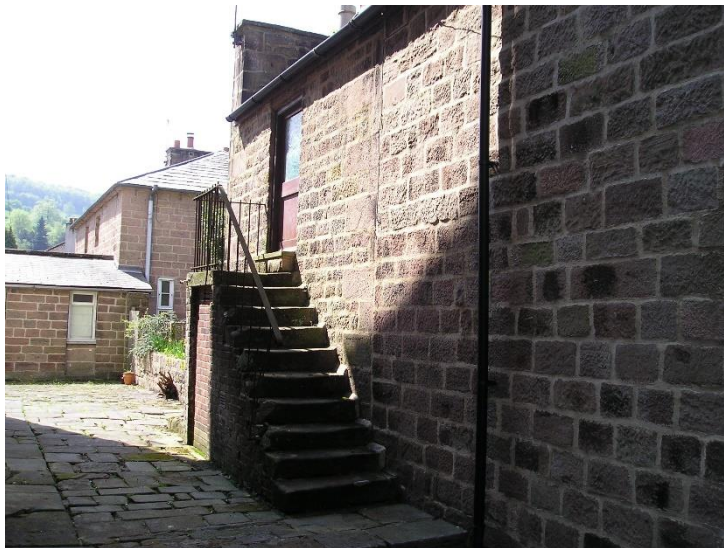
Access to the upper room is gained via an external stone staircase, supported on brick walls.

The pitched roof is asymmetrical, having a longer slope on the house side. The eaves of the short slope, i.e. the Mill Road side, sits uncomfortably low down, onto the top of the Venetian window. Was this slope originally hidden behind a parapet, the top of which was level with the top of the flank parapet walls. There are chimney flues within both of these two flank parapets, suggesting the existence of at least two fireplaces.

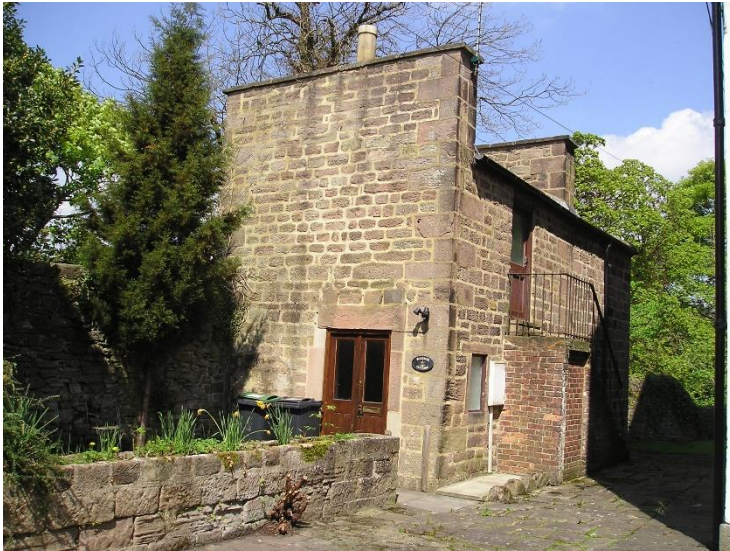
The entrance door to the lower room was originally immediately under the door to the upper room. This is now bricked up. The lower room was originally lit by a window where the entrance door has been re-located.

The low yard wall between Rockside Cottage and Ridge House is in fact a truncated remnant of a 7'-0" or so high wall which completely enclosed the space behind it until the wall was lowered in about 1980. There was also until the 1980s another high wall spanning between Rock House and the cliff face, closing off the yard from the garden beyond.

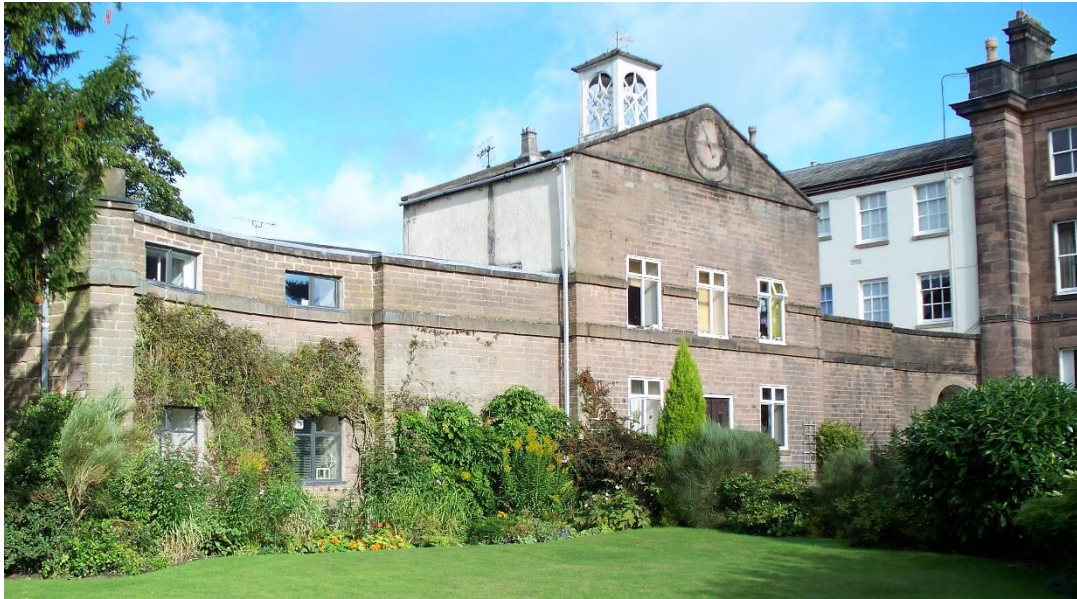
It is a symmetrical Palladian composition and in its original form rather severe in character. The east façade is now punctured by a door and five windows and the southern flank screen wall punctured by a further four windows, but a photograph in the sale catalogue of 1924 reveals that the whole façade was originally completely blank. It may be seen therefore that The Mews was carefully designed to provide an august setting for Rock House and to screen the service courtyard from view.

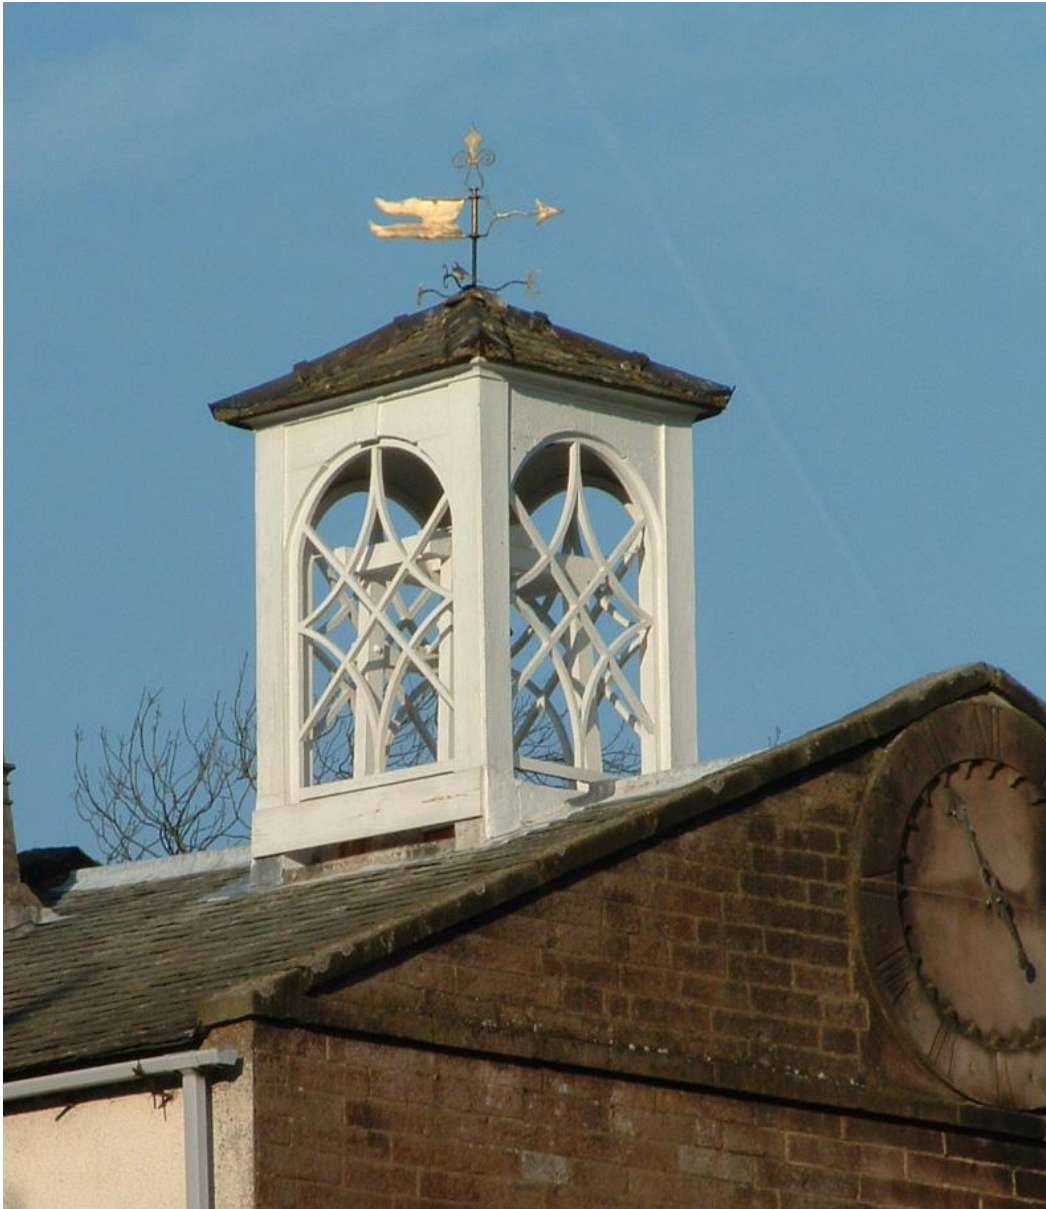
Further architectural enrichment is provided by a carved clock dial within the pedimented gable. The clock dial retains its decorative single hand. Capping the

whole ensemble, above the graduated Westmorland slate roof, is a decorative bell-cote or cupola, itself topped with a gilded wind vane.

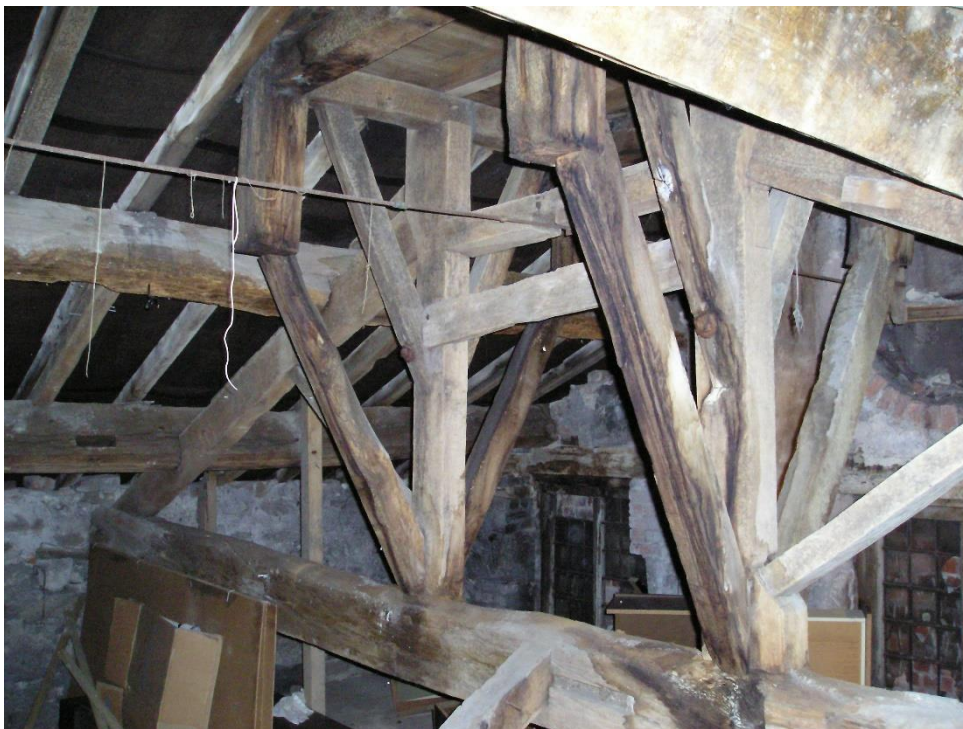
The roof timbers are oak. It is apparent from the existence, within the four purlins and the tie beam of the queen post truss, of mortice slots and peg holes designed to receive and fix tenoned elements of a timber frame, that these are reused timbers from a timber framed building of 17th century or earlier origin. The tie beam of the truss has an (internal) span of 24'-6".

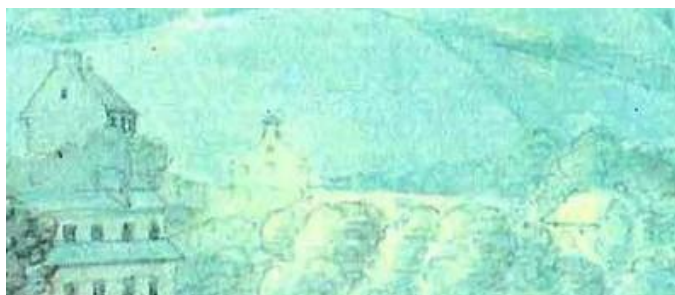
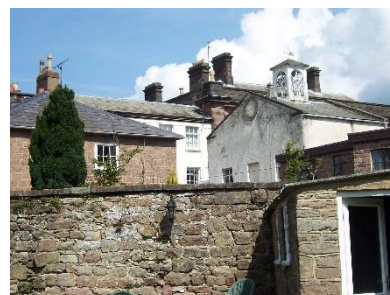
The Day painting of 1789 shows the western (rear) face. The existing stone roundel may be made out in the apex of the gable. This accommodated a clock face for the

service yard. It perhaps had a painted face. The metal rod connecting it with the hand to the clock face on the front façade may be seen in the photo of the attic space⁴⁸.

Day shows three equally spaced windows on the first floor and second floors. The first floor openings survive and 'sit' on a continuous stone band course. The second floor windows are no longer visible on the exterior, because they have been blocked up with brickwork and rendered over but they may still be seen internally, and remarkably retain their original rectangular leaded lights and horizontal saddle bars.

⁴⁸ The remains of the clock and the attached control mechanism for the striking of the bell were inspected on 21 June 2009 by tower clock expert Michael Applebee. His report records finding evidence of a 2-train (stable) turret clock movement, but without its original mechanism, except for one unusual dial with an unusual single hand and a rusty horizontal power transmission rod, approximately 15'-0" long from the back of the main dial via a heavily corroded universal joint to the site of the former clock works. The absence of gears behind the dial implies that the single hand is original (although highly unusual). In addition a simple bell crank system survives, leading to the bell cupola.

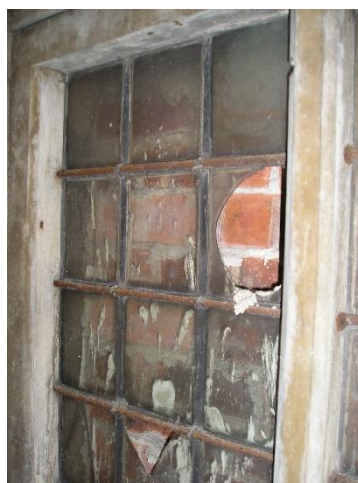
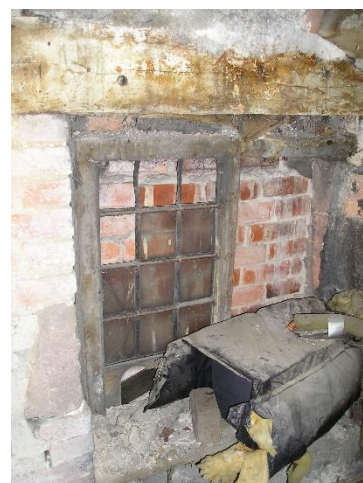
The boarded floor to this (originally lit) attic space has within it, below the clock dial on the service yard side, a 'trimmed' opening which was presumably made to accommodate the weights for the clock, which must have hung in the room below.

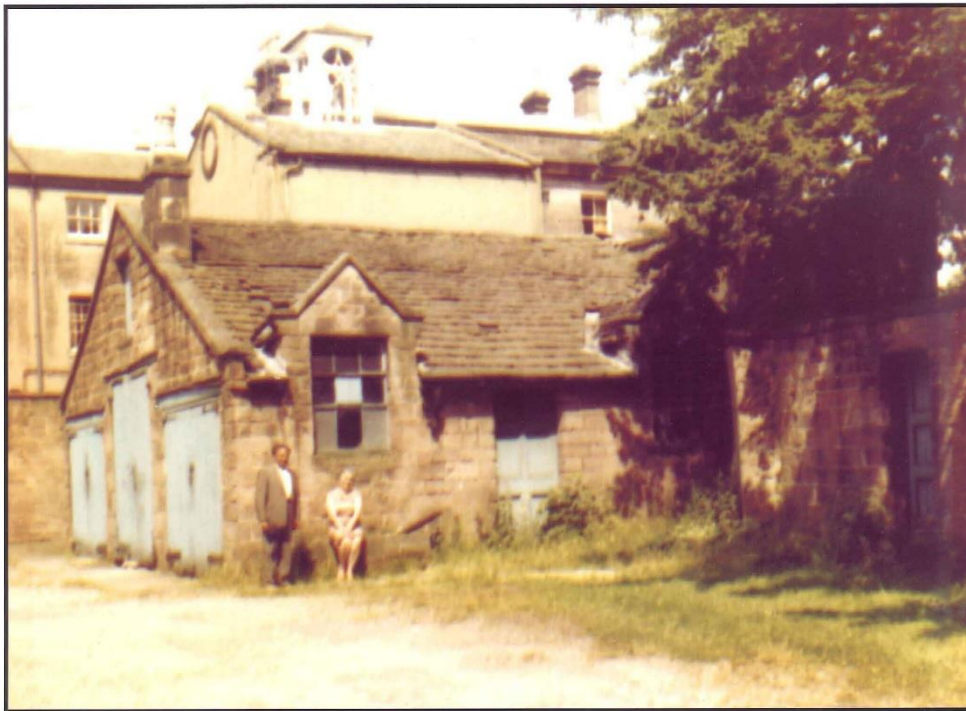
Planning permission was given in January 1973 “to demolish old yard garages and erect two storey dwelling house behind existing stone screen walls”. This presumably refers to the modern house called Stable Grange.

The building in the photograph has the appearance of having been built in the 19th century. The need to construct a new service building is unknown. It may have coincided with the addition to the Mews, on the northern side, of the existing single storey extension, which has two large, tall, windows. Was the Mews given a new use at that time?

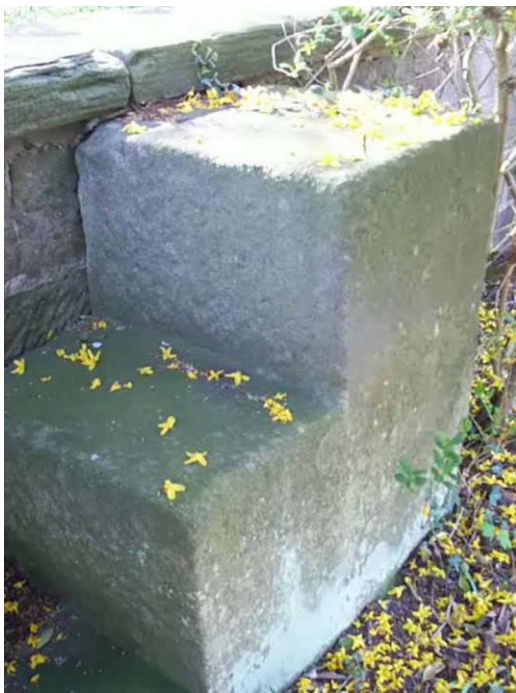
Beside Stable Grange lies the truncated remains of the tall screen wall seen in the photograph of the 19th century stables. A stone mounting block stands beside it.

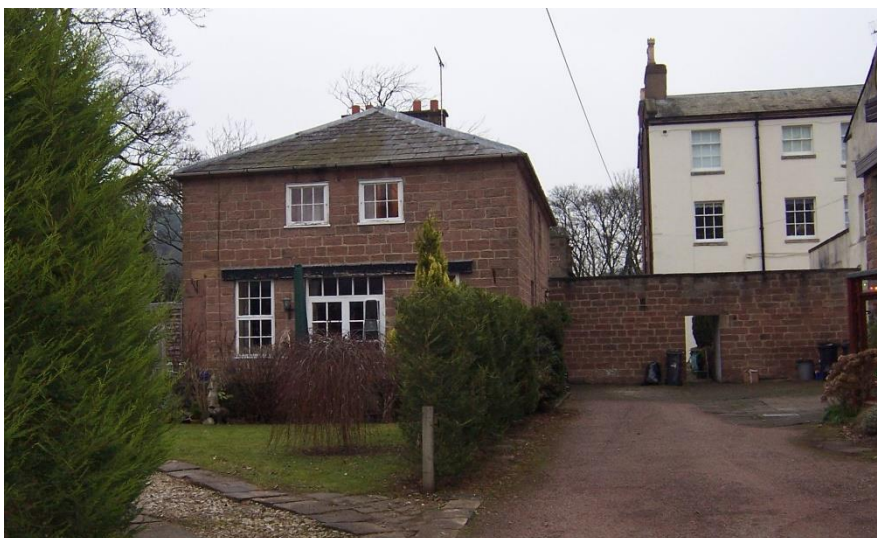
RIDGE HOUSE. Curtilage listed grade 2

Like Rockside cottage, this building sits on the very edge of the rockface above Cromford Mill. A 1976 planning notice, with a plan identifying this building, allowing for the conversion of “coach house to dwelling”, reveals its former use. This may therefore be where Sir Richard Arkwright housed his long-distance coach and perhaps a lighter vehicle for local journeys.⁵⁰ The existence of inverted T shaped lintels to the original ground floor windows, like those that appear in some of the Mill buildings and in Market Place buildings, a building detail which probably came to Cromford from John Carr’s Buxton Crescent of 1785-90, suggests that the building may date from the late 1780s.

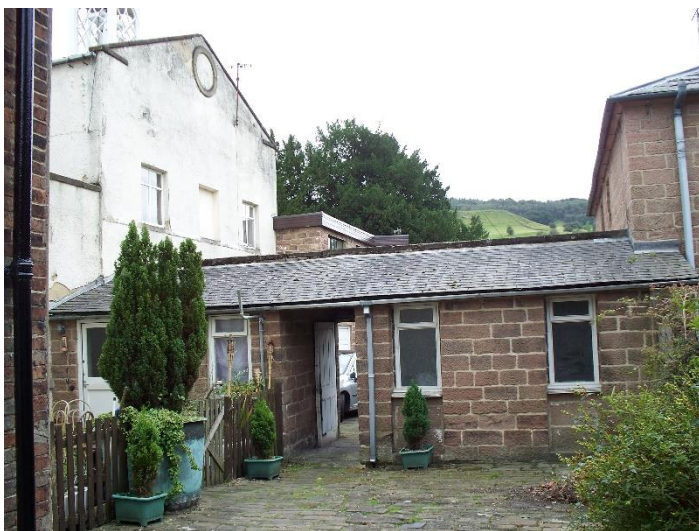
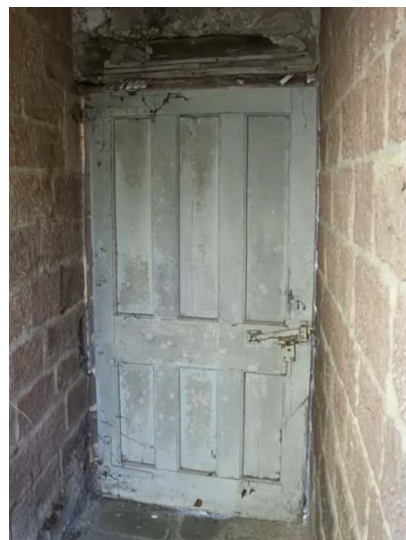
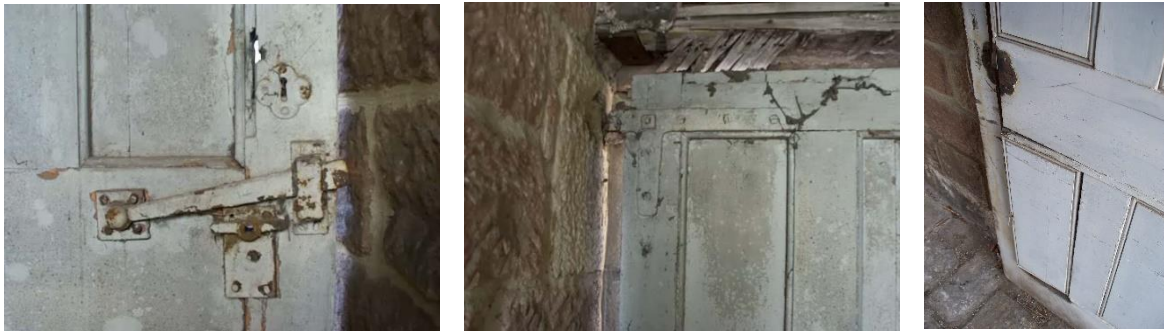
Connecting this former coach house (Ridge House) to the stables (the Mews) is a range of four piggeries, lying surprisingly close to the service range of the house. The back wall of the piggeries provides a screen wall to the yard between the coach house and the stables, part of which retains its original gritstone paving, as does the service yard between the Service Range and the Piggeries. Although in a bad state of repair the flush six panel door within the south wall of the Piggeries would seem to be the original. It retains original L shaped hinges, pintle hanging arrangements and latch.

All the piggery stall openings have been altered to accommodate windows and a door. The sills to the windows seem to be made from pigsty dividing screens, which have reeded edges. The monopitch roof is covered in Welsh slate.

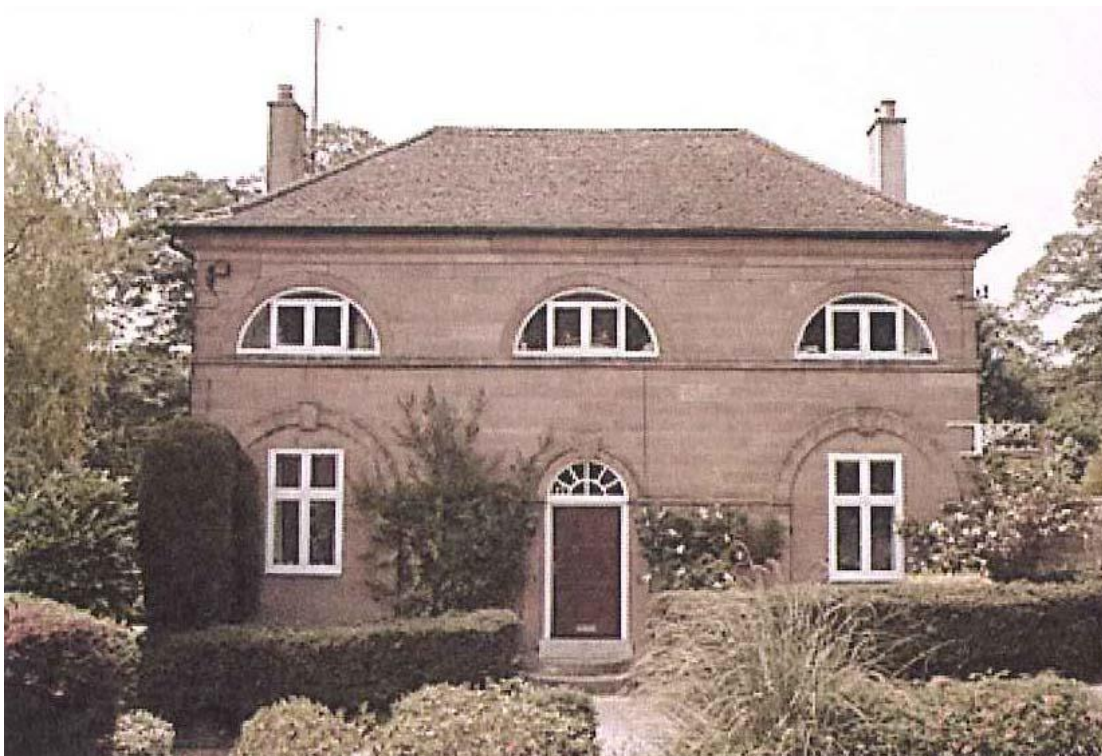
The elaborate detailing includes a deeply moulded stone eaves cornice and a belled hipped roof. The walling is dark red gritstone, finely tooled to produce an ashlar finish. The coach house originally had two arched openings, with key blocks,

This is an imposing architectural composition with elaborate detailing. The coach house is given a date of circa 1780 in the statutory list and its architectural style certainly suggests a date of 1780-1790.

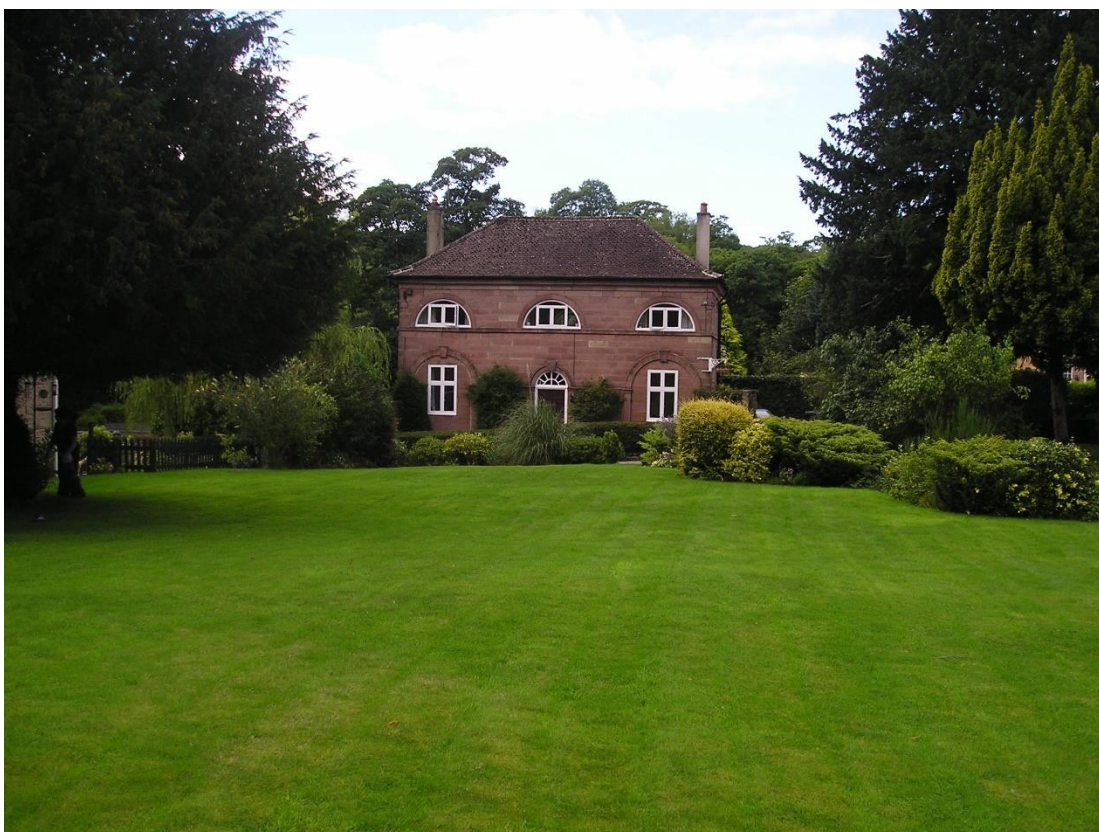
Above the doorways, sitting on a band course are three, equal sized, semi-circular openings, which are matched in the rear wall. These would have lit the upper floor if glazed. Even if they had been shuttered they would have provided light when open or partly open. There are two modern chimney stacks. This suggests the building may originally have been unheated. The interior, following conversion to a house, provides no clues to its original appearance. The roof has king post trusses and all the roof timbers are oak.

The architectural sophistication of this building is interesting. It is out of sight of the house, but on the route of the carriage drive leading up from Mill Lane. Perhaps it was intended to be a garden feature.

It does not appear in Day's painting of 1789 but its architectural style and the use of oak for its roof certainly puts it more at the end of the 18th century than at the start of the 19th century. It is clearly designed by a different hand than that which designed the Mews, which has quite a different feel about it, and probably predates the Coach House. An important factor is the relative lavishness of the detailing of the masonry⁵¹. It is superior in architectural quality and craftsmanship than that of the stables to Willersley Castle, in which the mason/architect Thomas Gardner is believed to have played some part.⁵² Another factor is that the door openings (7'-0" wide and 10'-0" high-to the head of the arch) are of a scale that would not easily accommodate a carriage designed to travel long distances⁵³. Was it built to accommodate phaetons or gigs for local journeys? Perhaps it was not built for Milnes or Richard Arkwright I but for another generation of Arkwrights,

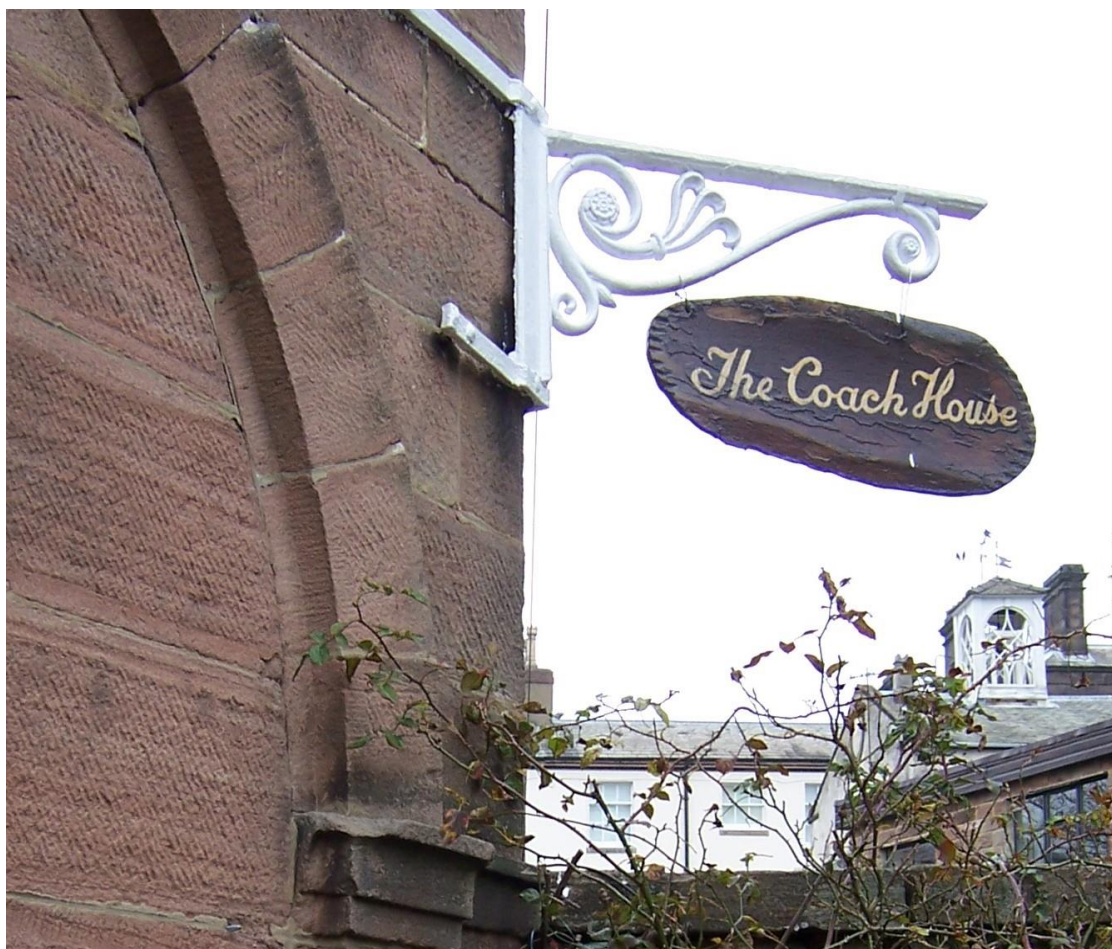
There is one ironwork detail which can be roughly dated; a decorative corner bracket (originally for a lamp?). which has a decorative motif derived from the anthemion. This motif would fit an early 19th century date very well. However, the bracket could well have been added at a date after the construction of the building.

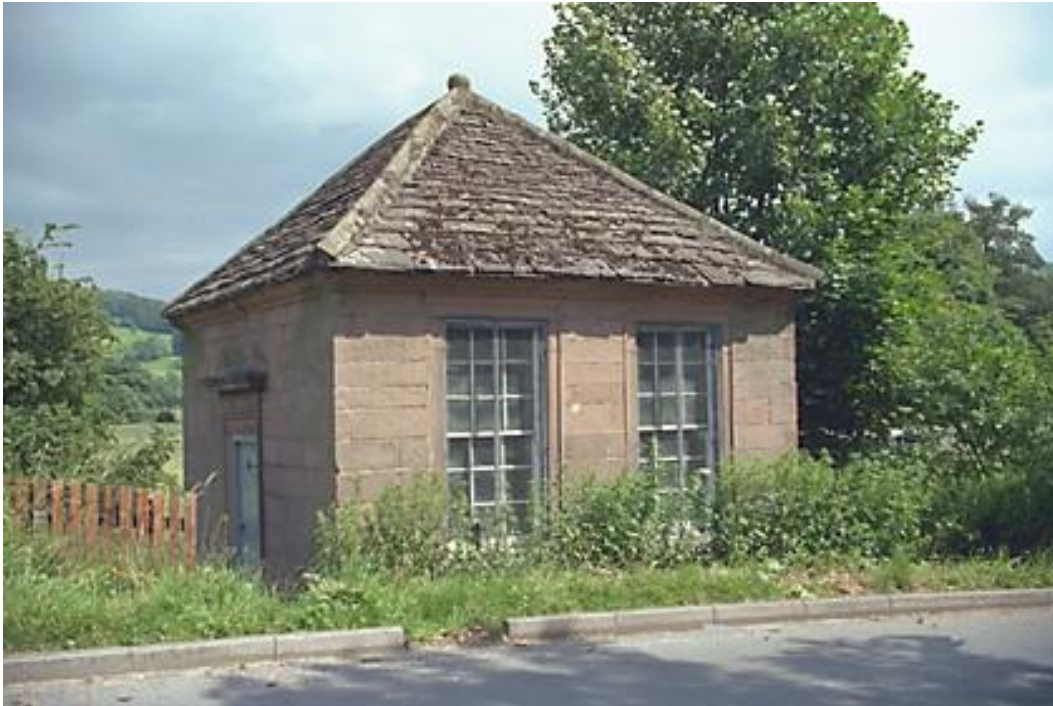
FISHING LODGE Listed grade 2

A watercolour dated 1786 shows a cluster of vernacular farm buildings beside the river bridge at Cromford which includes a pyramidal roofed building.⁵⁶ In 1796 this vernacular building was refashioned by Richard Arkwright II to function as a dwelling for his water bailiff. It must have been a considerable re-fashioning, requiring the insertion of a moulded eaves cornice as well as sash windows and a door, all with elegantly moulded surrounds. The door has inscribed over it "piscatoribus sacrum", this being an allusion to the 17th century Fishing Temple in Beresford Dale, made famous by Izaak Walton, which also has a pyramidal stone slate roof crowned by a ball finial.
