# Cromford Mills Complex

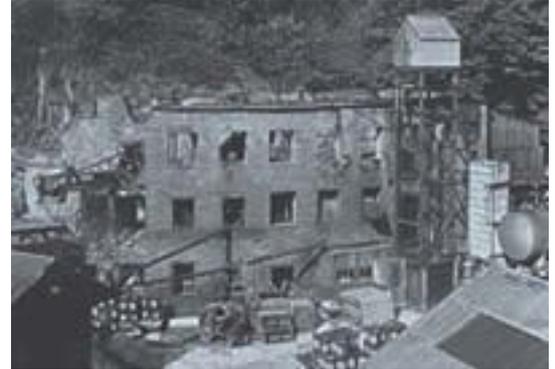
## The Barracks

The 'bow-fronted' building was in existence by 1786. It was badly damaged by fire in 1961. Subsequently it was demolished, but not before it had been photographed by the Royal Commission on the Historical Monuments of England (RCHME). Oral tradition has it that this was the barracks: the accommodation for the unmarried male workers of the mill who lived too far from home to travel from work each day. The foundations of this structure have been excavated and consolidated as part of the conservation and interpretation of the Cromford Mill site.

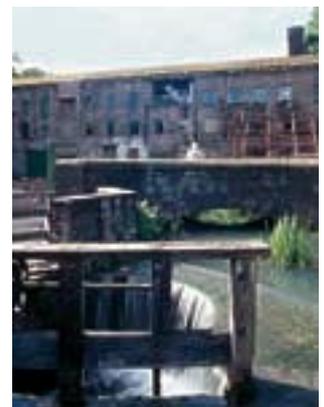
## The Mill Basin Weir and Culverts

The basin weir c.1777, in the middle of the mill yard, the wheel pits of the first mill extension c.1786 and second mill 1777, the culvert which took water to the Cromford Canal c.1820; in particular, the massive culvert 1777 which runs from the second mill into Cromford Meadows and on to the river Derwent though for the most part unseen, are all features of outstanding historical importance.
