Cromford Mills Complex

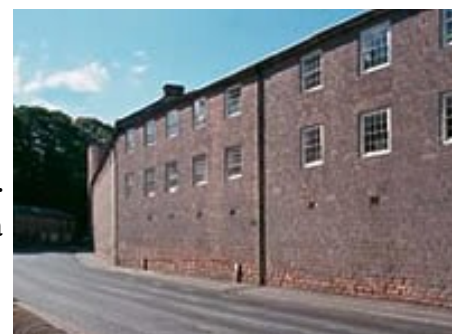
Building 15

This three-storeyed stone building with sash windows links buildings 14 and 16. It is clearly later than either of its neighbours. It contains significant remains of a hot-air heating system which may have served both this building and the adjoining building 14.

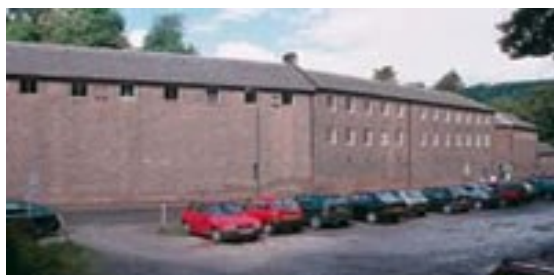
Building 14

This three-storeyed stone building is thought to have accommodated workshop space on the ground floor. The upper floors show signs of having been used for machinery, possibly knitting frames. The building was originally linked at first and second floor level by a bridge to the second mill.

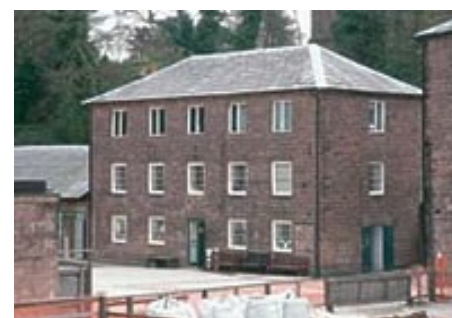
Building 10

Archaeological evidence suggests that this three-storeyed stone building was constructed and used as a warehouse. The second floor windows remained unglazed until the 1980s, protected solely by internal shutters. Once its textile function had ceased, it is known to have been used to store cheese awaiting shipment on the canal, and later timber.

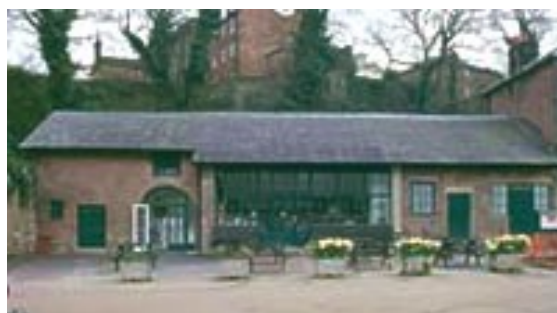
Buildings 8 and 9 (The Restaurant)

The original use of this building was as a stable and coach-house. It has now been incorporated into the Cromford Mill restaurant.
