SWAINSLEY FARM

**A SHORT STUDY OF
THE SIGNIFICANCE OF THE FARMSTEAD**

Alex Gilbert

August 2024

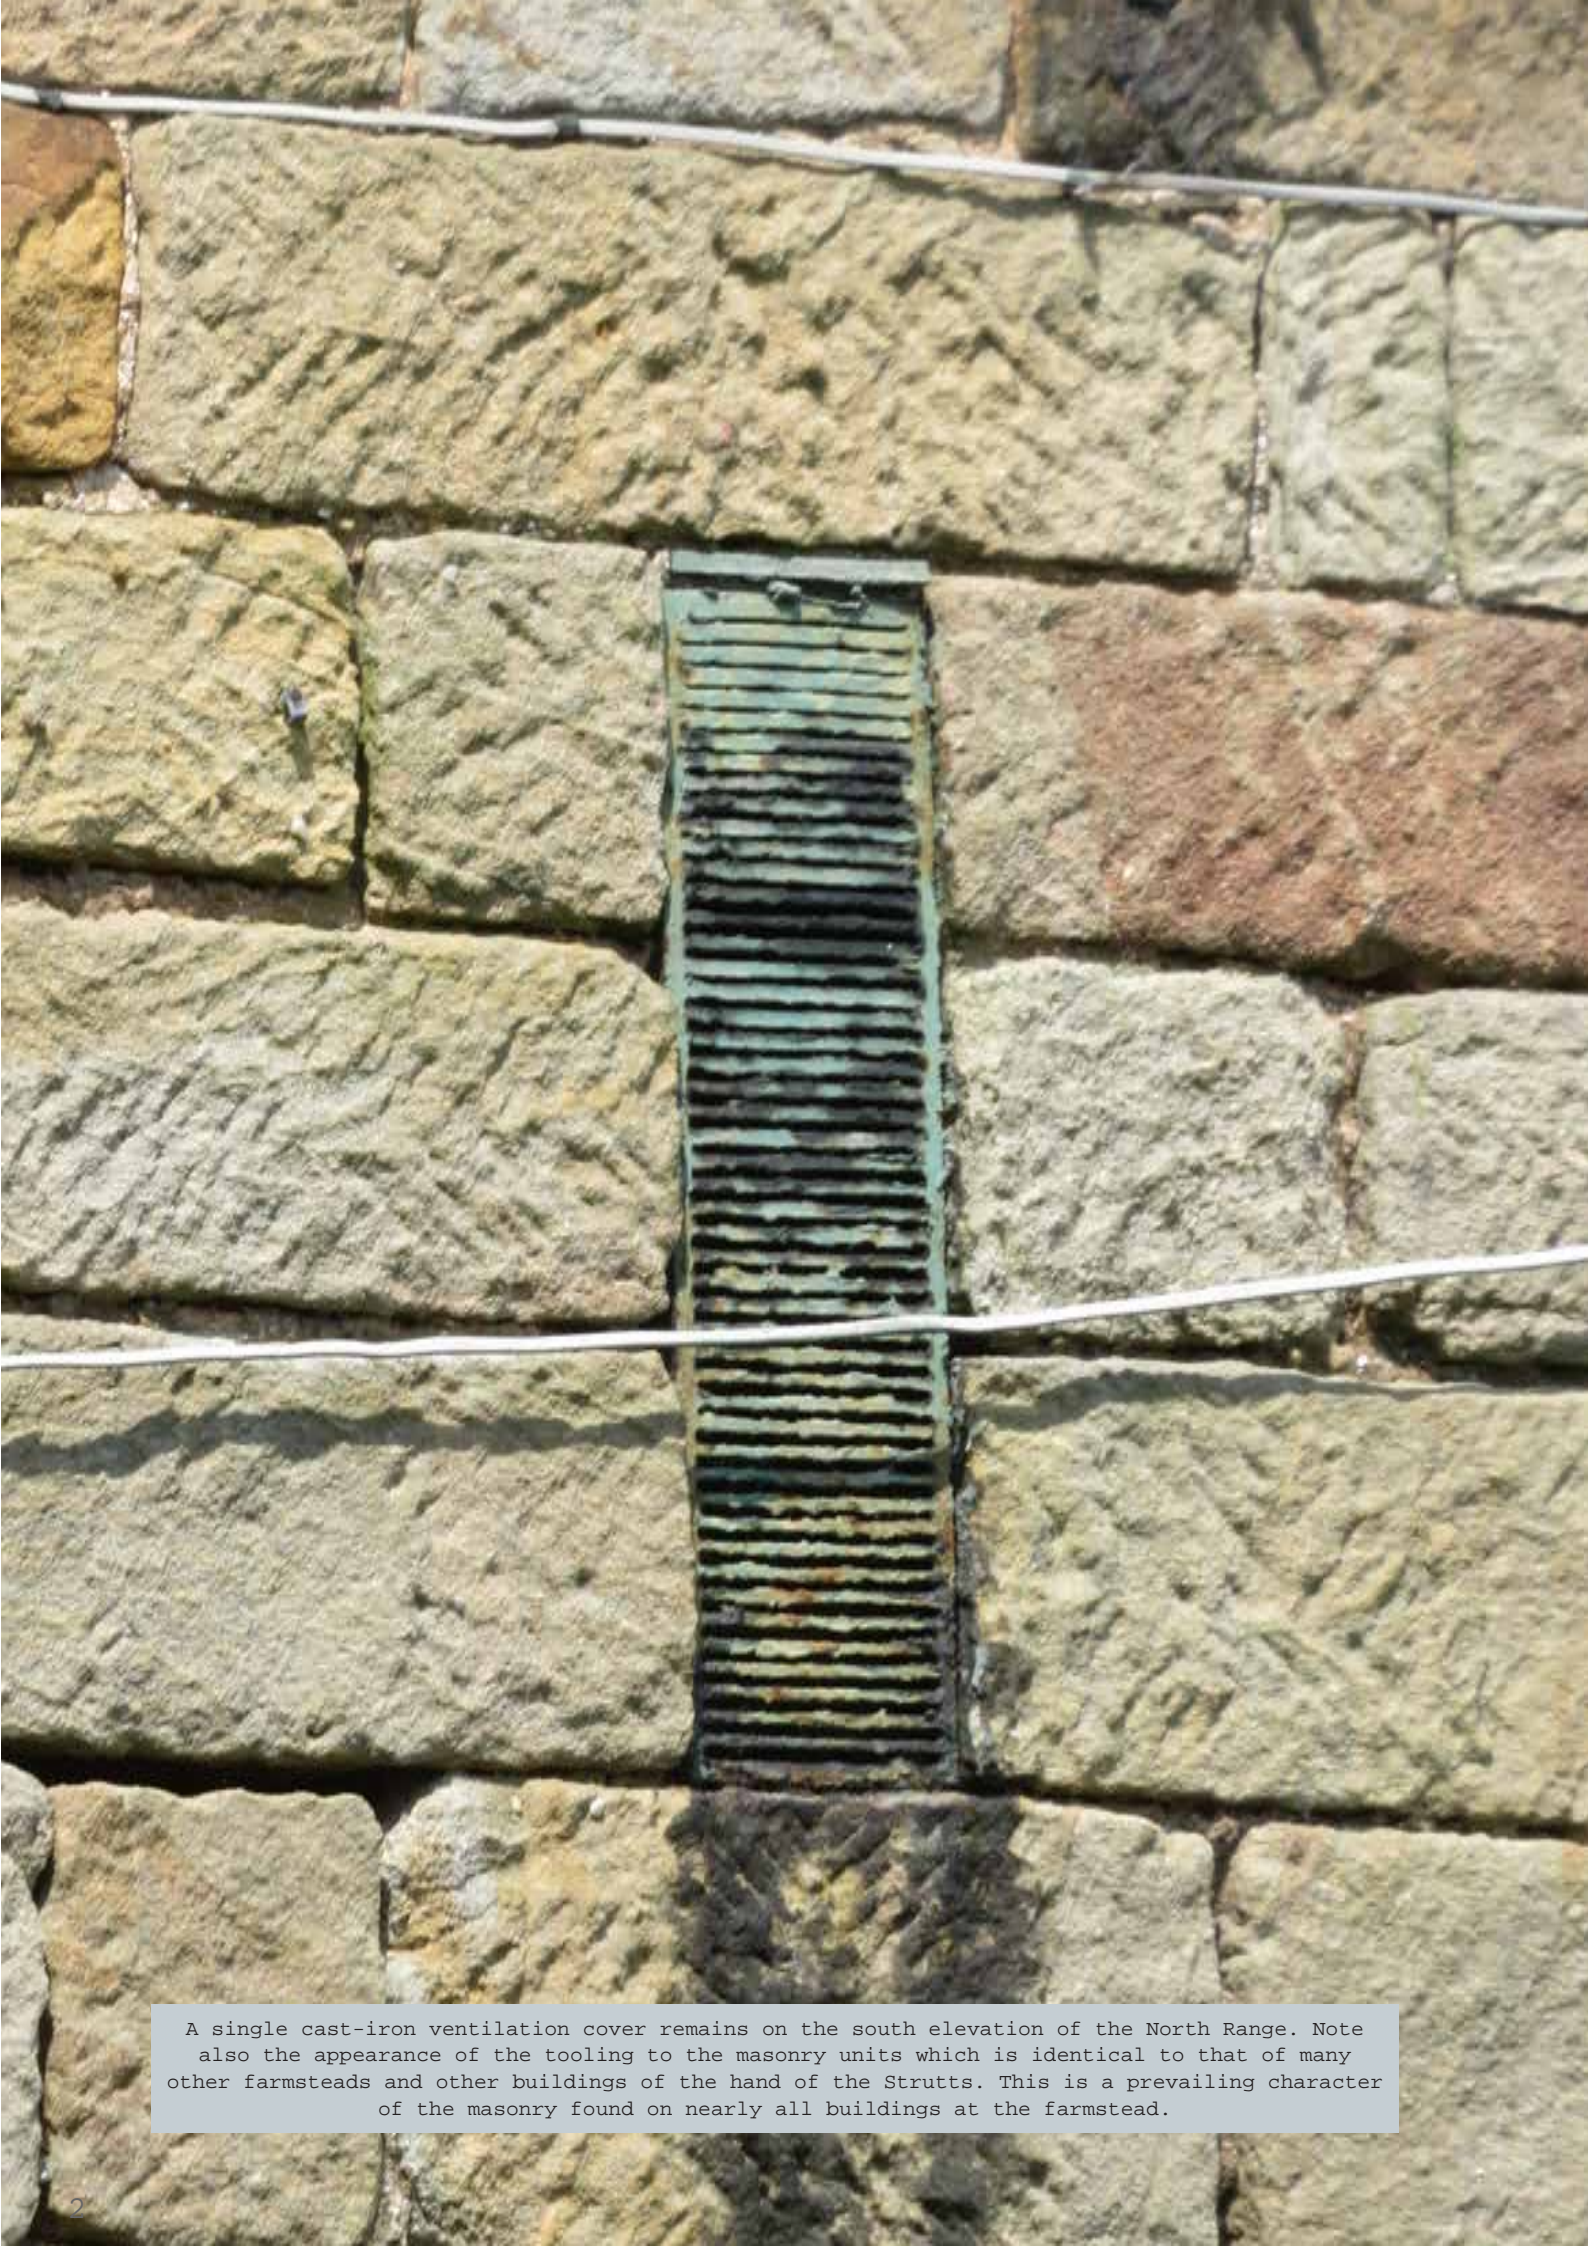
A single cast-iron ventilation cover remains on the south elevation of the North Range. Note also the appearance of the tooling to the masonry units which is identical to that of many other farmsteads and other buildings of the hand of the Strutts. This is a prevailing character of the masonry found on nearly all buildings at the farmstead.

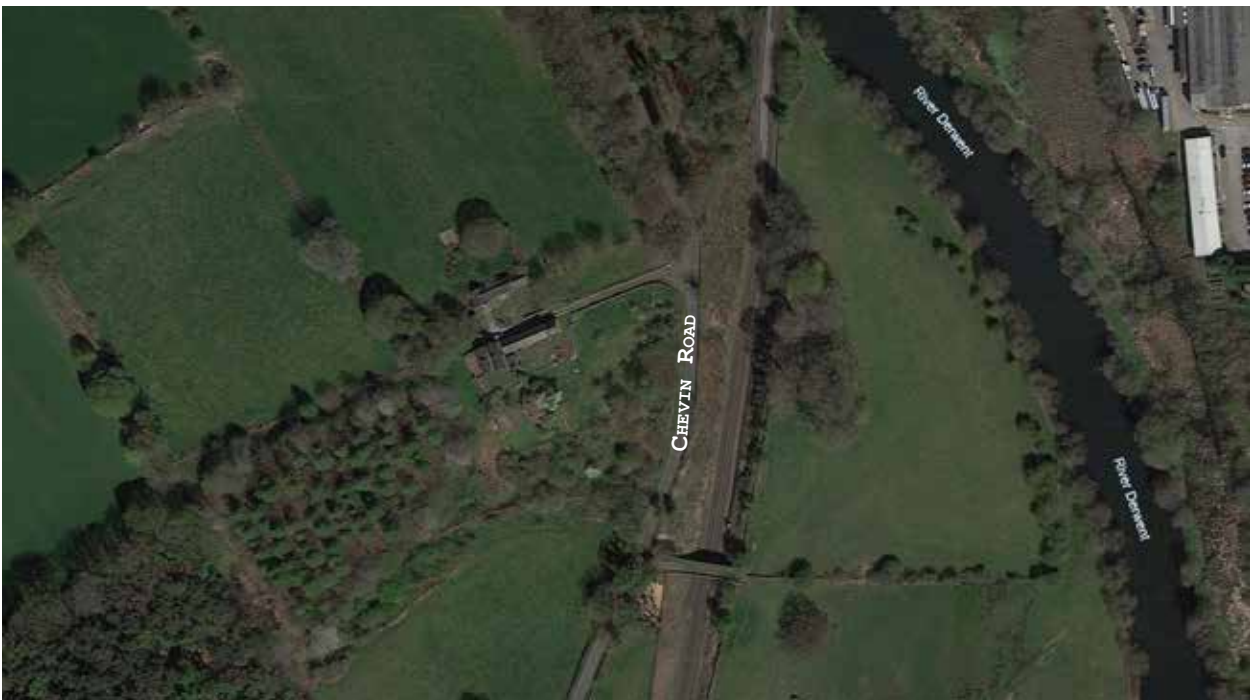
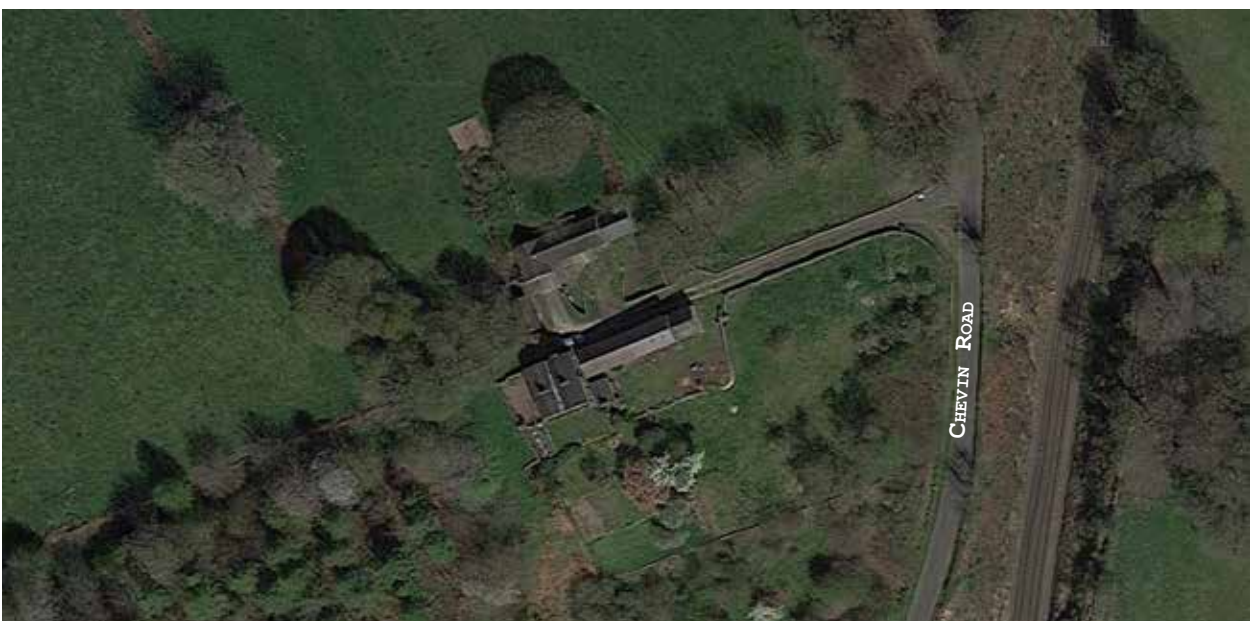
Fig's. 03 & 04 (top to bottom): Distant and close-up aerial views of the farmstead, respectively. The farmstead can be accessed from the north and south from Chevin Road.

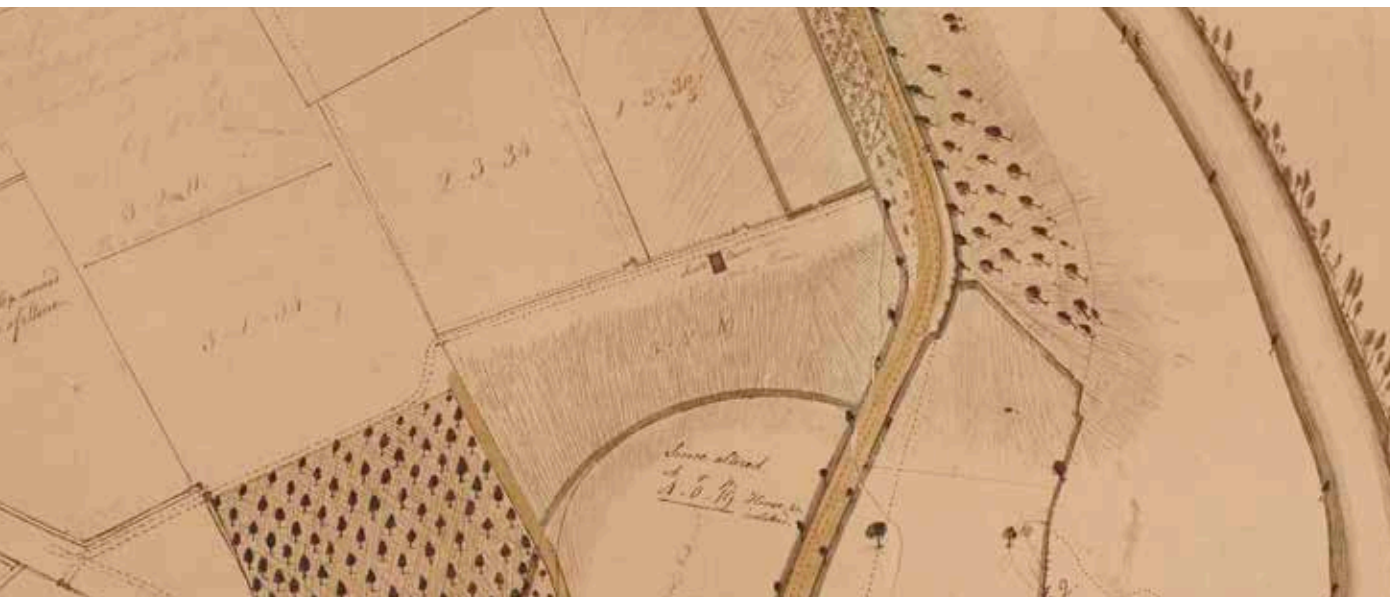
Fig. 06: 1792 Survey and plan of land etc. in Milford and Makeney belonging to Jedediah Strutt, Esq. of the New Mills, parish of Duffield (DRO Ref# D1564/13). The map shows a 'small barn later turned into a house' on the site of Swainsley Farm which indicates that part of the existing farmhouse could be 18th century. An access track is present although no other buildings are shown.

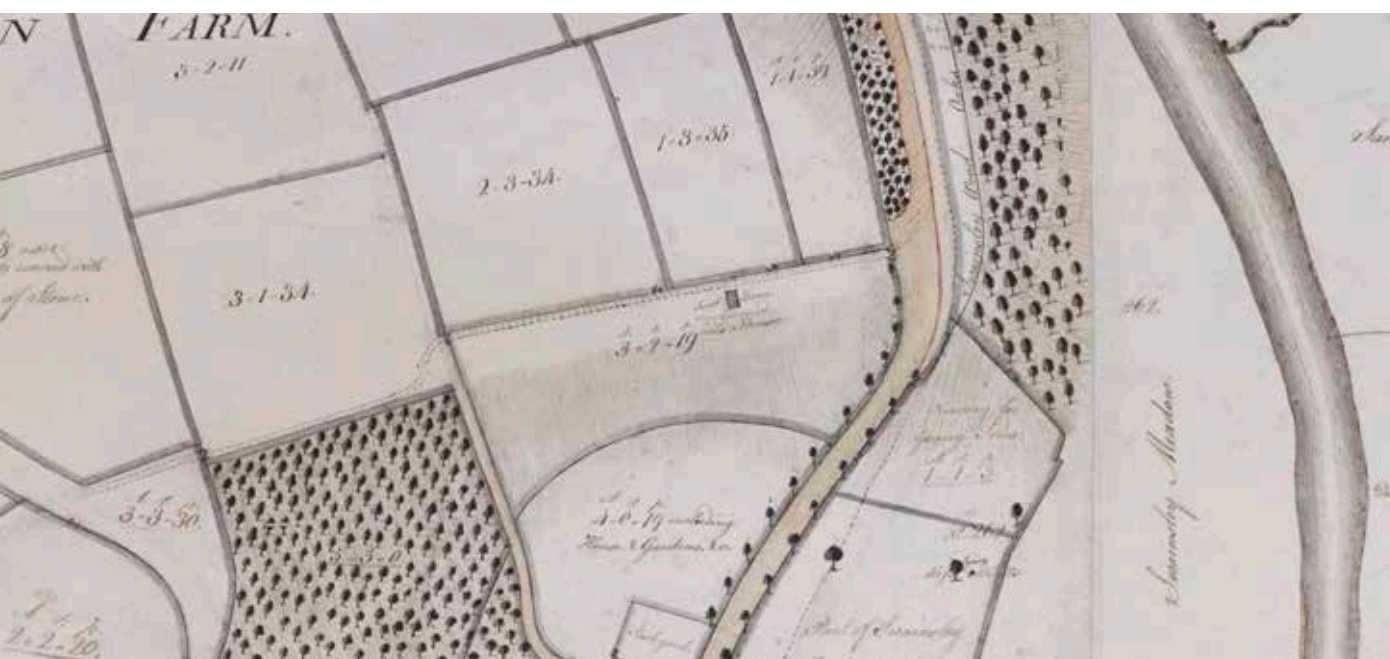
Fig. 07: 1805-1818 Map of the Strutt Estates in Belper, Duffield and Makeney (DRO Ref# D1564/3). No changes appear to be shown. The woodland to the right of the farm is labelled 'Swainsley Wood' which is presumably where the name of the farm later derived.

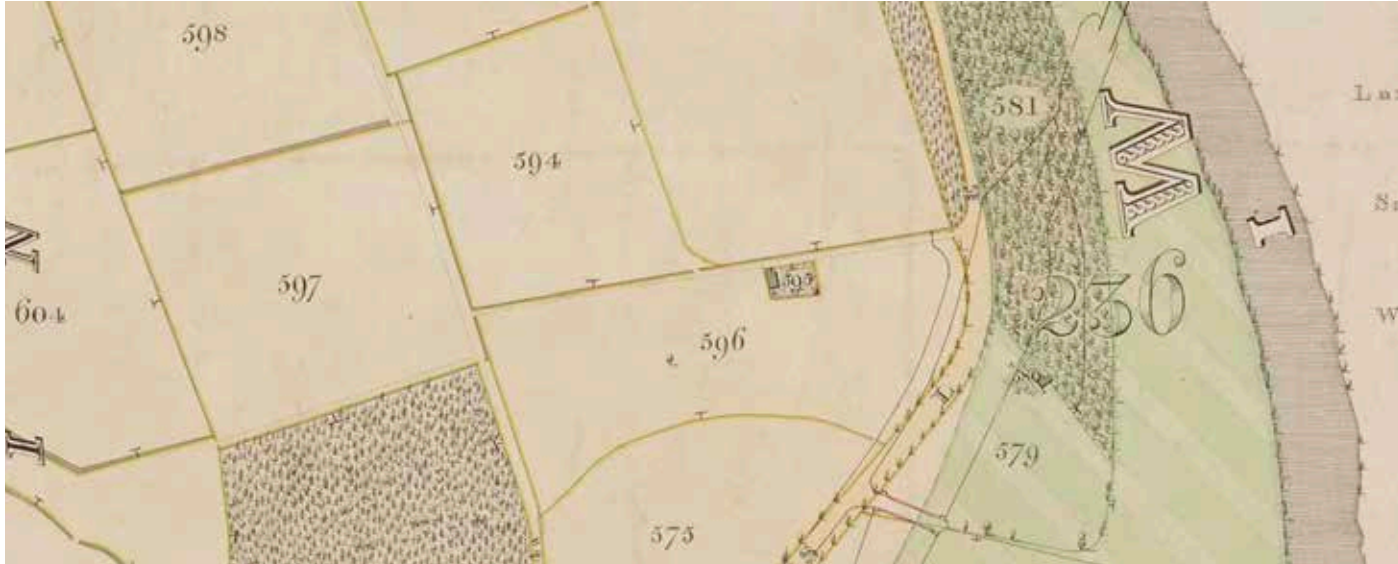
Fig. 08: 1819-20 Map of the Strutt Estates in Belper, Duffield and Makeney (DRO Ref# D1564/24). A garden area (595) appears to be shown, with a small built feature appearing in the SW corner; it is thought that this has long since been demolished.

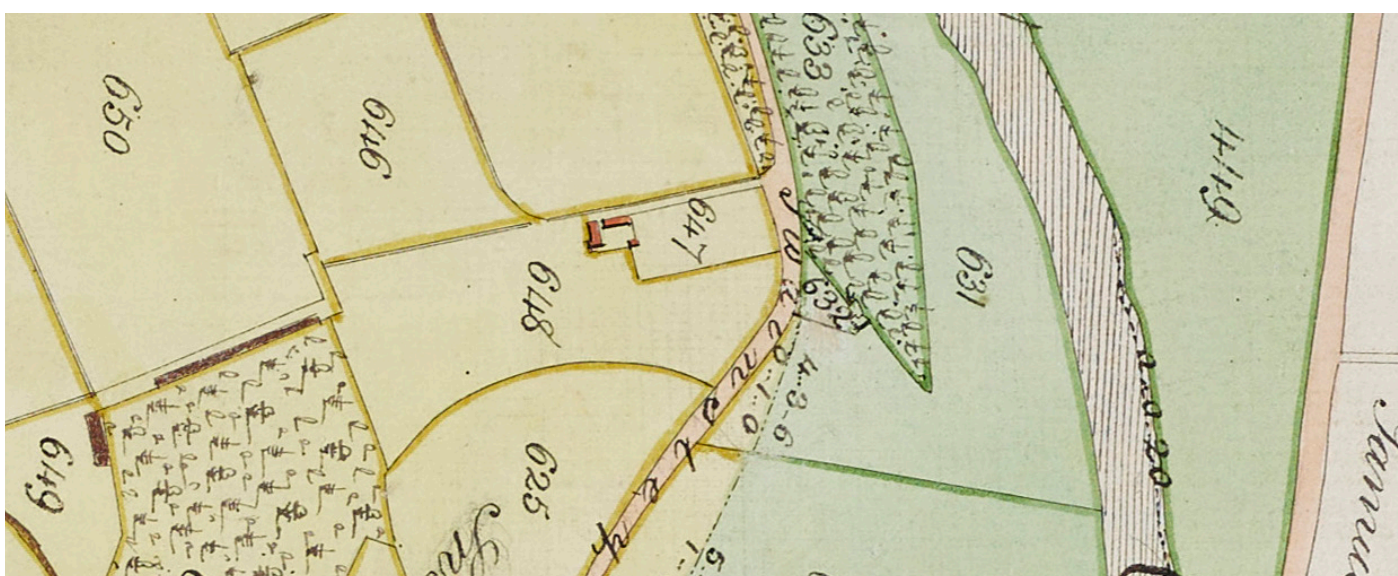
Fig. 09: 1829 Map of the Strutt Estates in Belper, Duffield and Makeney (DRO Ref# D1564/28). The map now includes what is now referred to as the South Range (Hay Barn, Cattle Sheds & Cart Shed) to the east of the farmhouse. A small walled enclosure (647) has also been added.

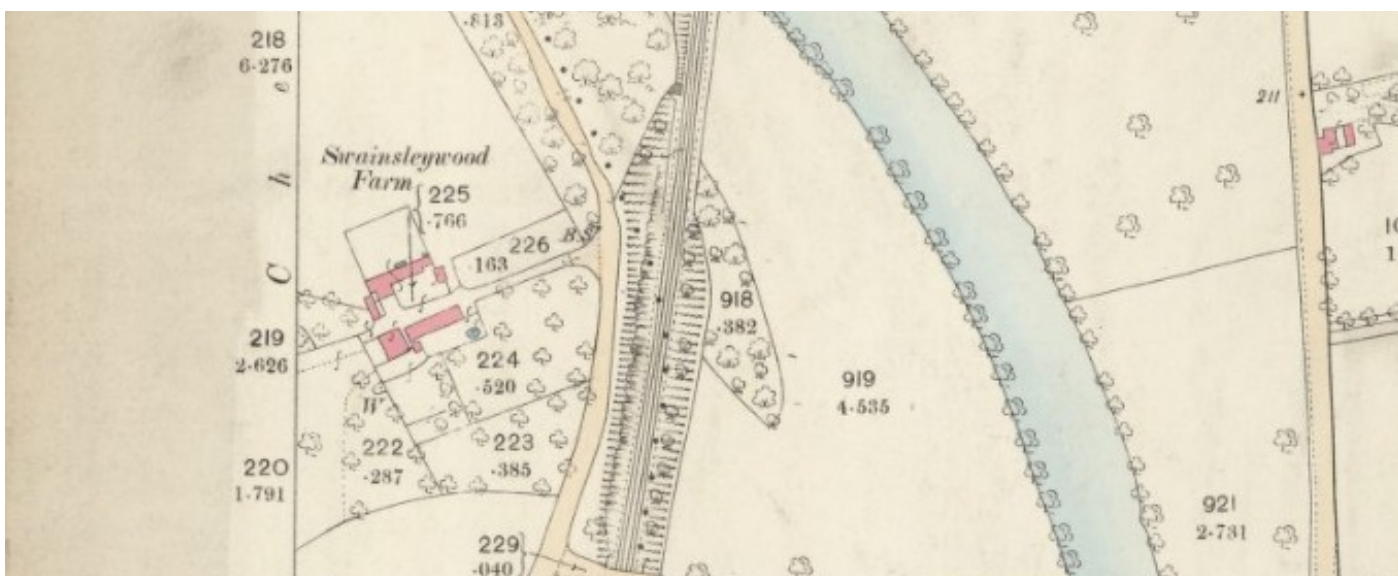
Fig. 10: 1877-1879 first edition OS Map (25"/mile). The information on the map indicates that the farmstead was significantly developed during the mid part of the century to include many of the buildings present today. Note that the farmstead is identified as 'Swainsleywood Farm' for the first time.

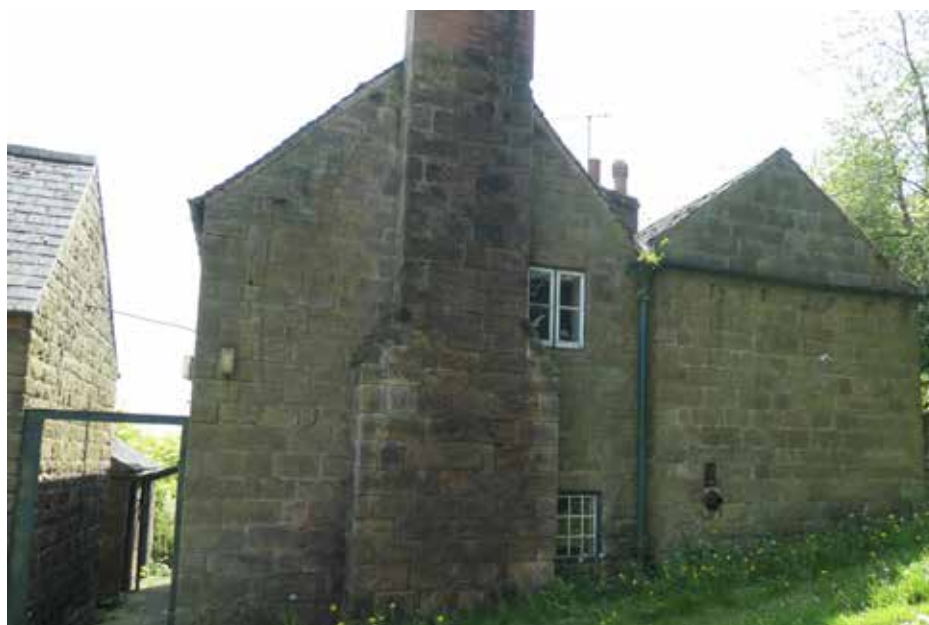
Fig. 14: North elevation of the farmhouse taken from the top of the access track.

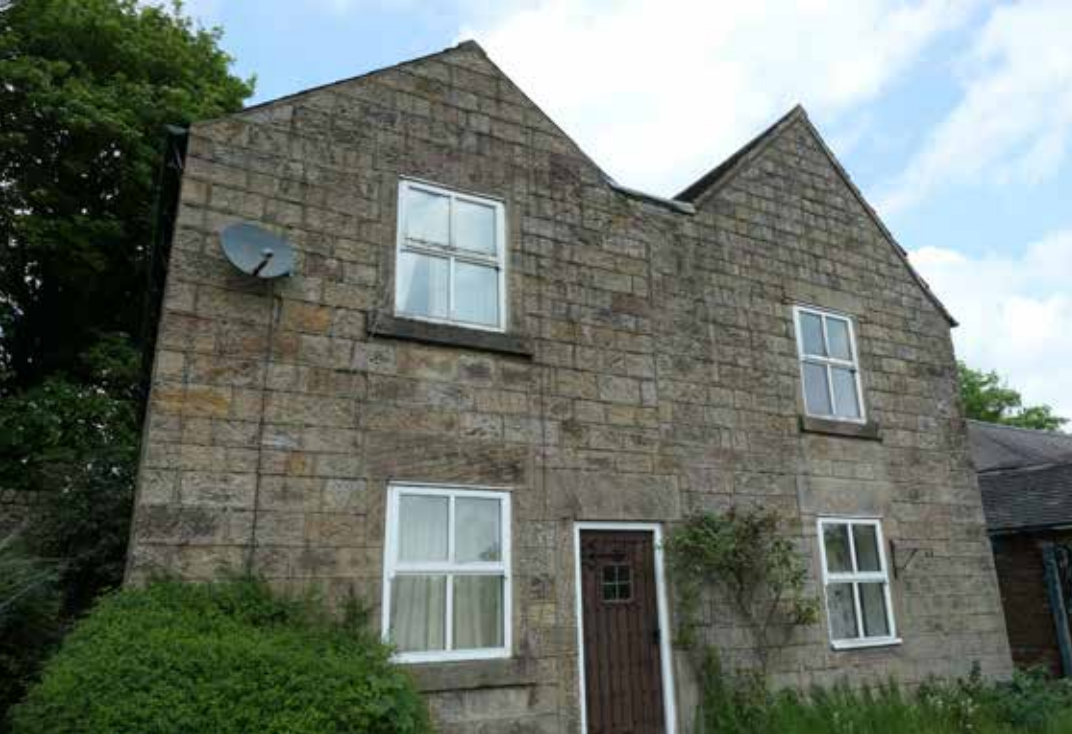
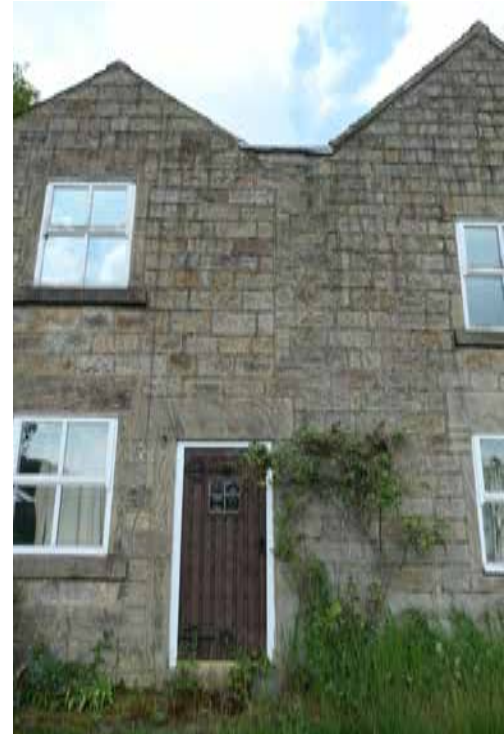
Fig. 15: South elevation of the farmhouse.

Fig. 16: A clear vertical division between the two farmhouse wings is visible in the masonry.

Fig. 17: An angled line in the lower part of the west elevation indicates that the west wing of the farmhouse may have been built off an earlier access ramp or lower structure.

Both the map regression exercise and observations on site indicate that the east wing of the house is the earlier farmhouse. This makes sense on a practical level, since it is closer to the other earlier outbuildings. A clear vertical division between the two wings is evident on the south elevation (Fig's. 15 & 16), suggesting at least two phases of development. The other indication that the west wing is later is that it could have been built on a former masonry ramp (Fig. 17).

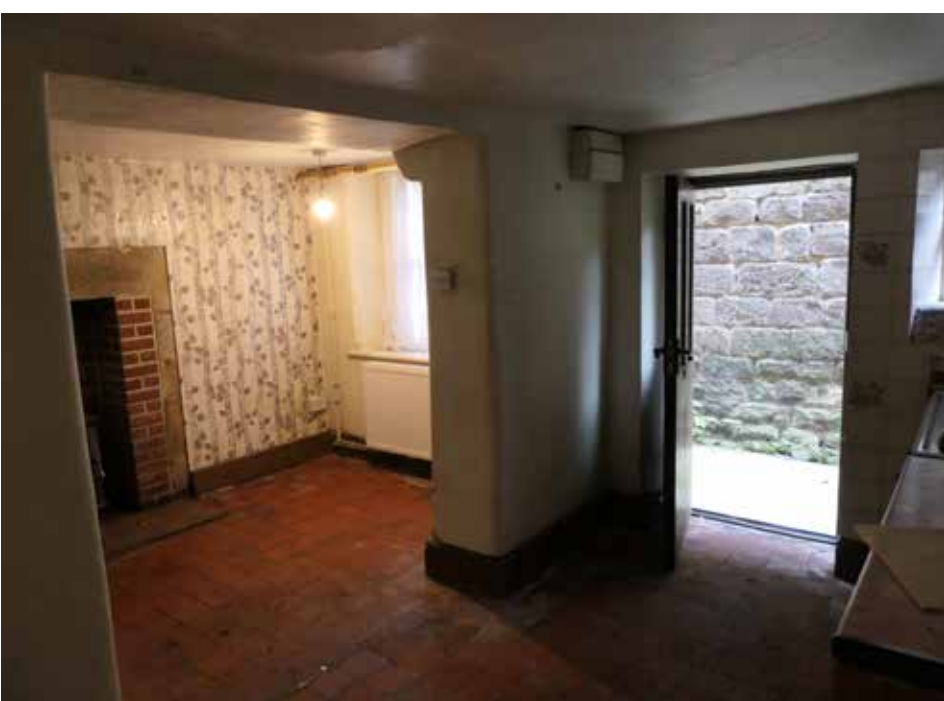
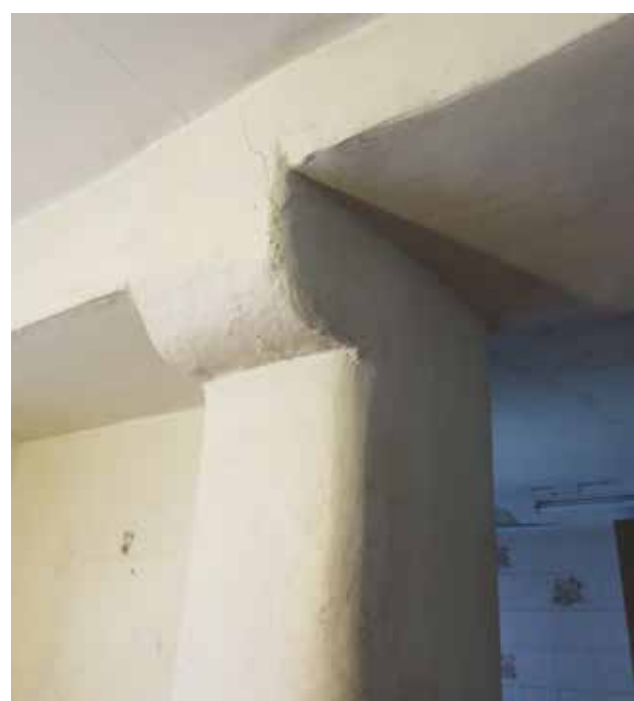
Clockwise from top left:
Fig. 21: Opening between the kitchen and hearth area.

Fig. 22: The bullnose profile masonry opening and simple rounded kneelers below the opening are typical of those found in other farmhouses of the Strutt estate.

Further features of interest survive in the interior of the farmhouse. The opening between the kitchen and hearth features masonry kneelers supported from an opening with a rounded or bullnose profile (Fig's 21 & 22). There are perhaps a reasonable number of similarities here to the kitchen area seen at Crossroads Farmhouse. A robust

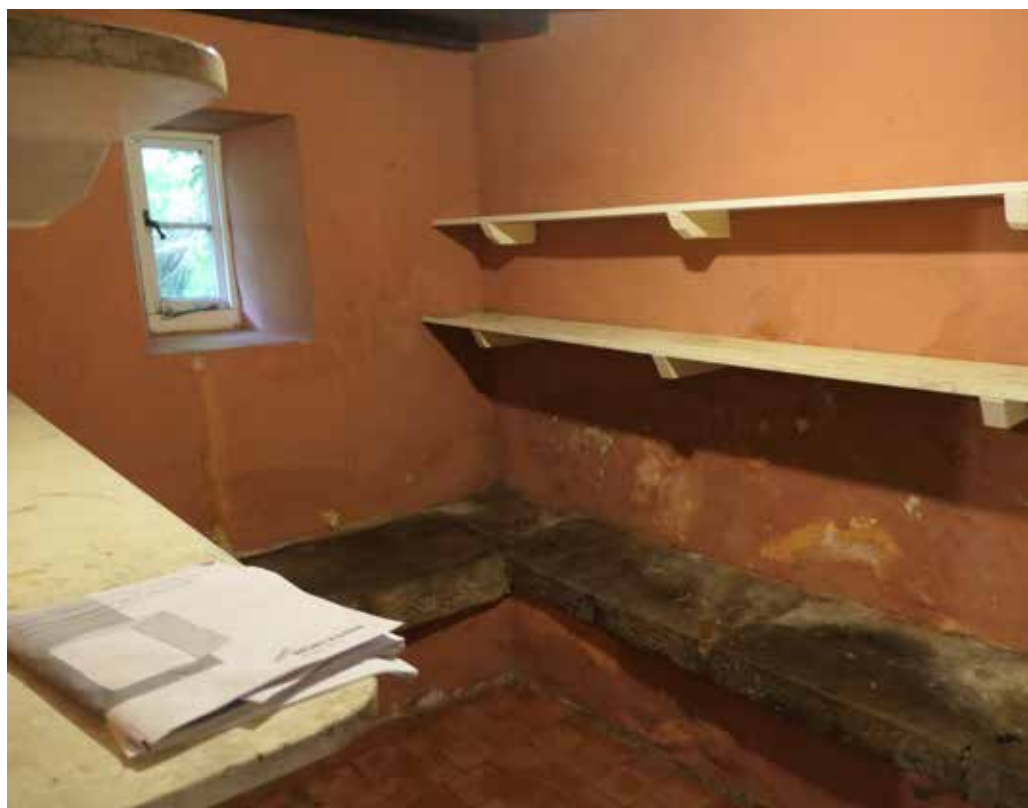
Fig. 23: Interior view of the larder.

larder with thick stone walls, a small window and quarry-tiled floor includes a 4" thick stone bench, presumably for keeping foodstuffs cool, bears great similarity to others of the Strutt estate (Fig. 23).

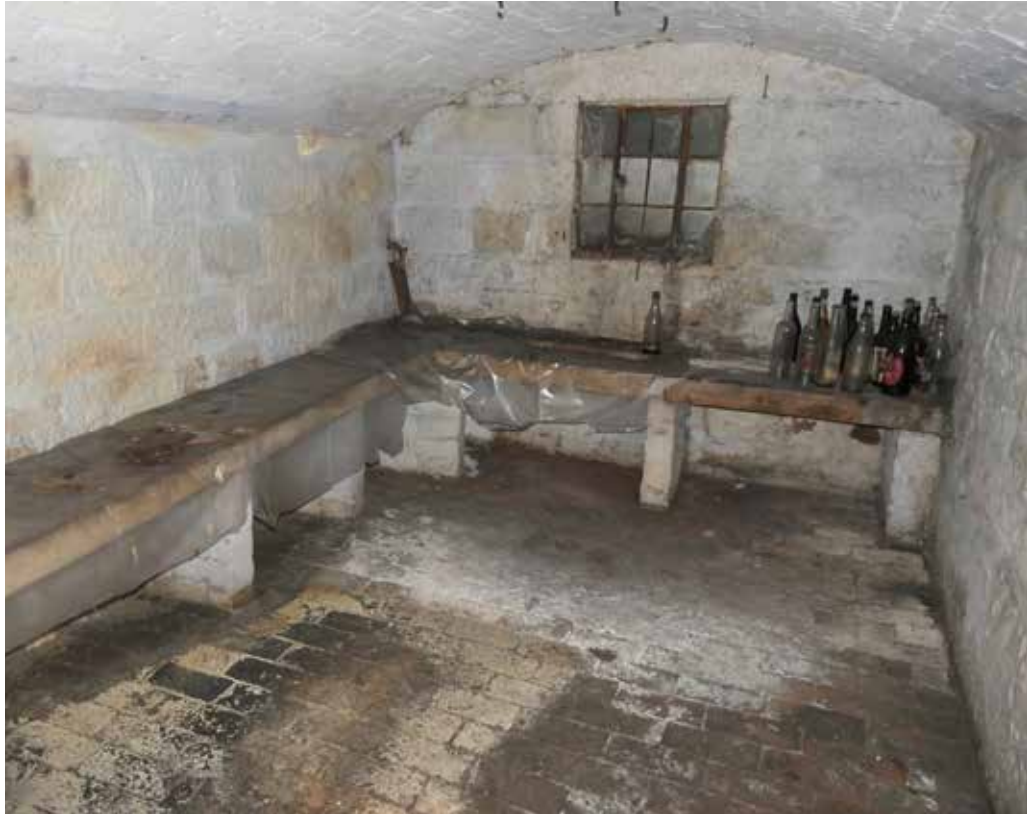
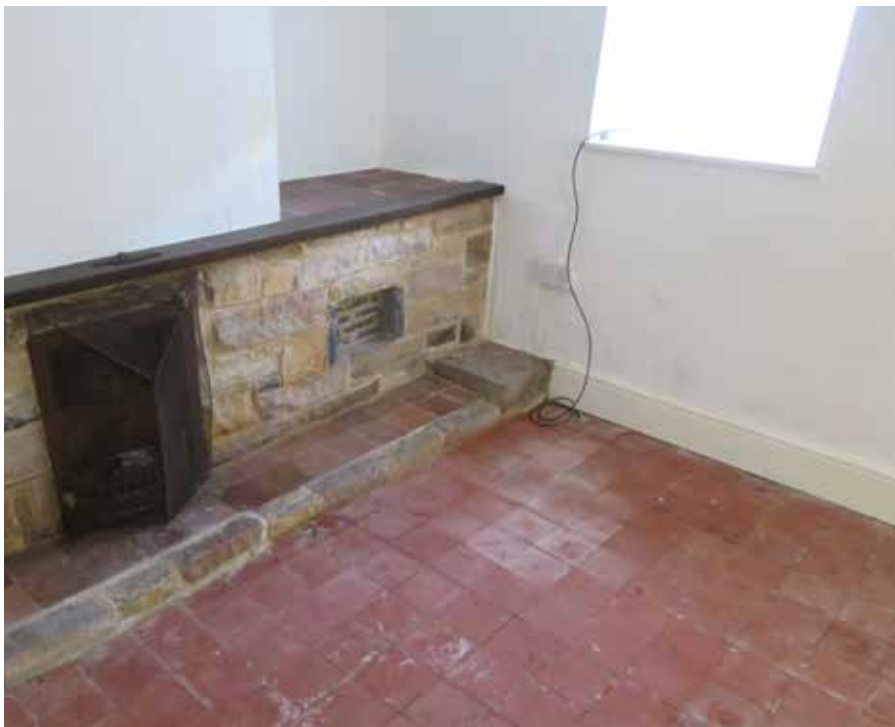
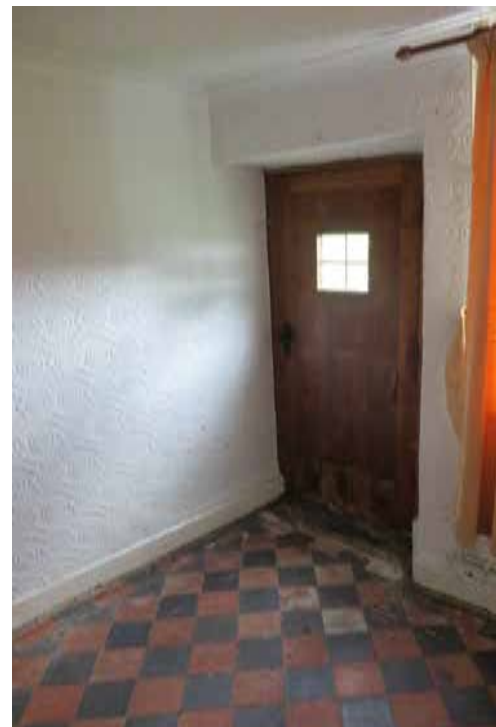
Clockwise from top:
Fig. 24: View of the cellar looking west.

Fig. 25: plain quarry tiles found in many areas of the ground floor.

Fig. 26: Diamond pattern checkerboard quarry tiles.

The cellar also includes similar robust design features (Fig. 24). It is also worth noting the presence of an industrial cast iron window at the end of the brick archway.

the ground floor rooms and circulation spaces; see Figures 25 & 26.

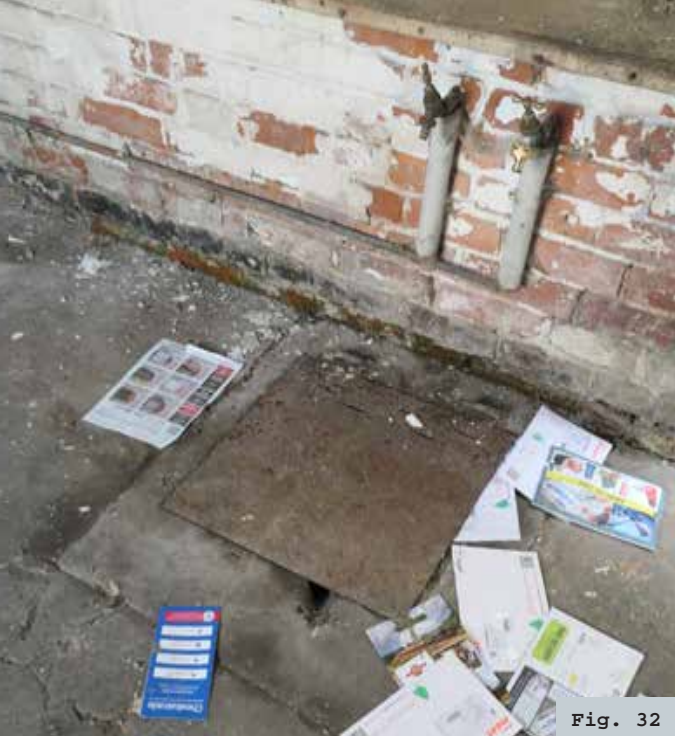
Fig. 32

for processing dairy produce. However, other interesting historic features suggest it could have been used for domestic purposes, including a stove and laundry pot, and concealed cast iron range within the hearth (see Fig's 30 & 31). A brick-lined well, which would have presumably used as a source of fresh water for the house and dairy (Fig's 32 & 33), is located on the entrance wall side of the interior.

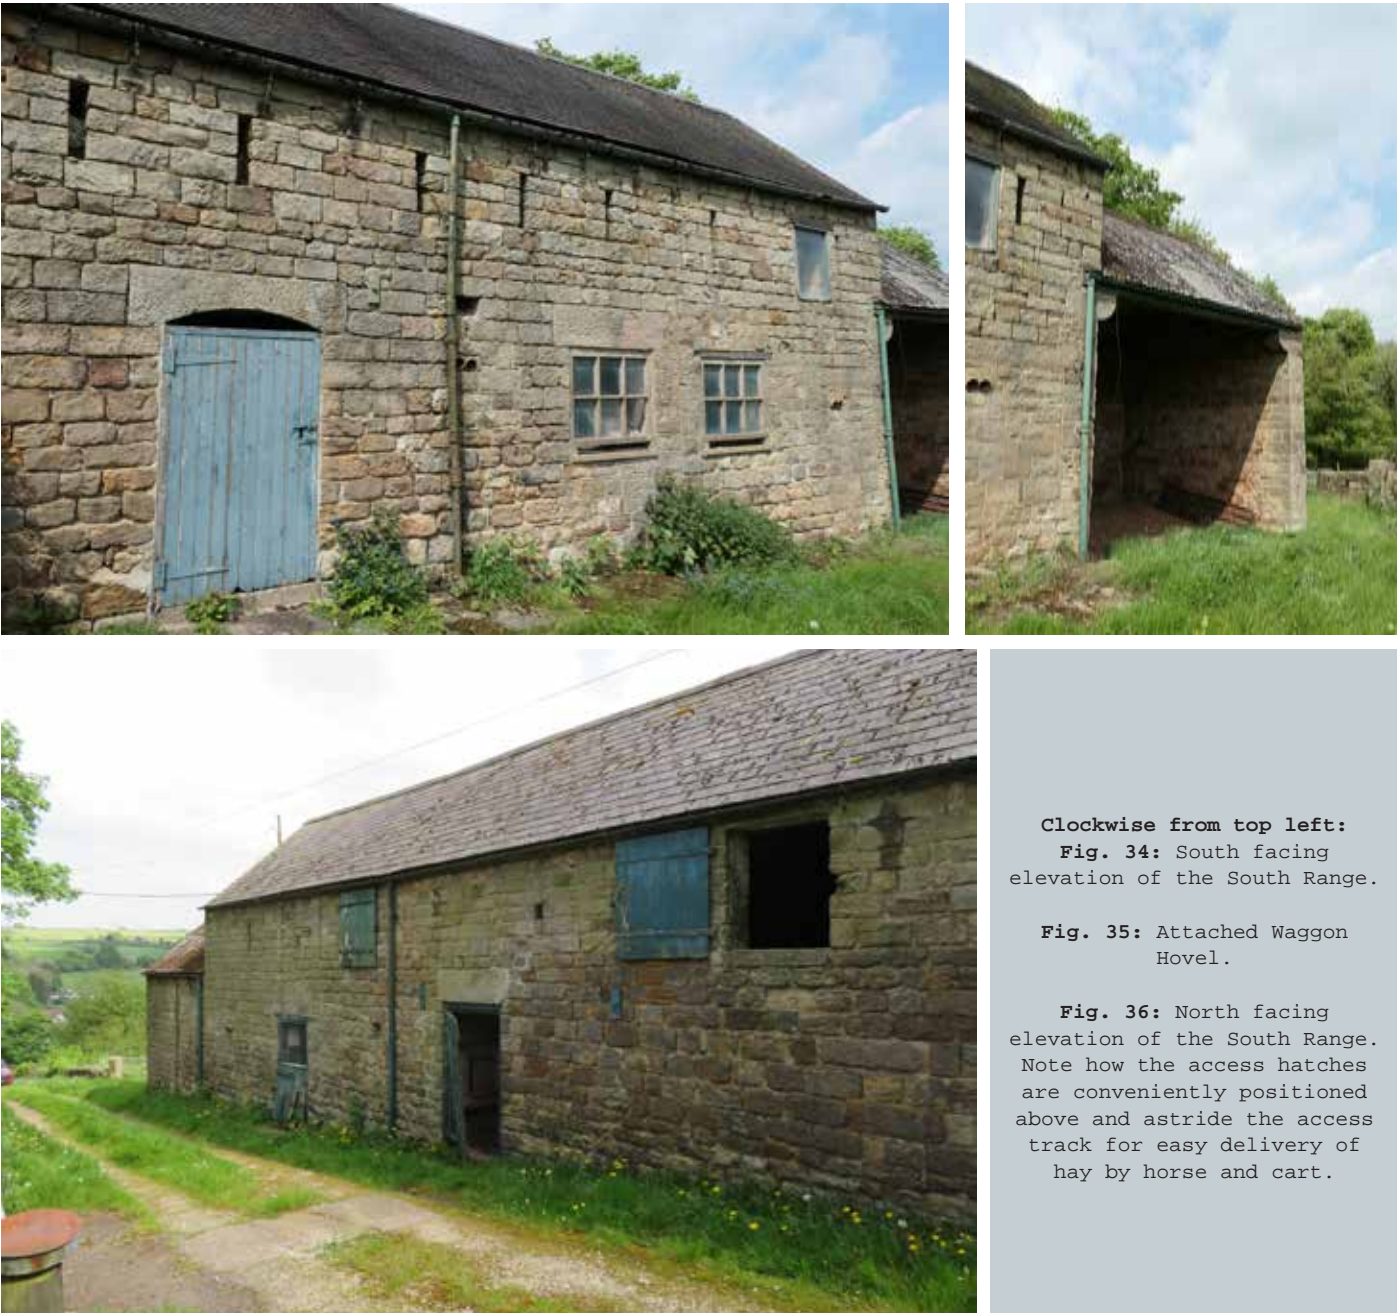
Clockwise from top left:
Fig. 34: South facing elevation of the South Range.

Fig. 35: Attached Waggon Hovel.

Fig. 36: North facing elevation of the South Range. Note how the access hatches are conveniently positioned above and astride the access track for easy delivery of hay by horse and cart.

wagon hovel (Fig. 35) features an opening similar in characteristic to those found on some of the larger Strutt Farmsteads, such as the pair of large bull-nose masonry kneelers.

Another example of efficient thinking in relation to topography of the site is perhaps seen with the positioning of the southern hay range, at the side of the access track. It was probably positioned here, at the lower end of the site, to allow the most direct and quickest access into haylofts for deliveries by horse and cart (Fig. 36).

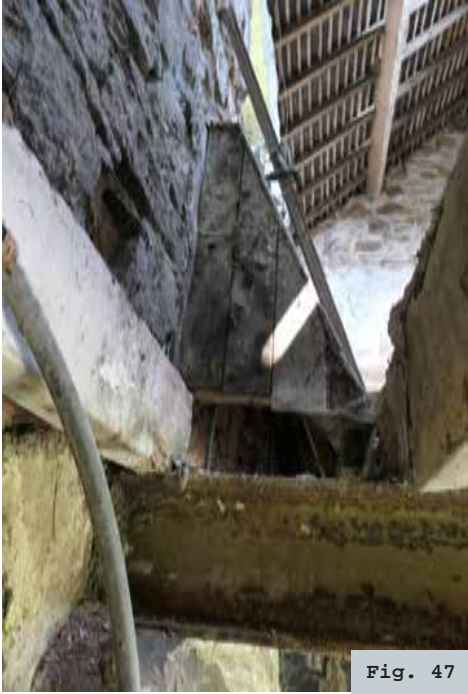
Fig. 47

Openings in the floor above the feeding troughs could have been formed to facilitate efficient feeding of animals, as seen at Wyver and Dalley Farm, although it isn't clear if these could be a later modification (Fig's 47 & 48). The floor is constructed of lime and straw, and appears to be generally intact. Steel beams support the

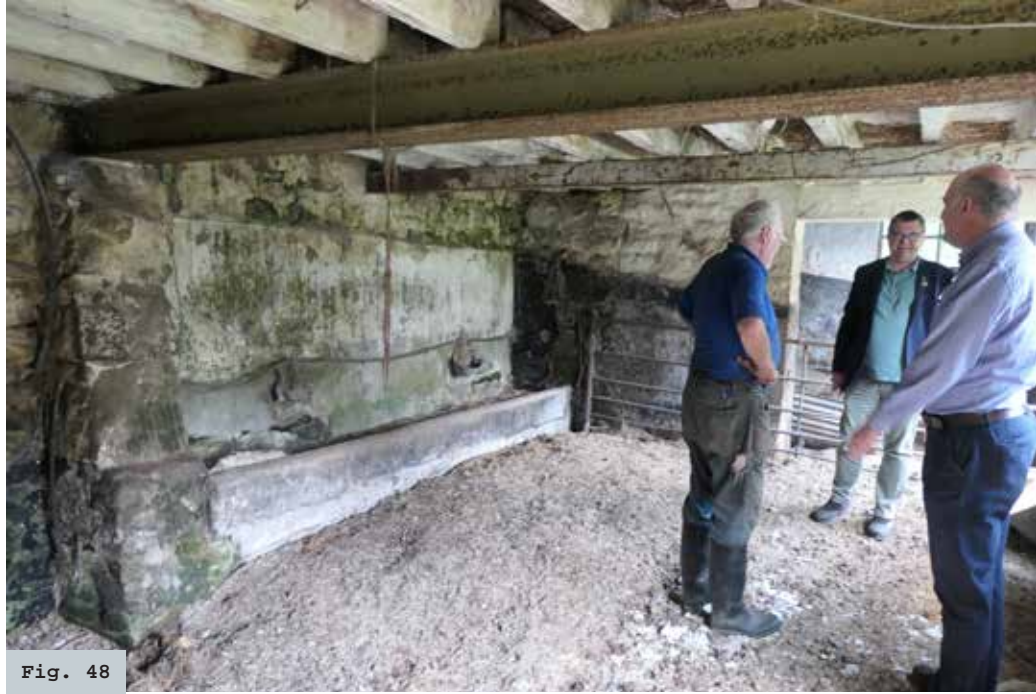
Fig. 48

floor but these appear to be modern I-sections (Fig. 48), and not historic cast iron.

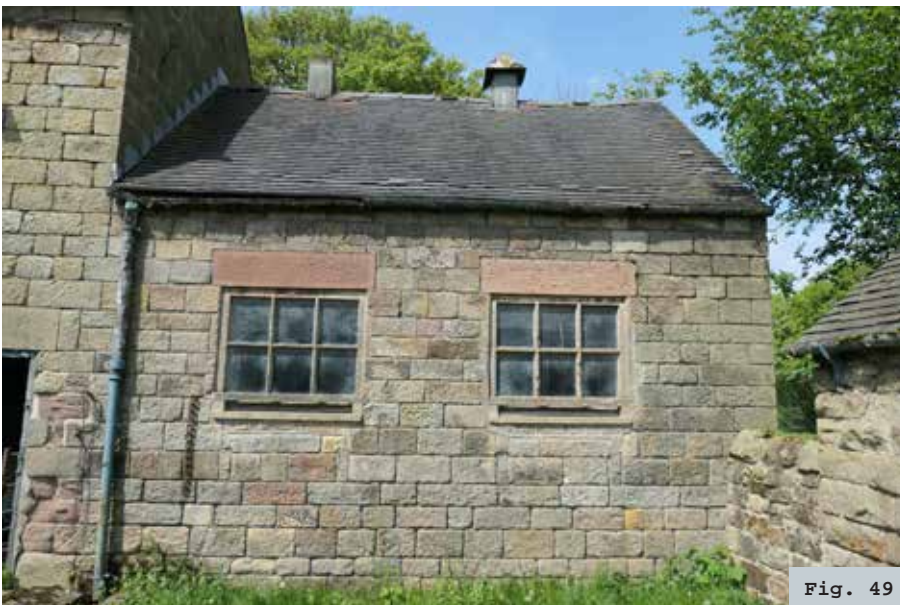
Fig. 49

A lower single storey structure, presumably an additional animal shelter (Fig. 49 & KP Ref# 9), appears to incorporate ventilation cowls. Although these seem to have been significantly altered (Fig 50), it is likely that these could have been of a similar design to those found on similar animal shelters at both Crossroads or Dalley Farm.

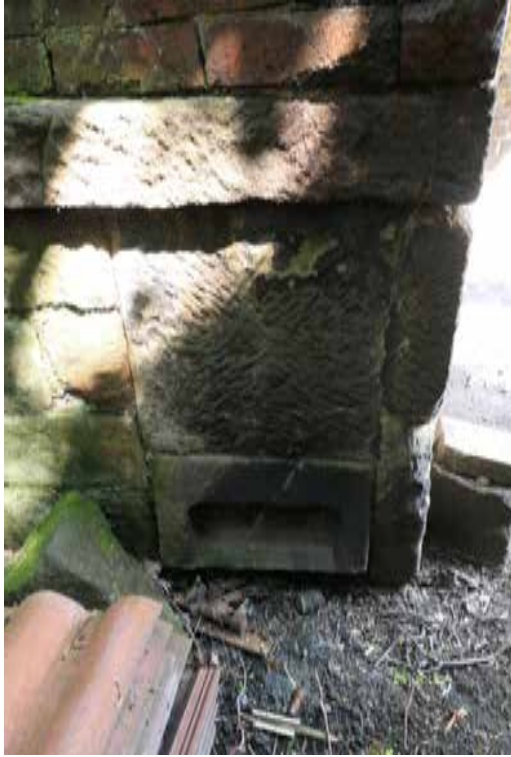
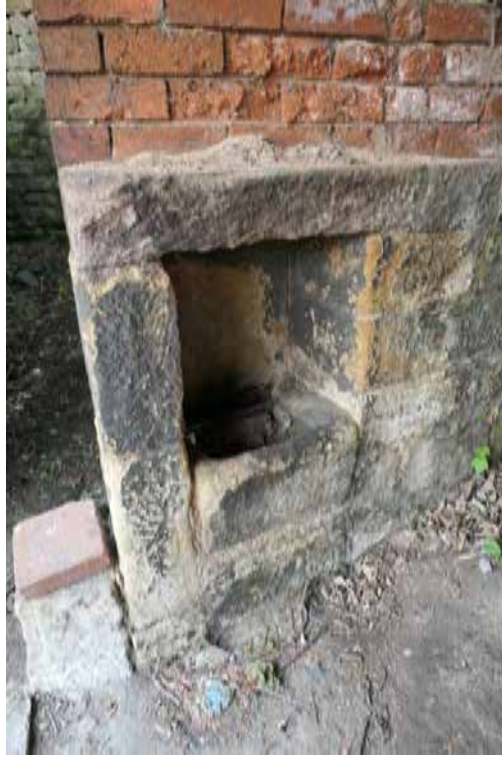
Left to right:
Fig. 58: View of the feeding trough/chute from within the small yard.

Fig. 59: View of the feeding trough/chute from outside the small yard.

facing elevation of the building features a timber door and cast iron window. The building is accessed from the 'Small Yard' (refer to key plan), which features an interesting low-level stone feeding chute or trough (Fig's 58 & 59). Presumably, this would have allowed animals to be easily fed without need to enter the building and, although just a small detail, this is further potential evidence of Strutt efficiency in spatial planning of their farmsteads.

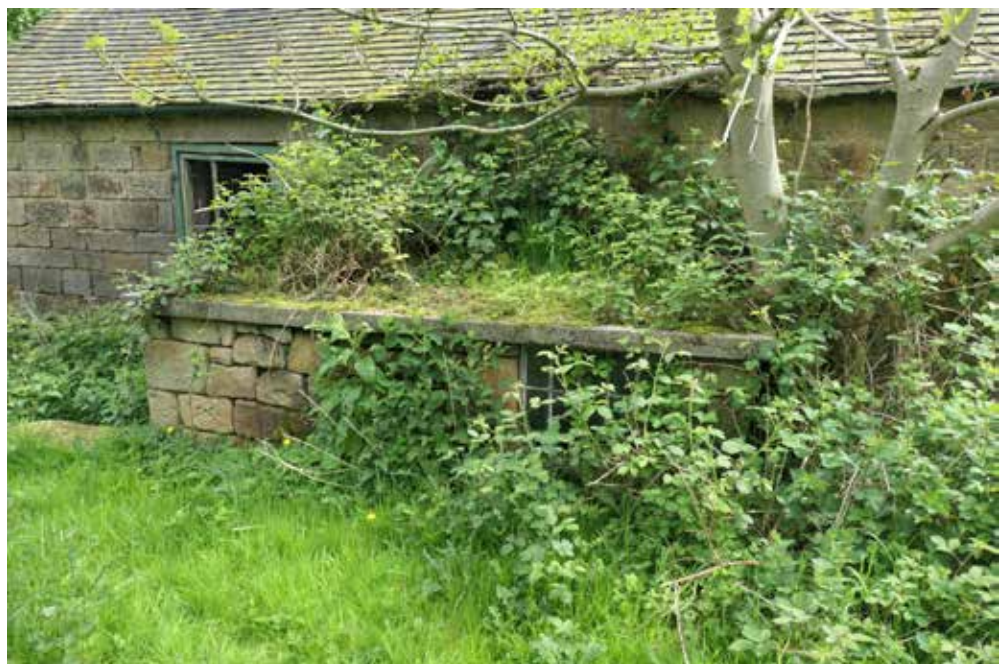
Fig. 60: View of what is thought to have been a brewers grain pit from the Rear Yard. The structure is heavily overgrown and appears to feature a relatively modern cast concrete slab over the top, making it difficult to appreciate how it functioned. The Strutts are known to have made use of spent brewers grain to feed their livestock; similar provisions were made for storing this feedstuff on the model farms.

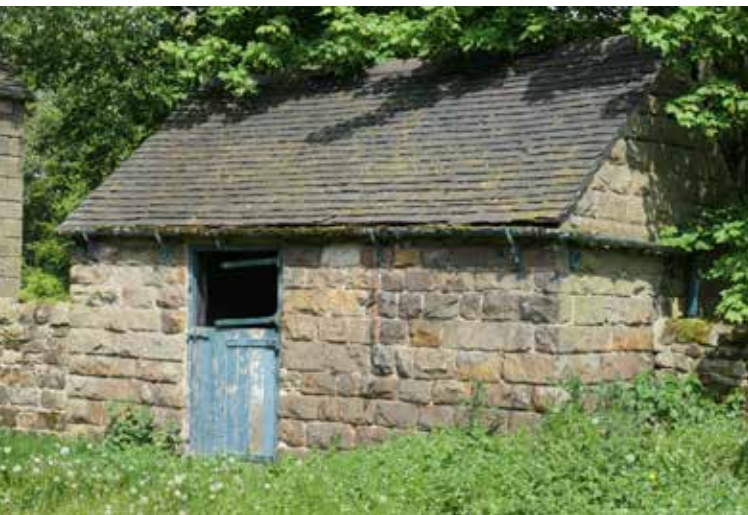
The Bull House sits quietly to the east side of the yard (Fig. 61) but also makes its own contribution to the significance of the farm.

Clockwise from top left:
Fig. 61: The Bull House

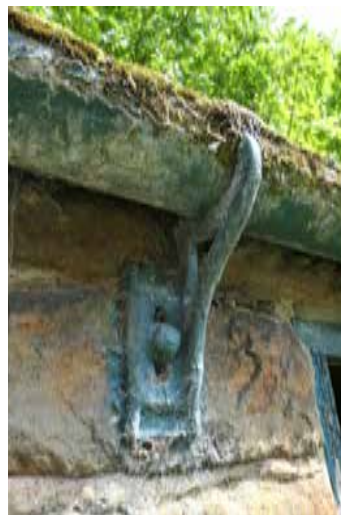
Fig. 62: An adjustable cast iron gutter bracket.

which are of a design unlike others I have seen on the farmsteads and in the wider Strutt estate (Fig. 62). They have the same 'spanner head' like gutter support as those found on Long Row, for example, but they are of a far more compact design. Further investigation to ascertain this would be useful.
