SWAINSLEY FARM

**A SHORT STUDY OF
THE SIGNIFICANCE OF THE FARMSTEAD**

Alex Gilbert

August 2024

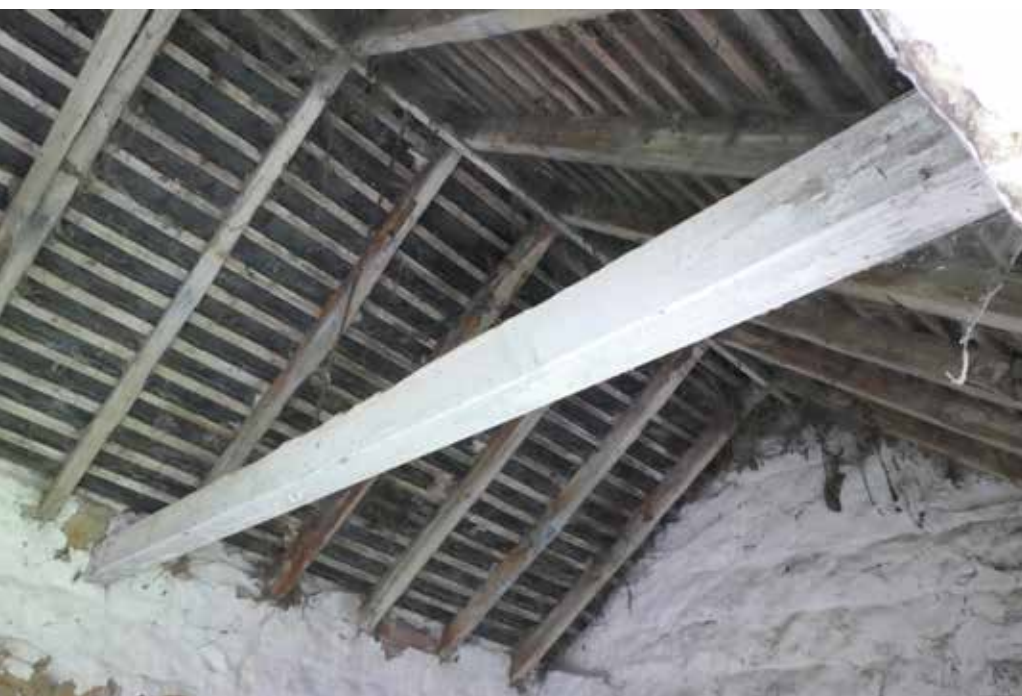
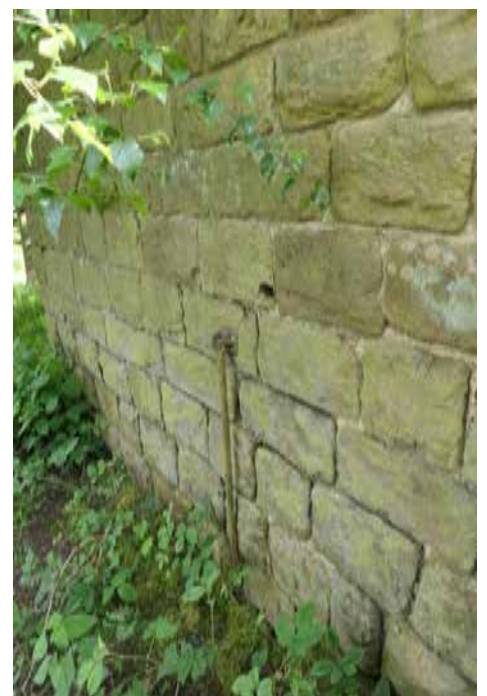
Clockwise from top left:
Fig. 61: The Bull House

Fig. 62: An adjustable cast iron gutter bracket.

Fig. 63: A cast iron restraining hook fixed to the north wall of the Bull House.

Fig. 64: View of the underside of the roof structure with wrought-iron tie bar.

which are of a design unlike others I have seen on the farmsteads and in the wider Strutt estate (Fig. 62). They have the same 'spanner head' like gutter support as those found on Long Row, for example, but they are of a far more compact design. Further investigation to ascertain this would be useful.

The supporting roof structure is of some interest, as this features a simple wrought iron bar supporting the timber bottom chord (Fig. 64). This is of a similar semi-industrial design used by the Strutts on some of the outbuildings seen at Dalley and Crossroads Farms.

A large, cast iron hook exists on the north wall of the Bull House (Fig. 63). This was possibly used to hold open a gate to provide direct access to the adjacent field from the Main Yard, although the opening from this appears to have been closed off at some point.

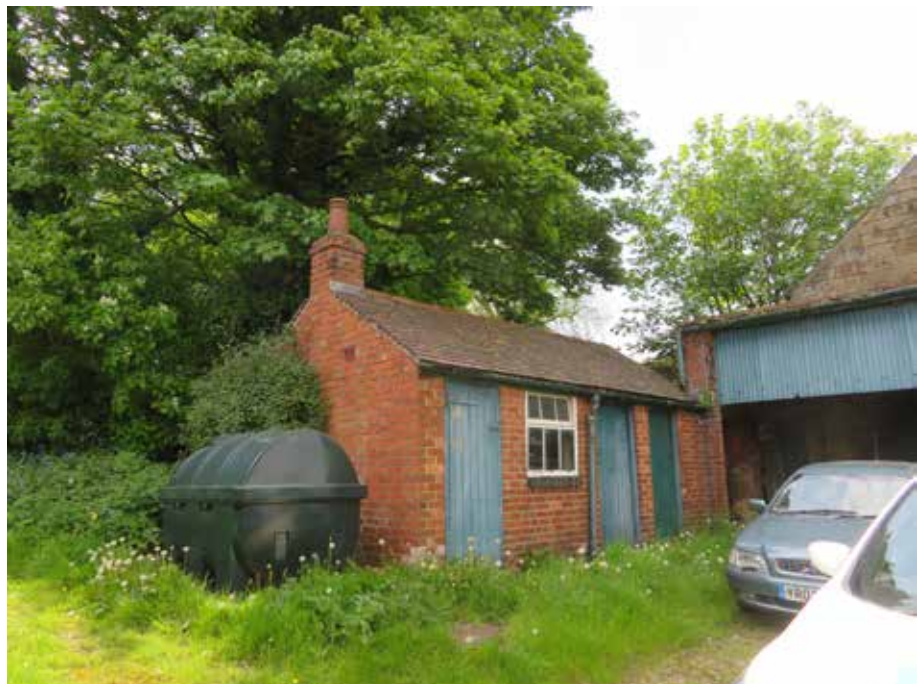
Fig. 65: The current building replaces the old Pigsty as the 'new dairy'. The chimney breast and plastered walls in the interior suggest that this was used for more domestic activities.

This small red-bricked outbuilding (Fig. 65) is simply identified within the HER description as a pigsty. Although the map regression exercise indicates that a similar structure has existed here since around the mid 19th century, its more modern construction indicates that it is likely to have been rebuilt more recently. The earlier pigsty is known to have been replaced by the current building which functioned as the 'new dairy'¹¹. The first edition OS map indicates that the building featured a walled pigsty enclosure to the east although there does not appear to be any surviving evidence of this.

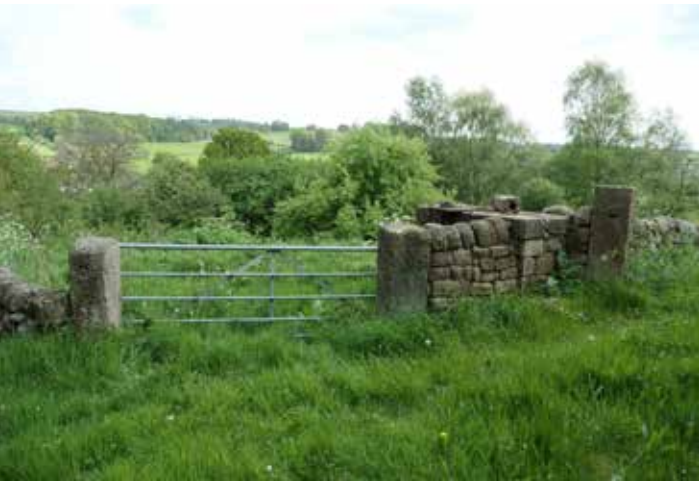
Left to right:
Fig. 66: The position of the manure reservoir is identifiable from the position of the manure pump to the right of the gateway.

There is evidence for similar 'liquid manure' arrangements, as can be found on some of the larger Strutt estate model farms. Evidence for an underground manure reservoir, can be found at the lower end of the site, which can be easily identified from the position of a hand-operated Manure Pump (See Fig's 66, 67 & Key Plan Ref# 7). The presence of the reservoir suggests that it is likely that there could be an underground network of 4" lead pipes, as seen at Crossroads and Dalley Farms. As this system relied on gravity to direct rainwater and manure into the reservoir, the position of the other buildings, on higher ground, makes perfect sense.

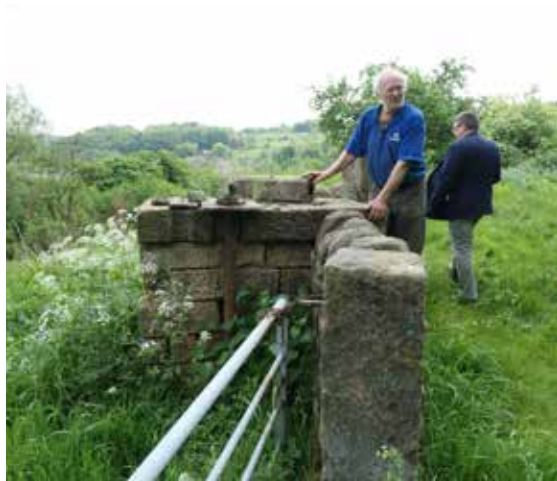
Fig. 67: The manure pump is broken but remains interpretable. This would have been similar to the one at Dalley Farm.

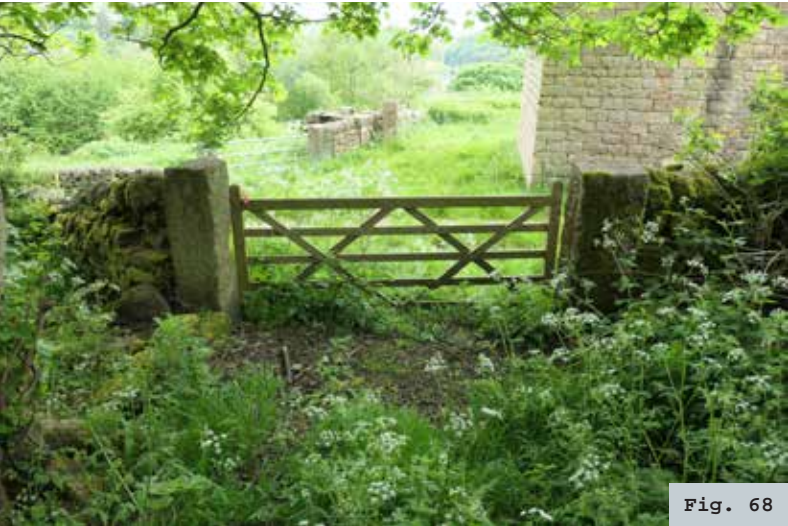
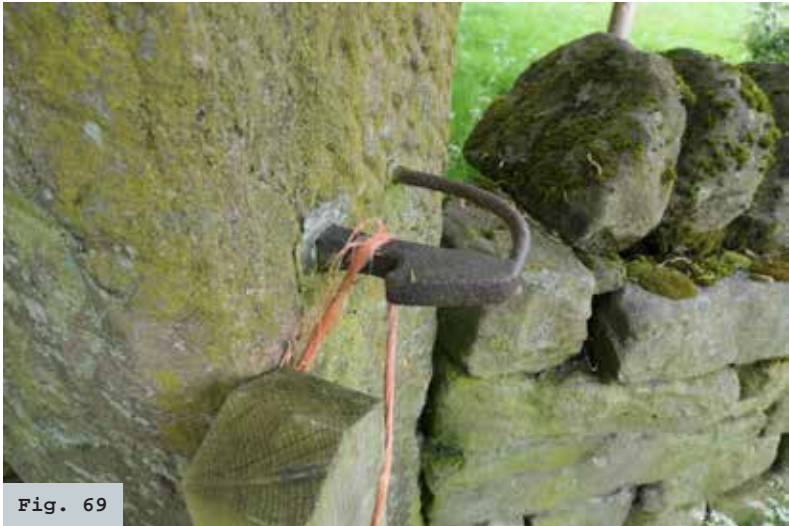
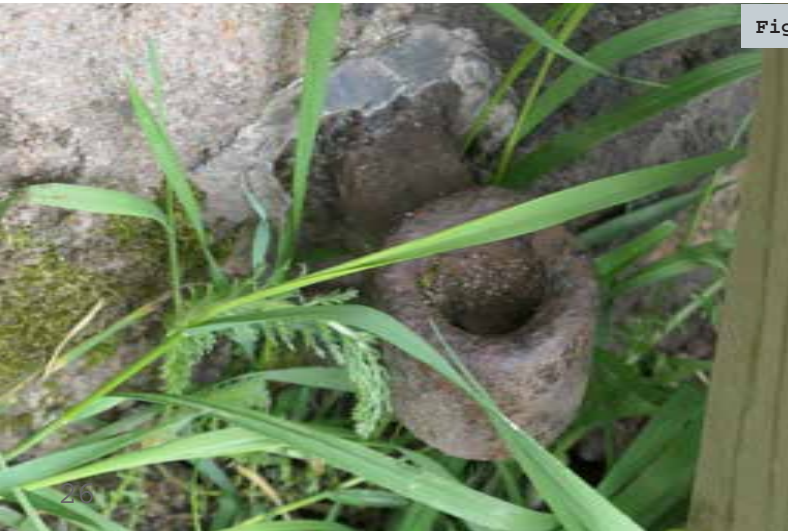
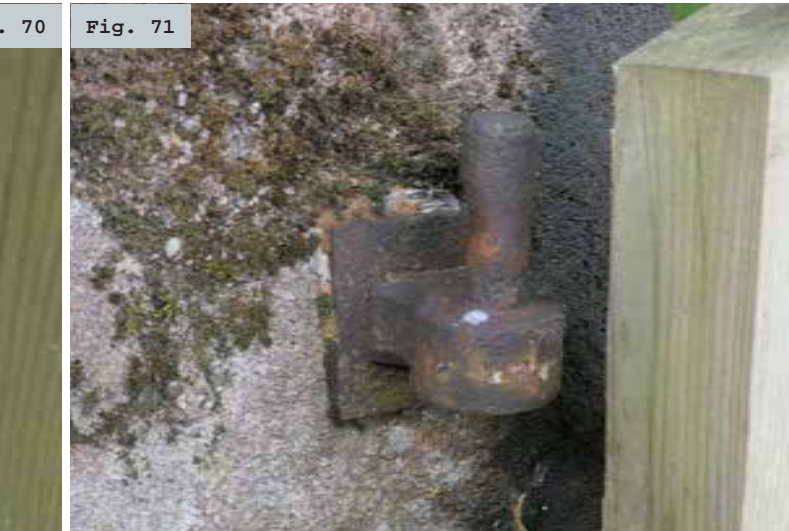
A number of original masonry gateposts have survived around the farmstead, of which some also appear to have retained some of their original ironmongery (see Figures 68-71). Some also appear to have survived in their original positions in that they do not appear to have been widened to accommodate modern agricultural machinery. A number of these gateposts also feature ironmongery which is consistent with that used on some of the unique Strutt designed gates used on their estate¹².
