Derwent Valley Mills World Heritage Site

Monitoring Views 2017

Appendix 9

Images from North to South

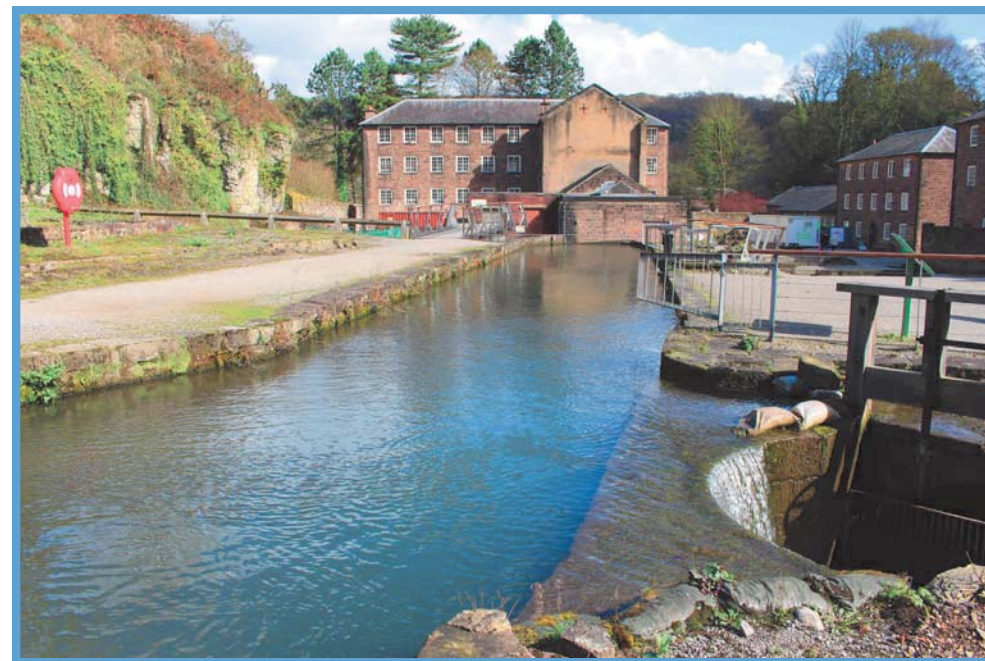
03 Cromford Mill building one with watercourse in foreground

Recent change to view (2017): No significant change.

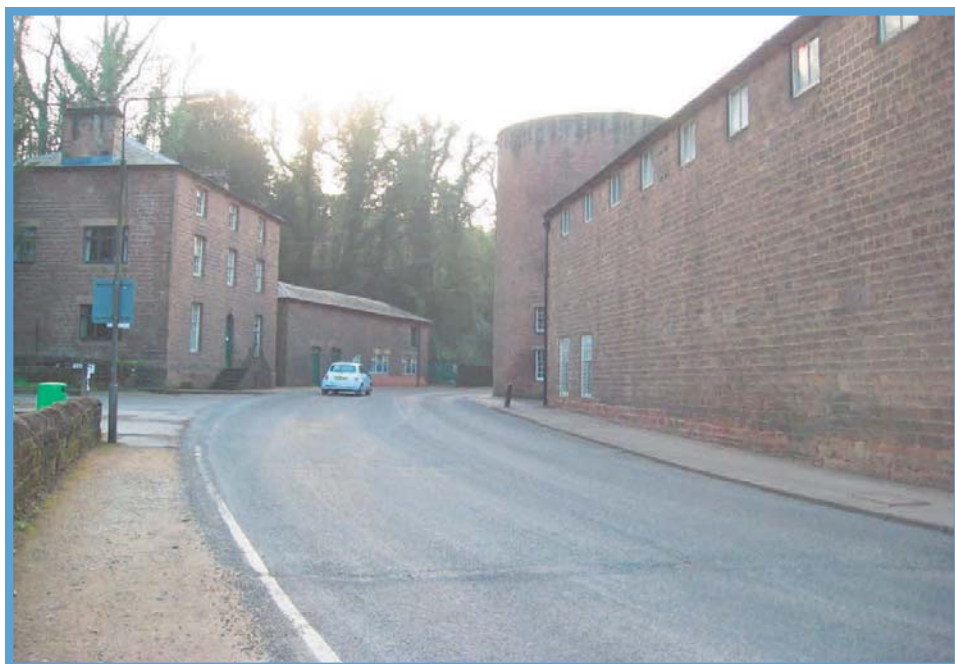
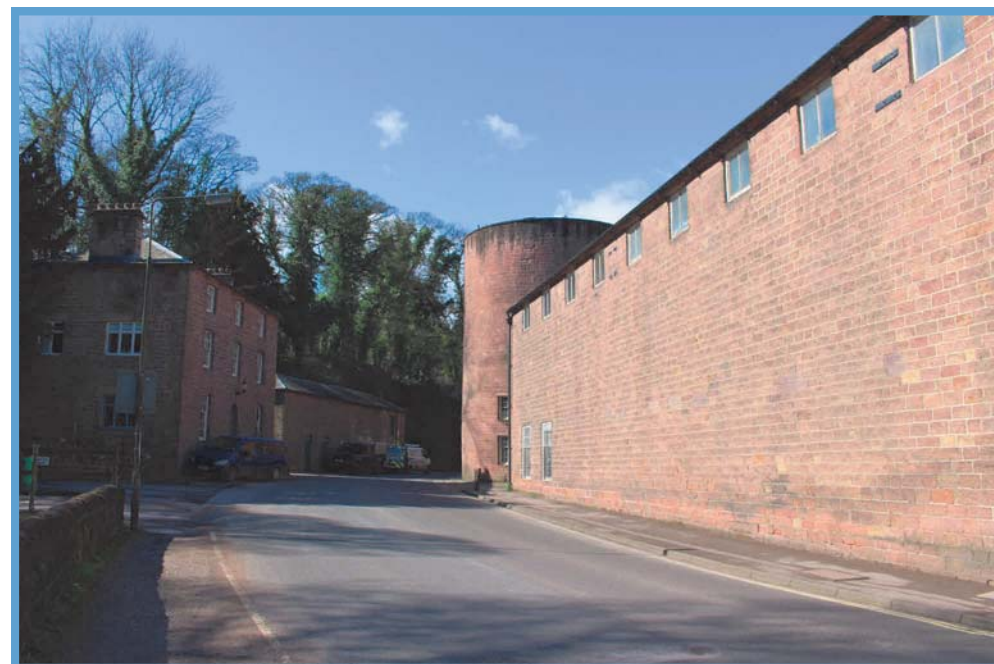
05 Cromford Mill from Mill Road looking west

Recent change to view (2017): No significant change.

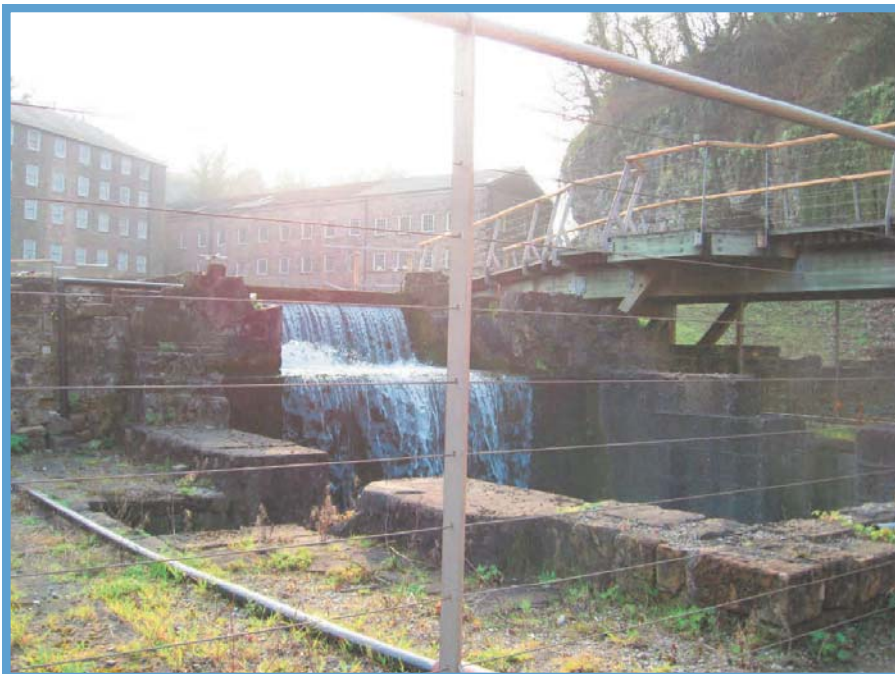
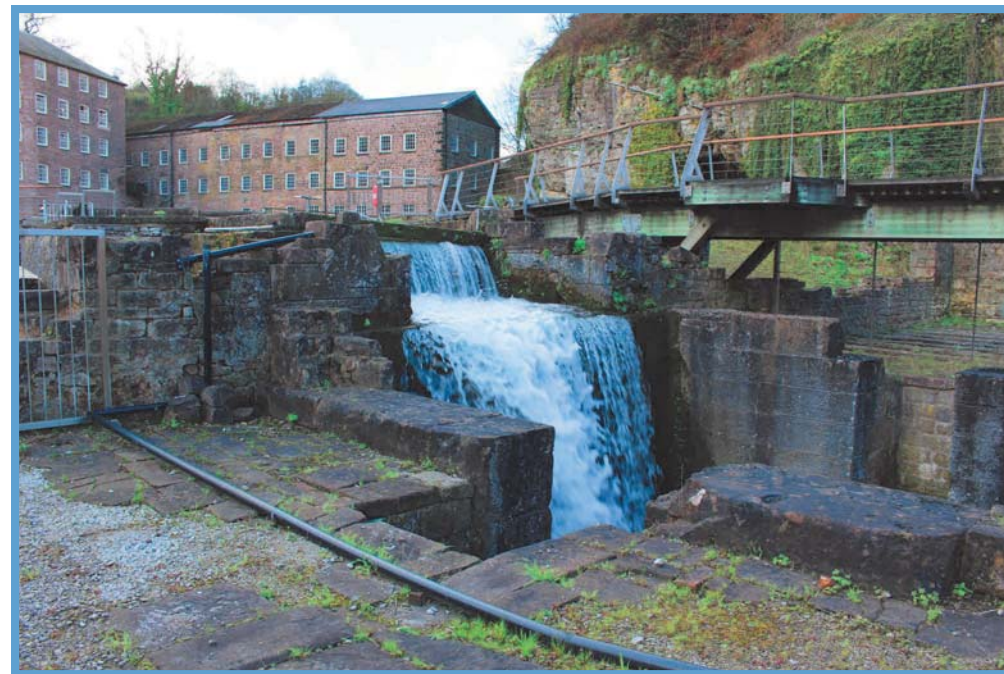
06 Cromford Mill - the first mill from the second mill wheelpit

Recent change to view (2017): No significant change.

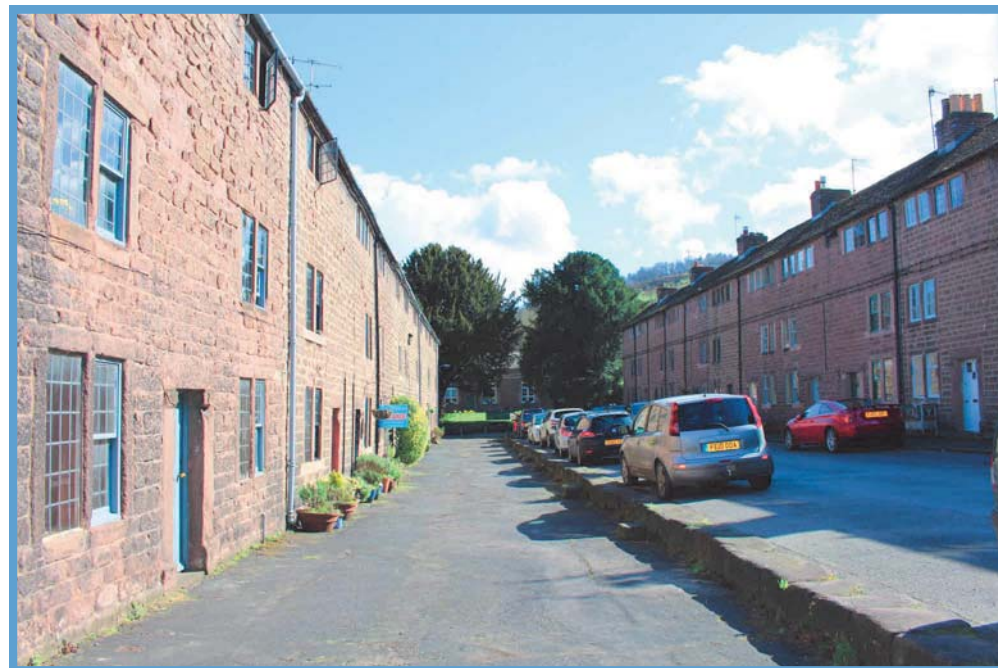
07 North Street, Cromford from Cromford Hill

The nature of the original paving has been researched and it is hoped it may be reinstated at some point. The absence of street clutter is an important quality. It would be preferable if some alternative site for resident's car parking could be found. The yew trees in the garden of the 1832 school are important.

Recent change to view (2017): No significant change.

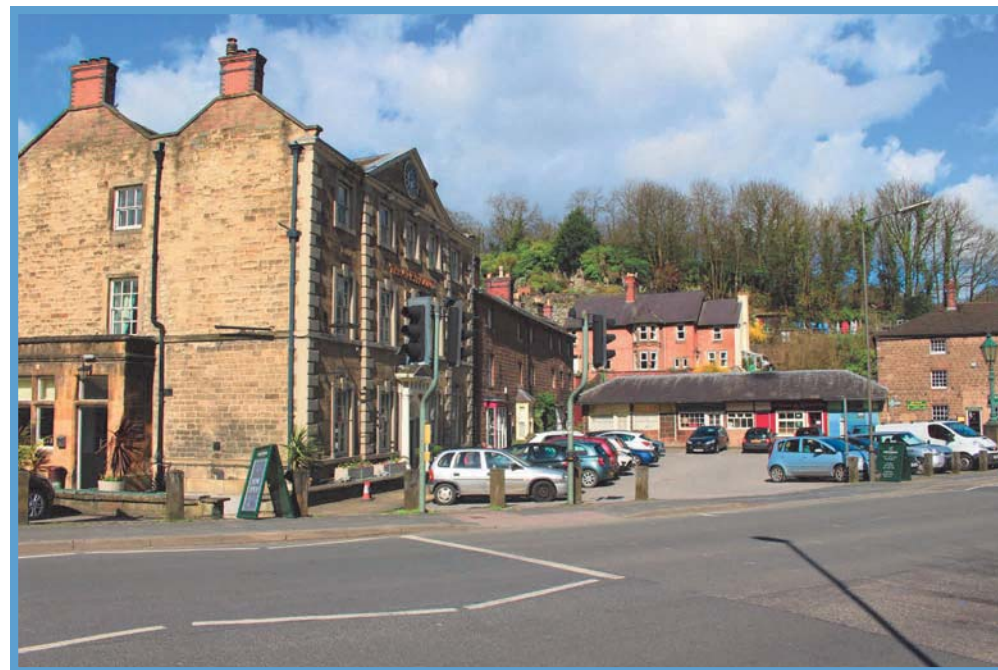
08 Cromford Market Place

Recent change to view (2017): No significant change.

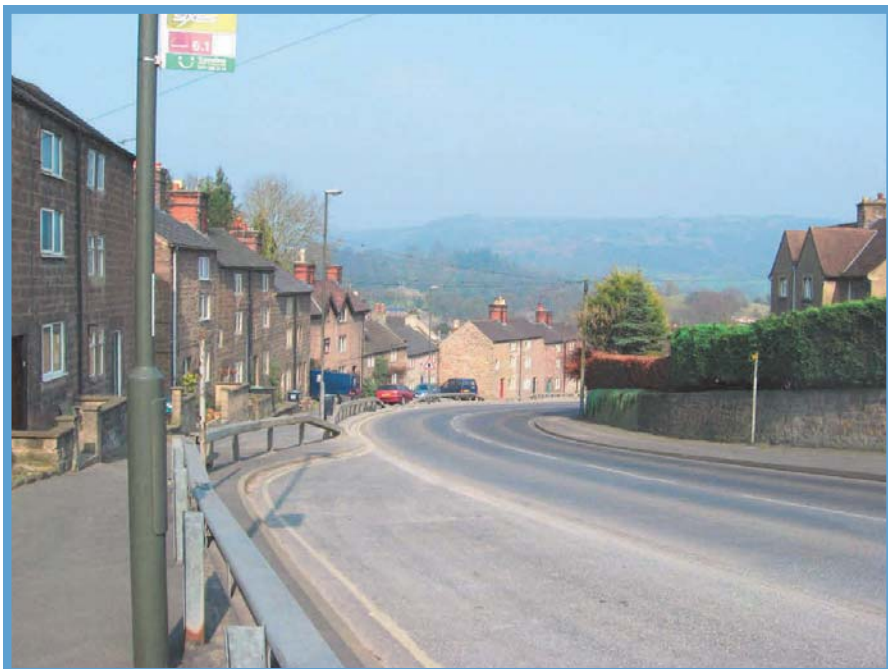
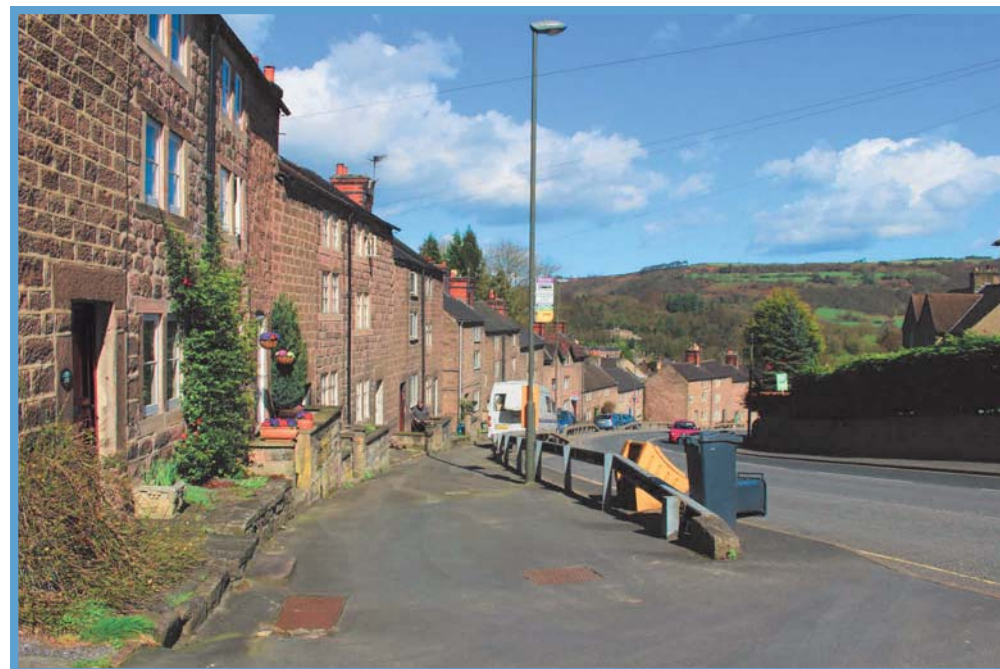
10 Looking down Cromford Hill to Willersley Castle and the landscape of Riber hillside beyond

Description (2008): The late 18th century and early 19th century millworkers' cottages which line Cromford Hill are an important part of the historic village. A number of the houses have inappropriate modern doors, windows and roof coverings and it is desirable these be replaced with more sympathetic alternatives based on historic patterns. The dramatic scenic setting is very important. The car parking and crash barriers are regrettable.

Recent change to view (2017): No significant change.

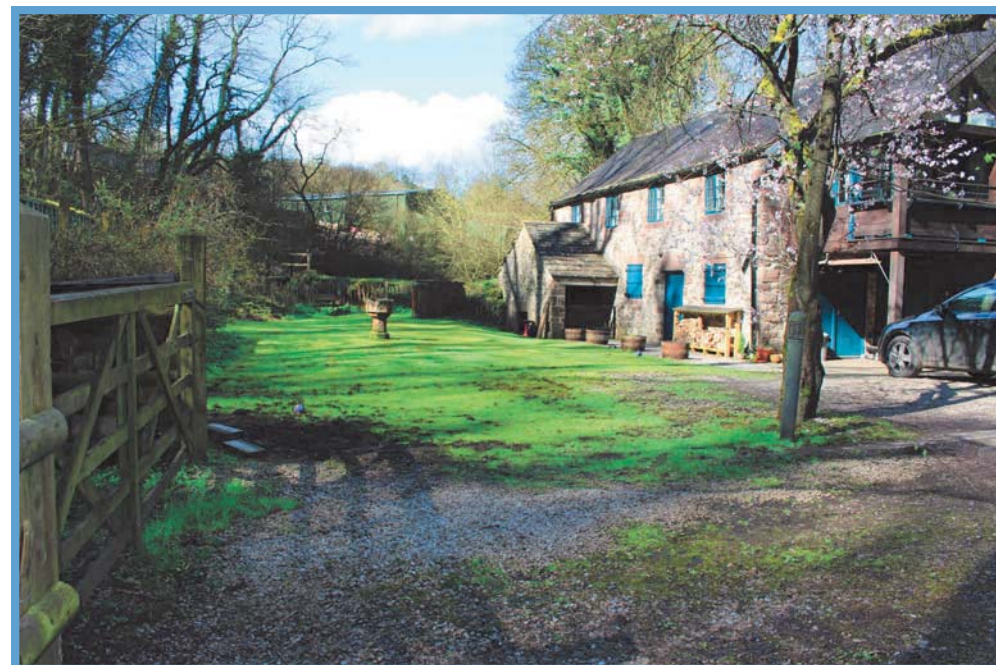
11 Slinter Cottage and millpond with Dunsley Mill behind

2012 – Dunsley Mill site, buildings currently demolished but awaiting redevelopment.

Recent change to view (2017): New build on the Dunsley Mill site is as recessive as possible so has no great impact on this view. Ownership changes for Slinter Cottage have not so far produced changes of any note.

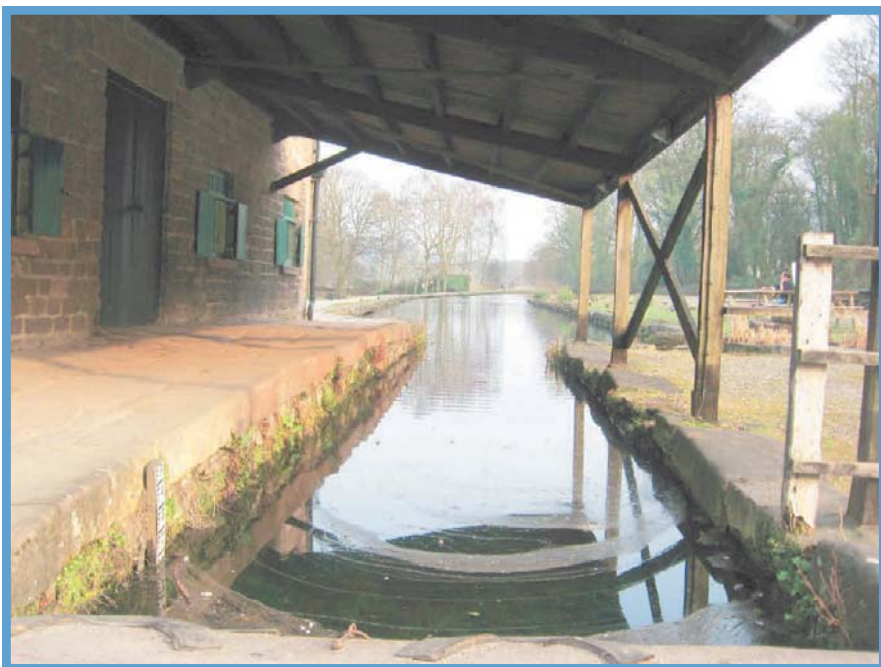
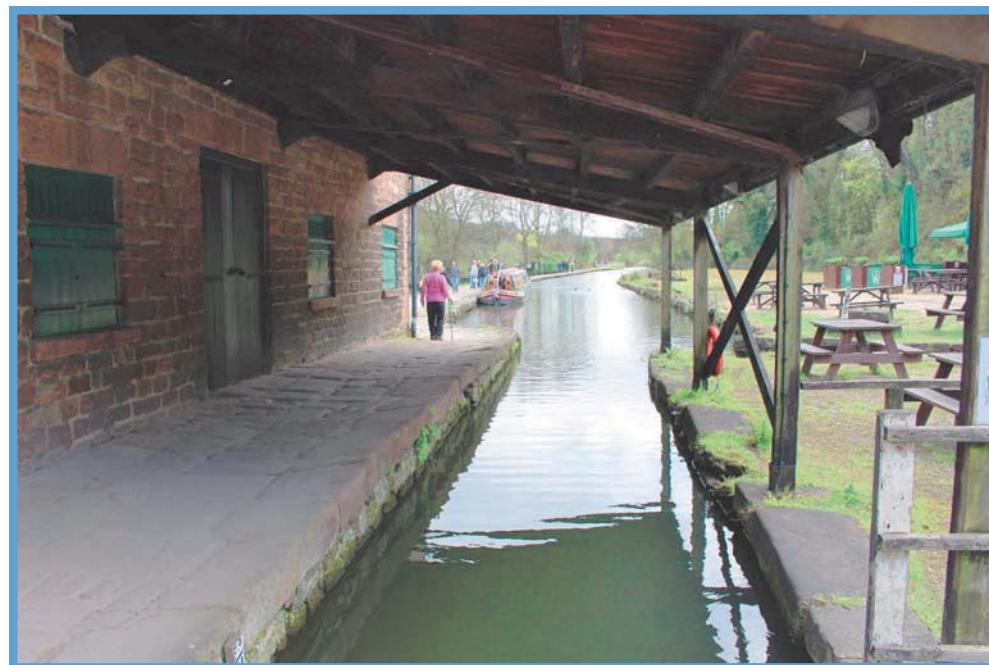
12 Cromford Canal Wharf from the Gothic Warehouse

Recent change to view (2017): No significant change.

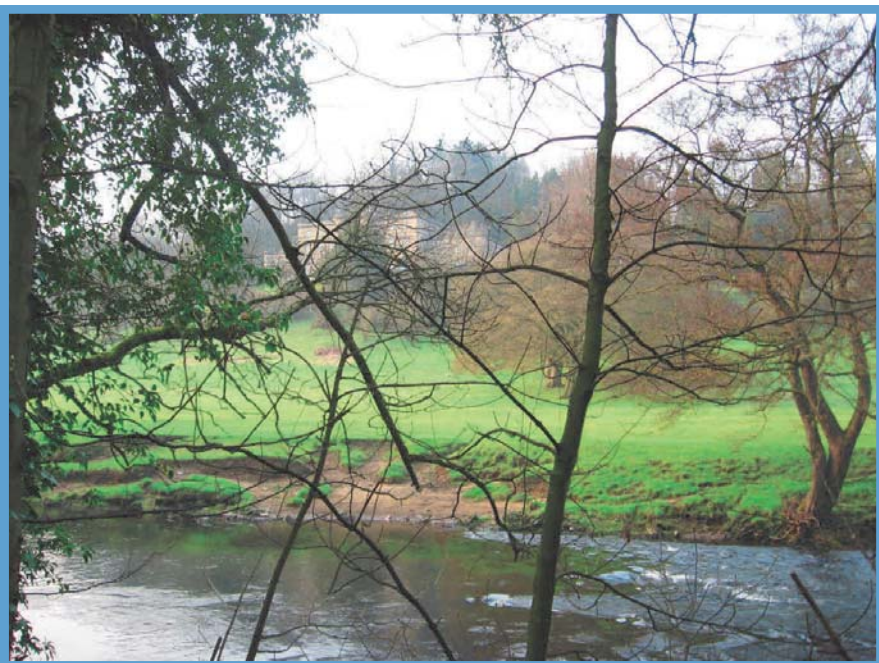
14 Willersley Castle and Park from the south bank of the River Derwent

2012 – Vegetation incrementally increasing and impacting on view.

Recent change to view (2017): Removal of some trees is helping to restore this lost view

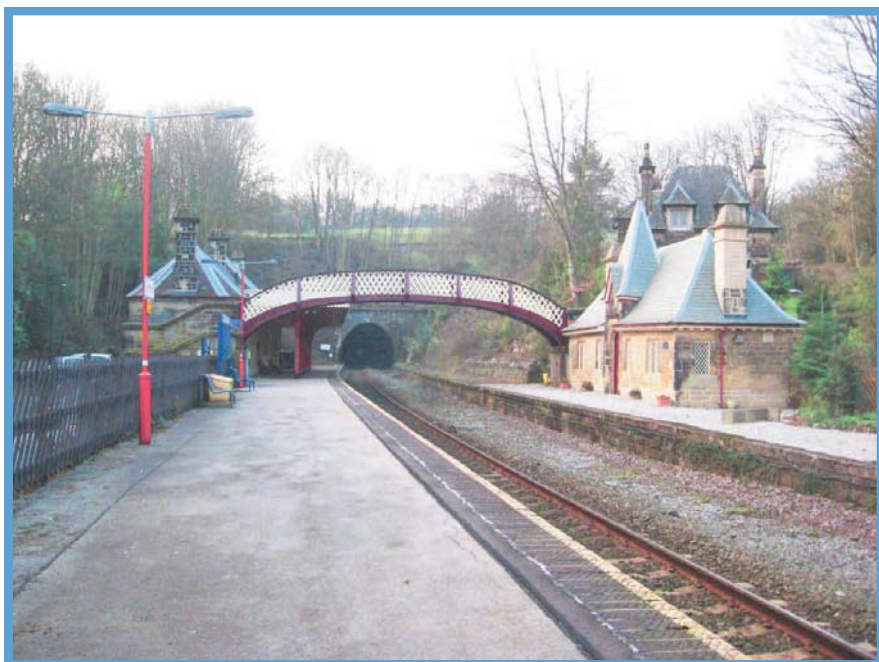
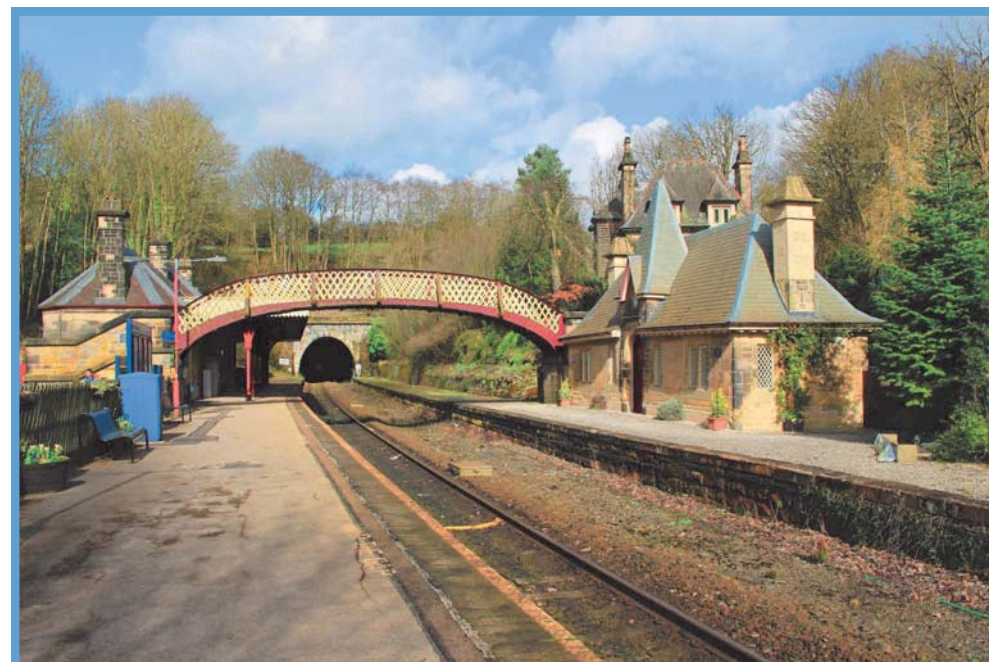
15 Cromford Station with stationmaster's house

Description (2008): The fact that the extravagantly designed 19th century railway buildings and footbridge at Cromford have survived is very important, but for many years the platform buildings have been empty, unused and falling into disrepair. Their repair with the reinstatement of lost architectural detail and their reuse as a holiday let (upside) and office suite/World Heritage Portal (downside) in 2008-9 is a major achievement.

2010 – The repair of the two platform buildings during 2009 delivered major objectives of the Management Plan with regard to 'buildings at risk' and economic development. The down platform building, restored by the Arkwright Society, is let as a suit of offices and the up platform building, restored by Mr Tim Collis and Mr Ryan Phelps, is as a holiday home.

Recent change to view (2017): No significant change since repair work was completed.

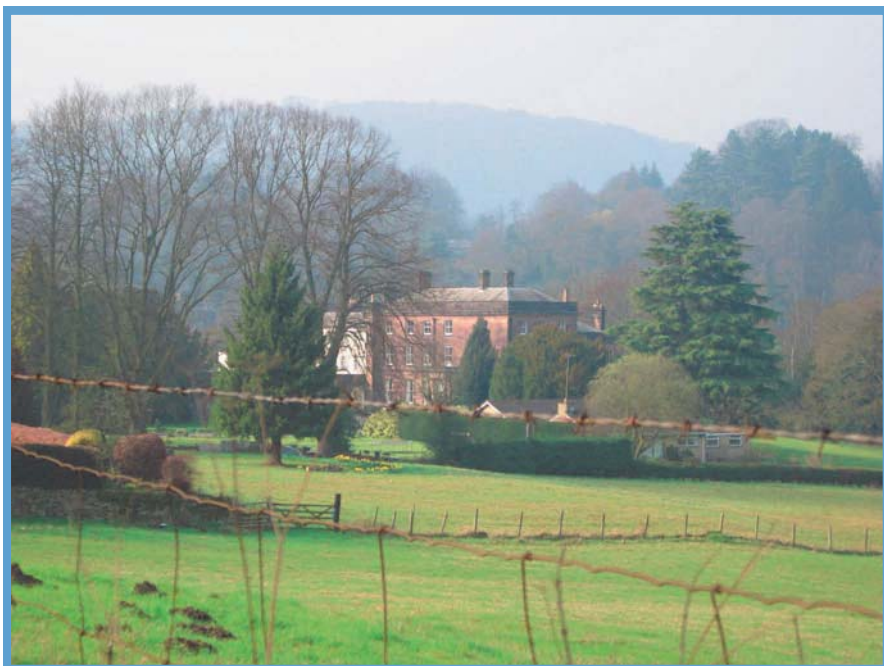
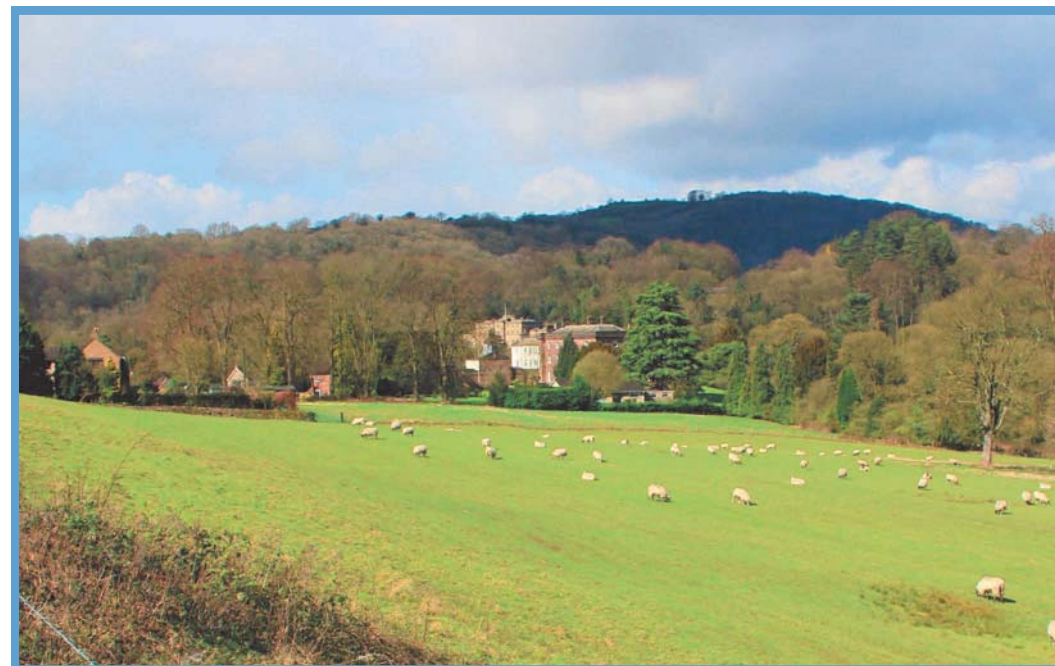
16 Rock House, with Willersley Castle in the background, from the A6

Recent change to view (2017): No significant change. Planning applications for new housing have been resisted.

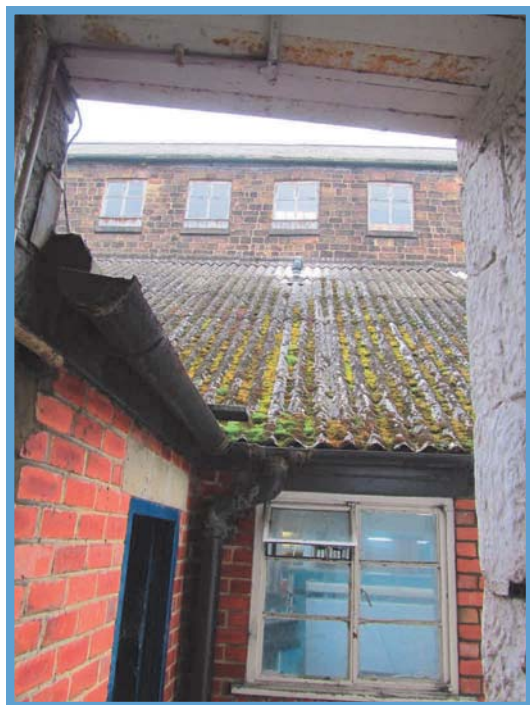
18 The Smedley Mills at Lea

Recent change to view (2017): Reroofing of the original 1783 mill has been completed successfully.

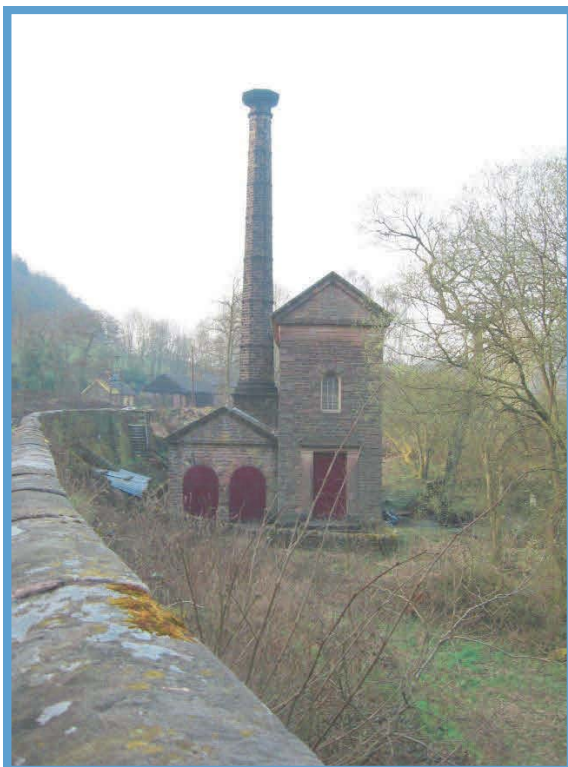
20 Leawood Pumphouse

Recent change to view (2017): Tree growth is increasing around the building and on the canal wall.

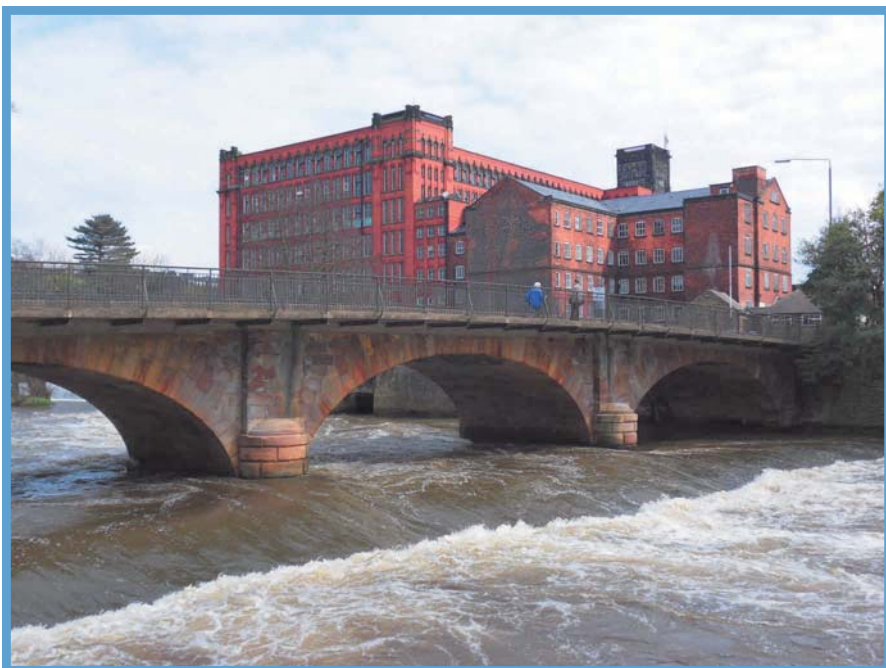
25 North and East Mills with river bridge in foreground

The poor condition of both mills and the weir are causes for concern.

Recent change to view (2017): No visible significant changes but the rock weir continues to deteriorate and may collapse in a future flooding event.

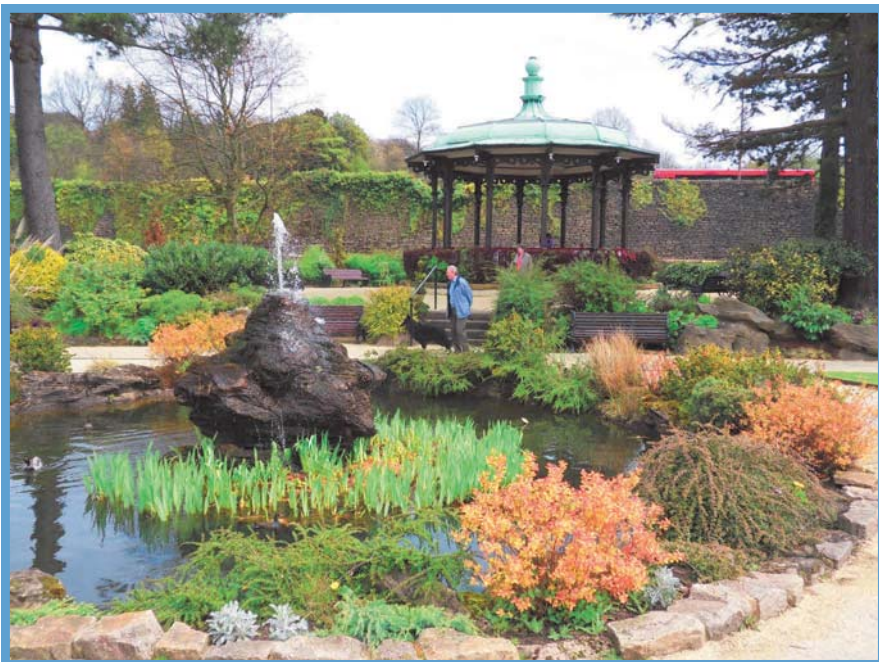
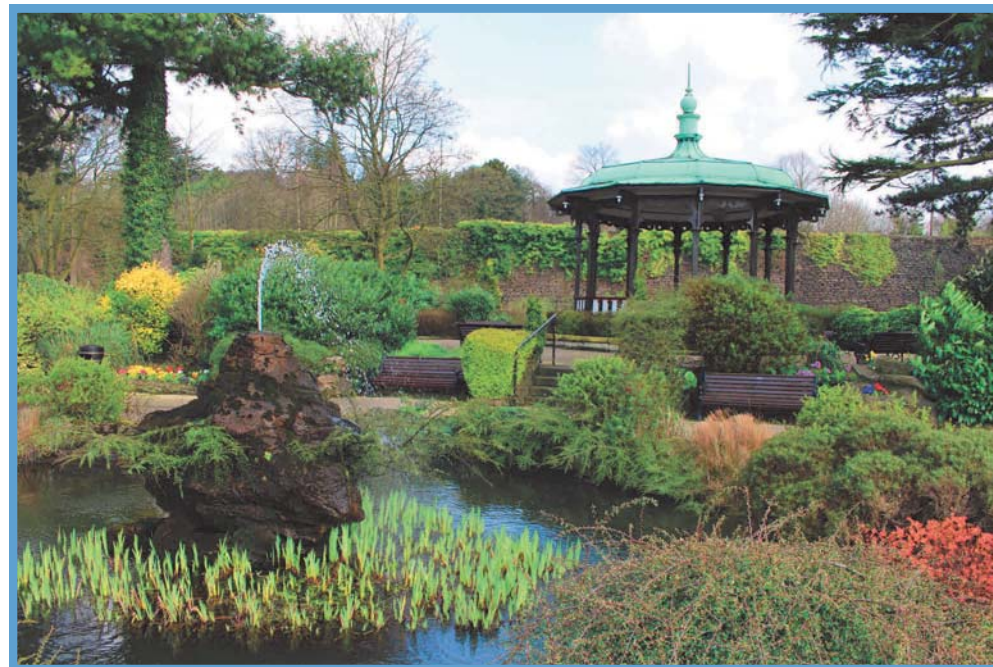
28 River Gardens fountain and bandstand

Recent change to view (2017): The finial has been restored to the bandstand but the ivy on the back wall continues to increase.

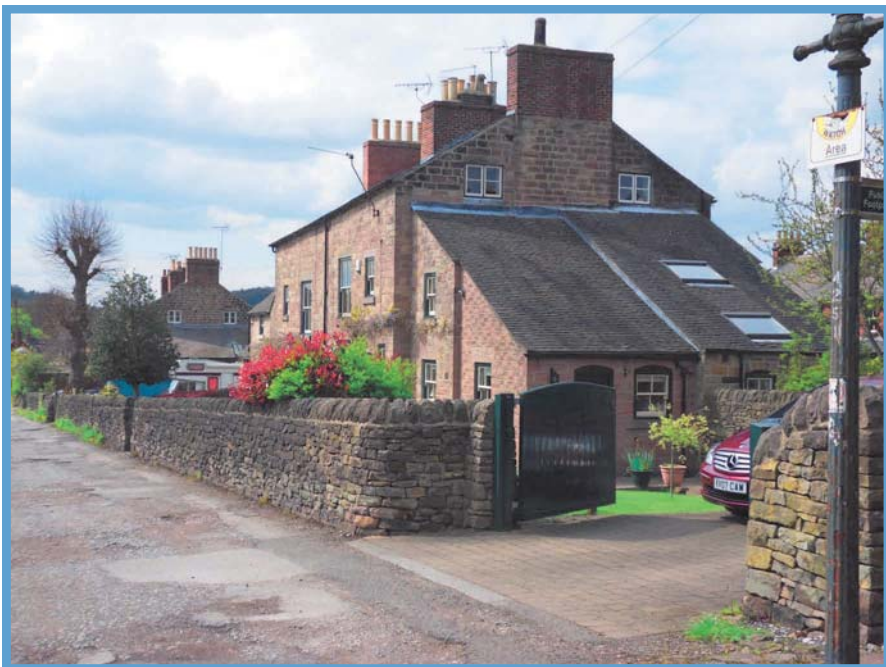
31 Cluster Houses on Joseph Street, Belper

Description (2008): The historic setting of these distinctive houses of 1805 is important, namely stone boundary walls and a Telford like road construction. The latter is in a poor state and is vulnerable to further deterioration. A World Heritage objective is the repair of the best surviving areas of road surface and the restoration of the remainder. An important characteristic of this historic scene is the absence of kerbs, street signs and other modern street clutter.

Recent change to view (2017): No significant change but the road continues to deteriorate.

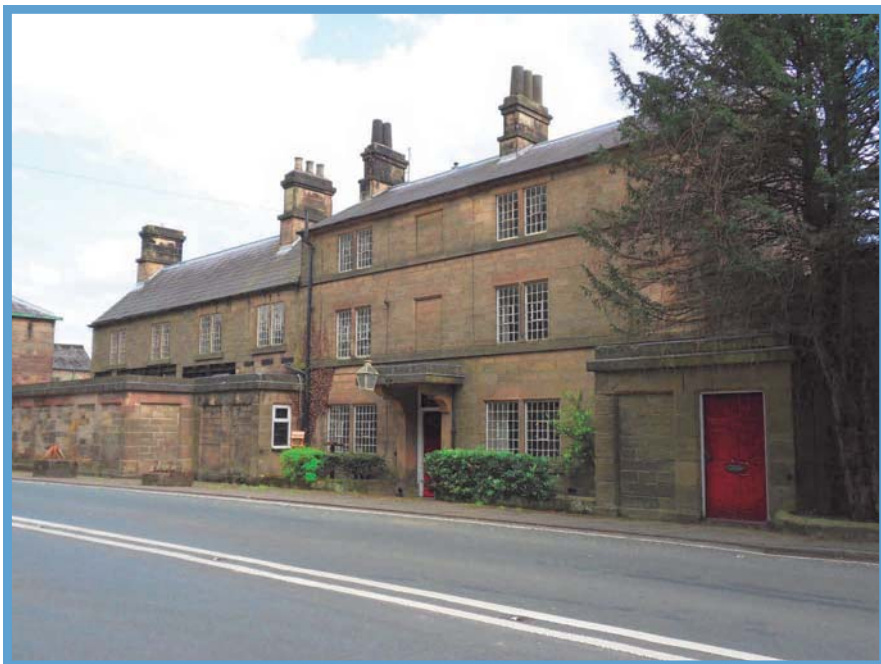
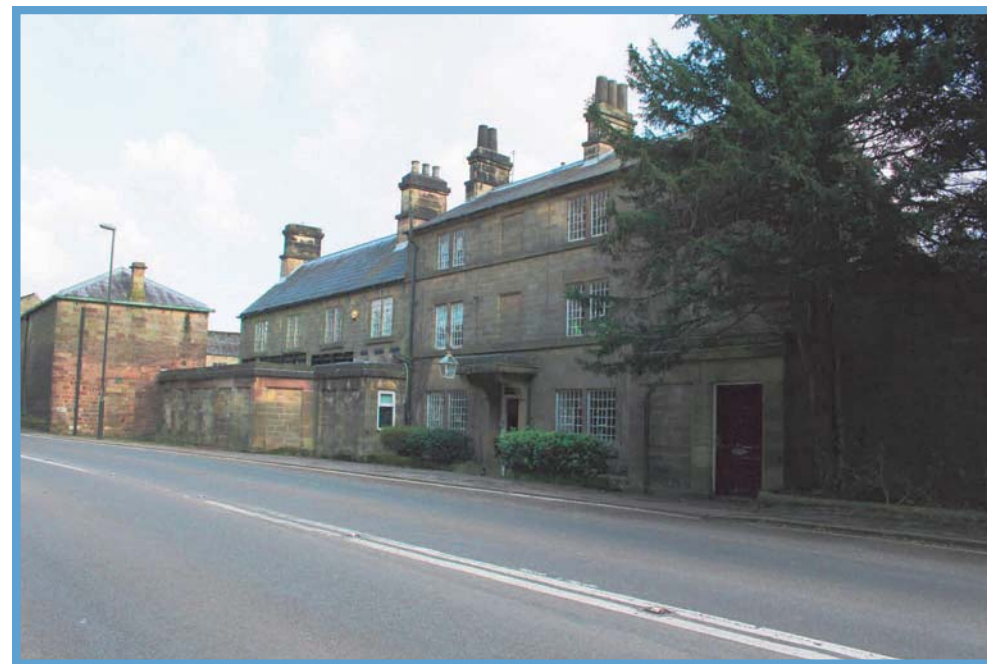
33 Crossroads Farm, from Ashbourne Lane

Description (2008): The Strutt farms are an interesting part of that family's enterprising developments. The farmhouses are most impressive but also of interest are associated features in the agricultural landscape, such as reservoirs and water supply structures, bridges and retaining walls.

Recent change to view (2017): No significant change.

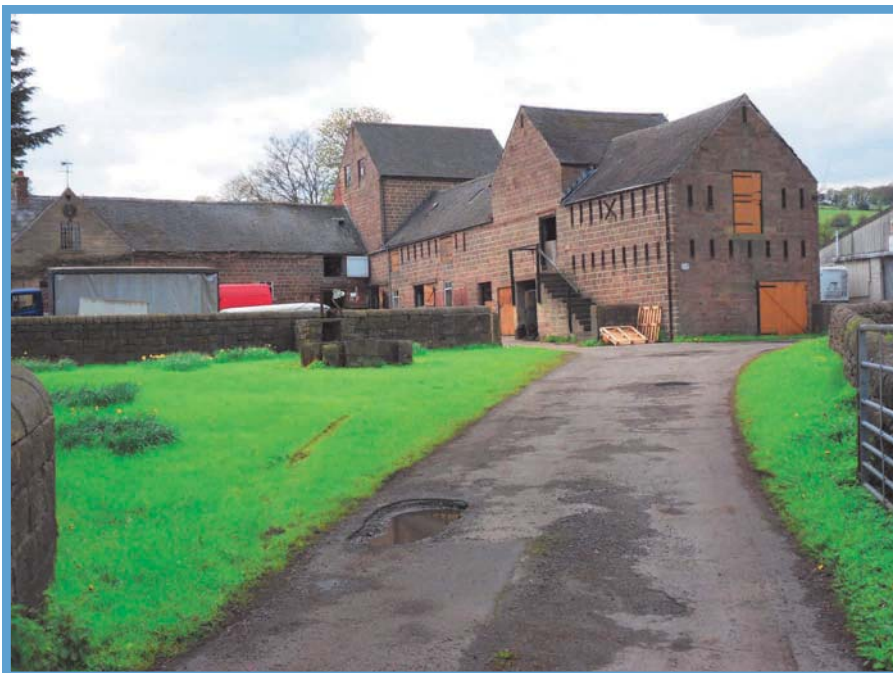
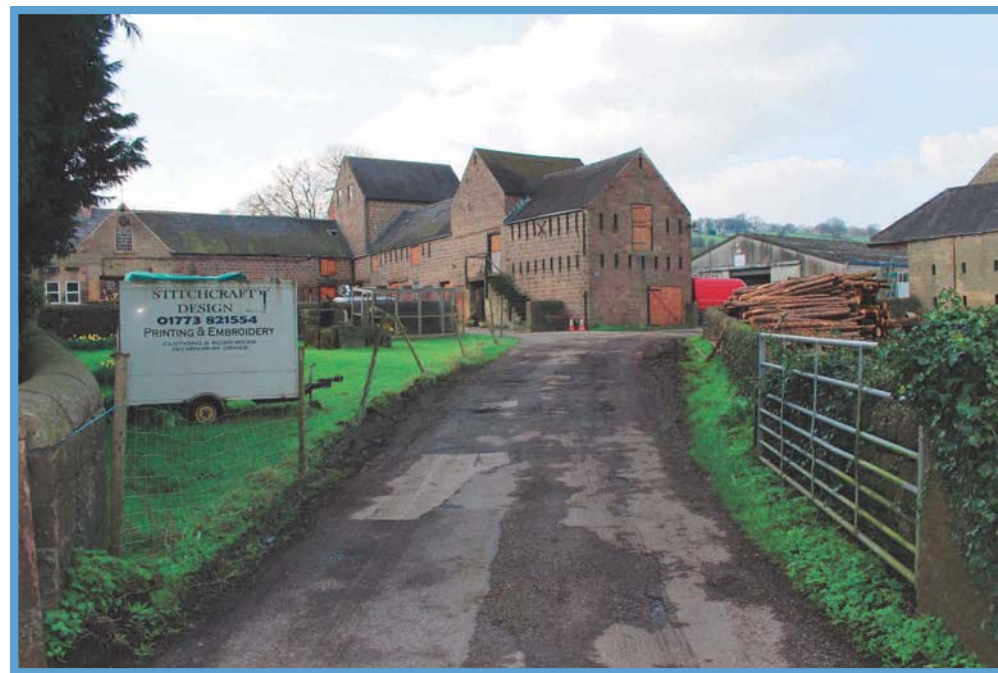
34 Dalley Farm

Description (2008): As the economic realities of agriculture change, more and more of the Strutt farm buildings are likely to become unsuitable for modern agricultural use. A major challenge is to find new sustainable uses which are compatible with preservation of their character and appearance.

Recent change to view (2017): A fire in 2015 had a significant impact on the buildings to the left of this view but they have been fully restored. The advertising trailer on the left hand side unfortunately blocks the view to some degree.

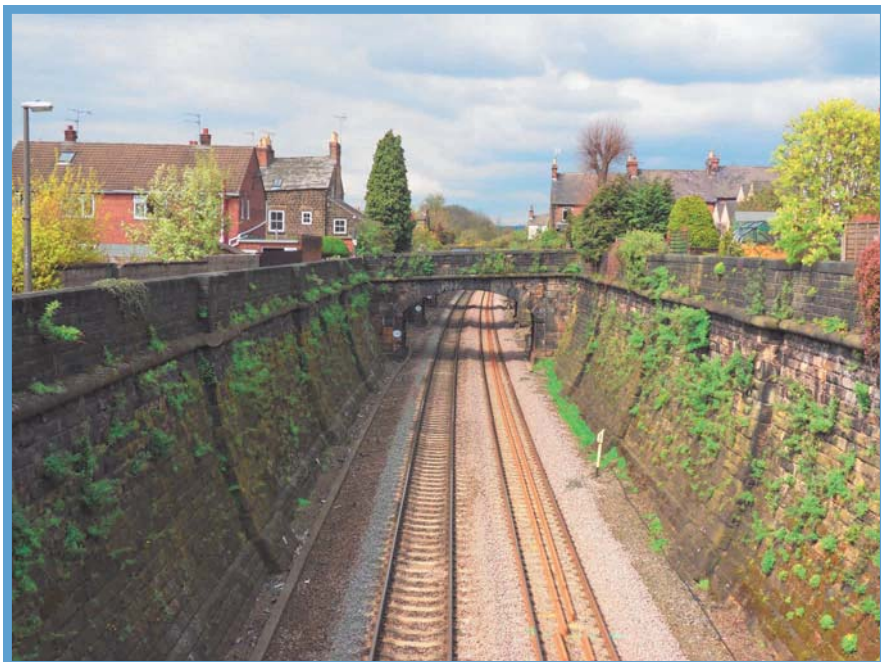
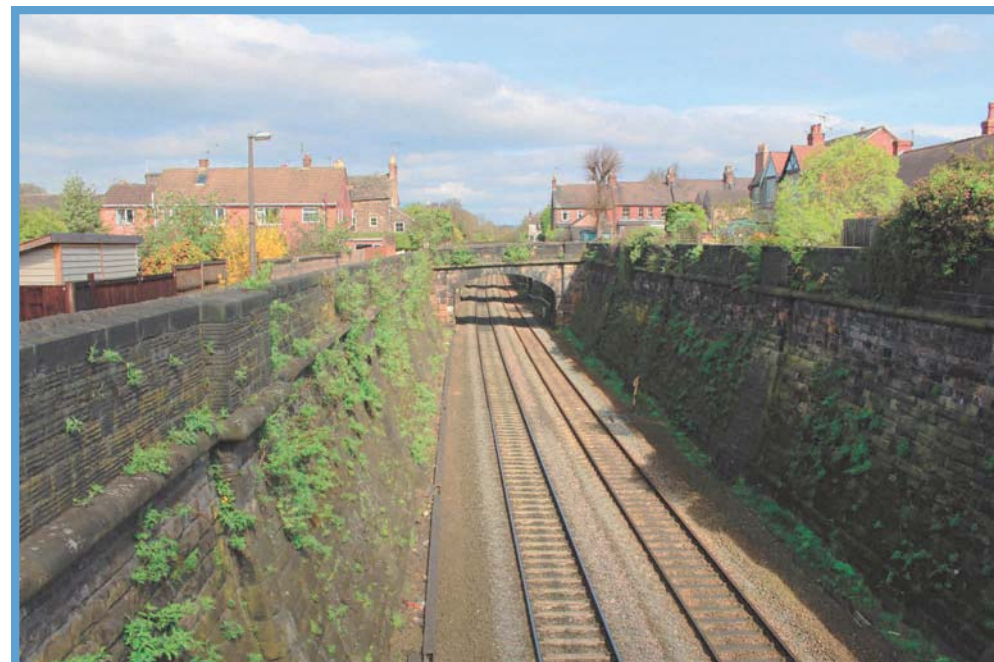
35 Rail cutting and bridges from Field Lane, Belper

Description (2008): This impressive engineering structure designed and built by George and Robert Stephenson needs regular and careful maintenance to prevent damage resulting from vegetation getting established in masonry joints.

Recent change to view (2017): Vegetation is beginning to take a significant hold on this cutting again.

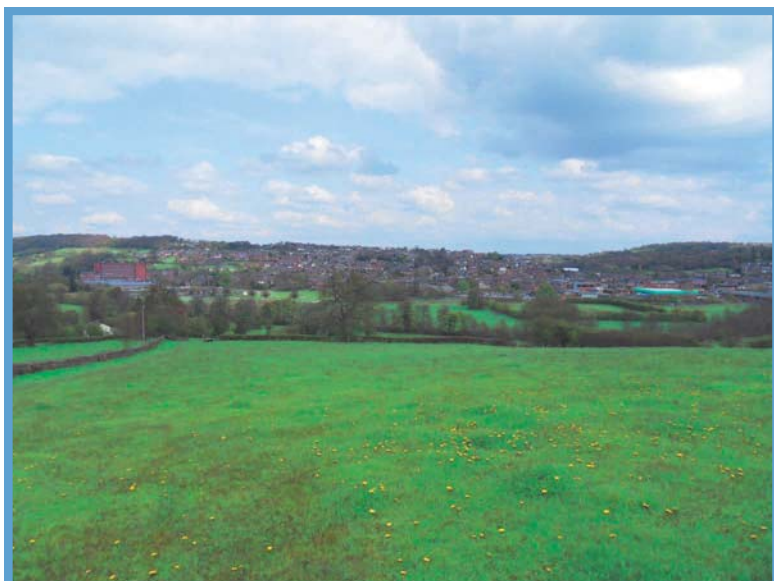
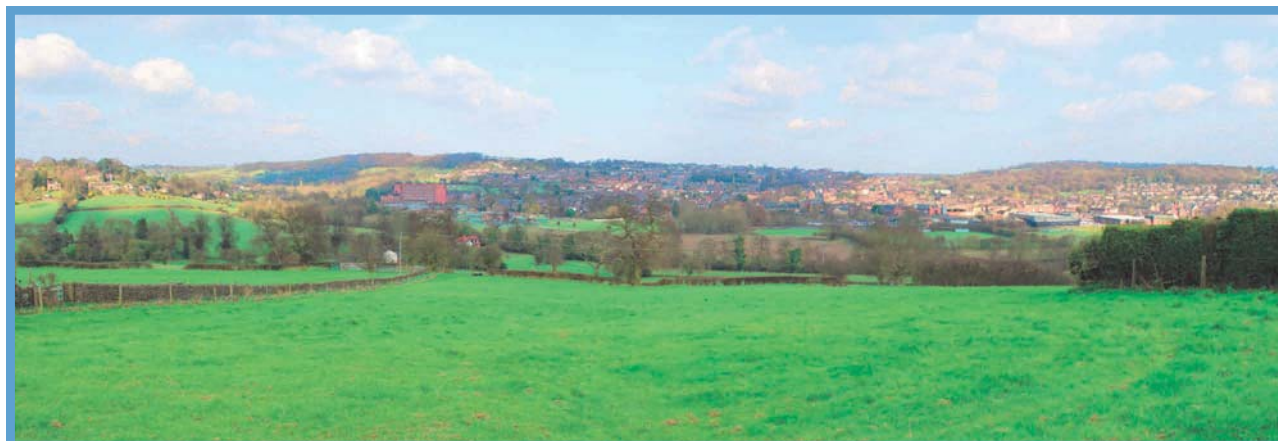
36 Belper and the Derwent Valley from the north end of Chevin Road

Recent change to view (2017): No significant change. The old focus building has been replaced with a more recessive structure to the right of this view. Development has been resisted for fields on the far side of the valley (Bullsmoor).

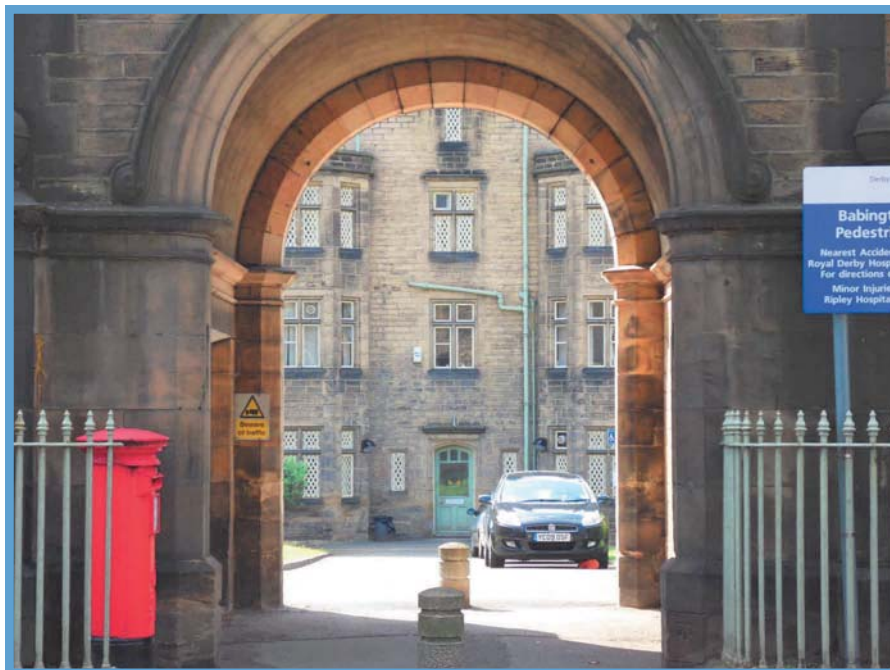
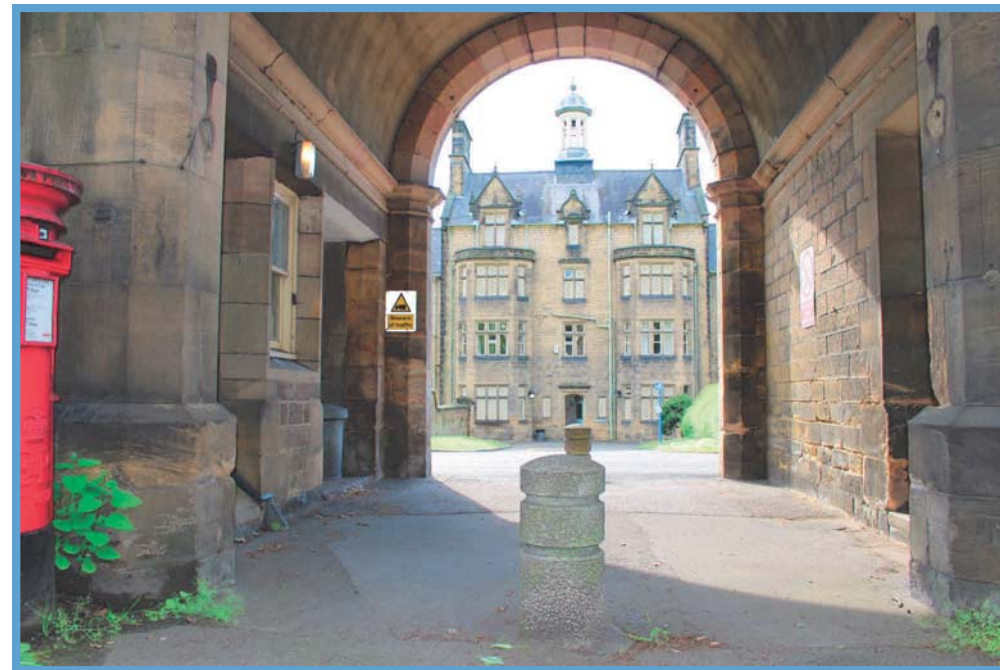
37 Belper Workhouse (Babington Hospital) from A6

Recent change to view (2017): No significant change. A proposed change of ownership and use could provide challenges for the future of these buildings.

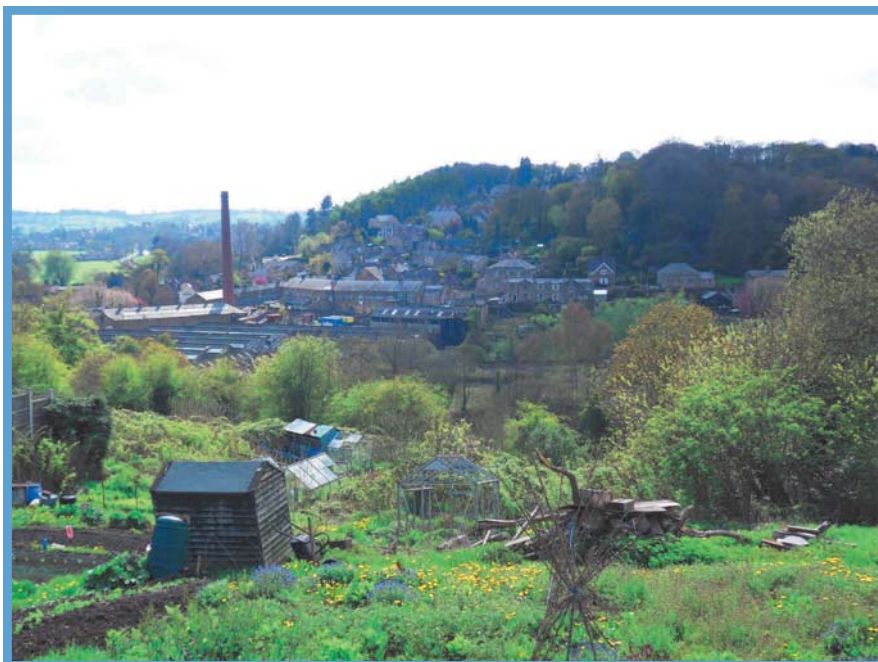
38 Milford from the east

Recent change to view (2017): No significant change although the allotments in the foreground are less tended than in the past.
