Derwent Valley Mills World Heritage Site

Monitoring Views 2017

Appendix 9

Images from North to South

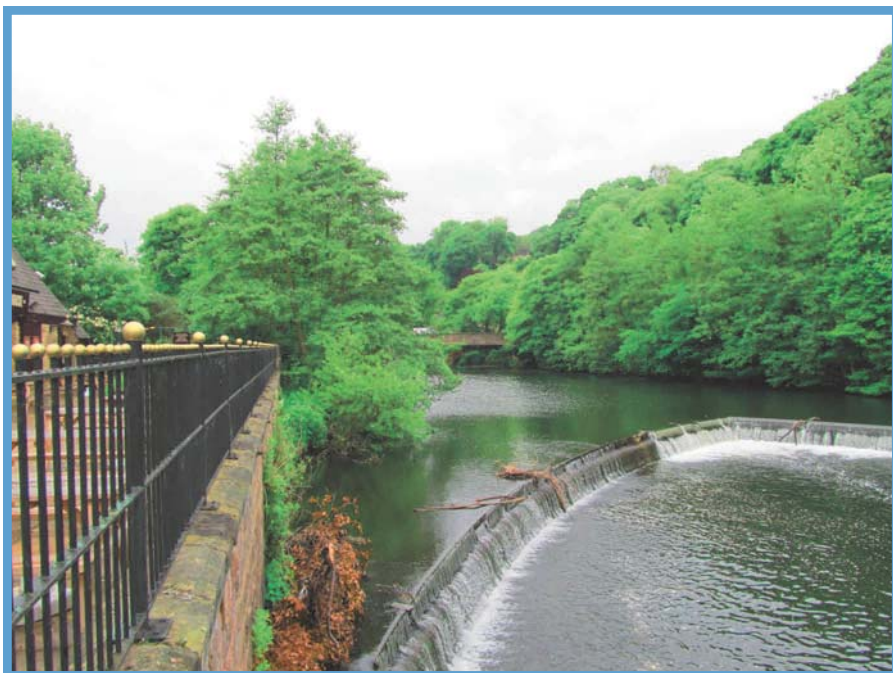
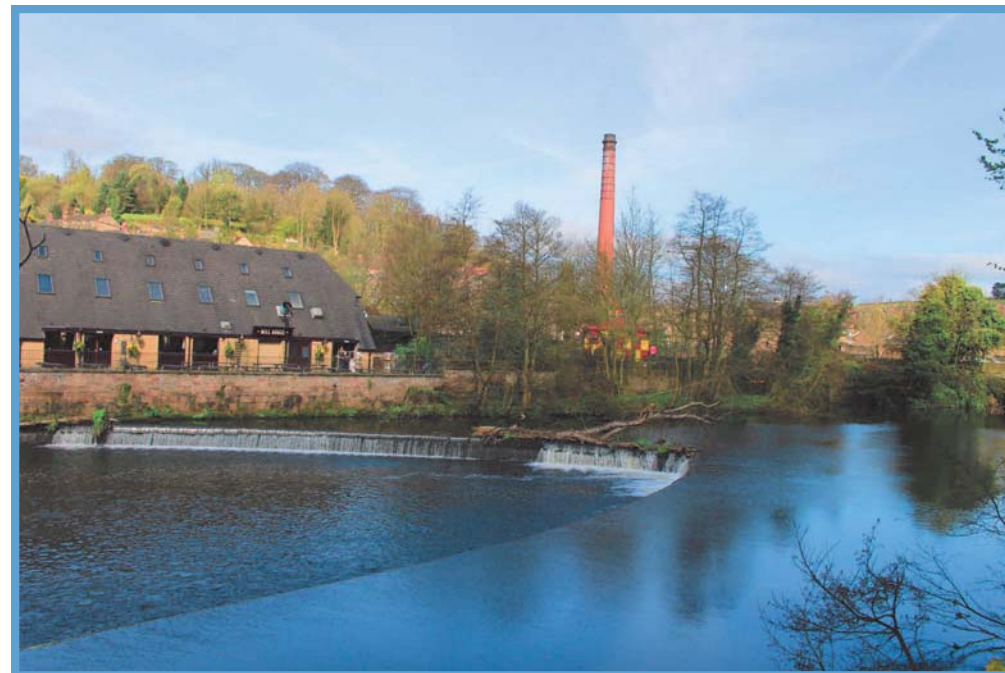
39 The weir at Milford

Recent change to view (2017): Trees in the foreground have been removed, restoring the view.

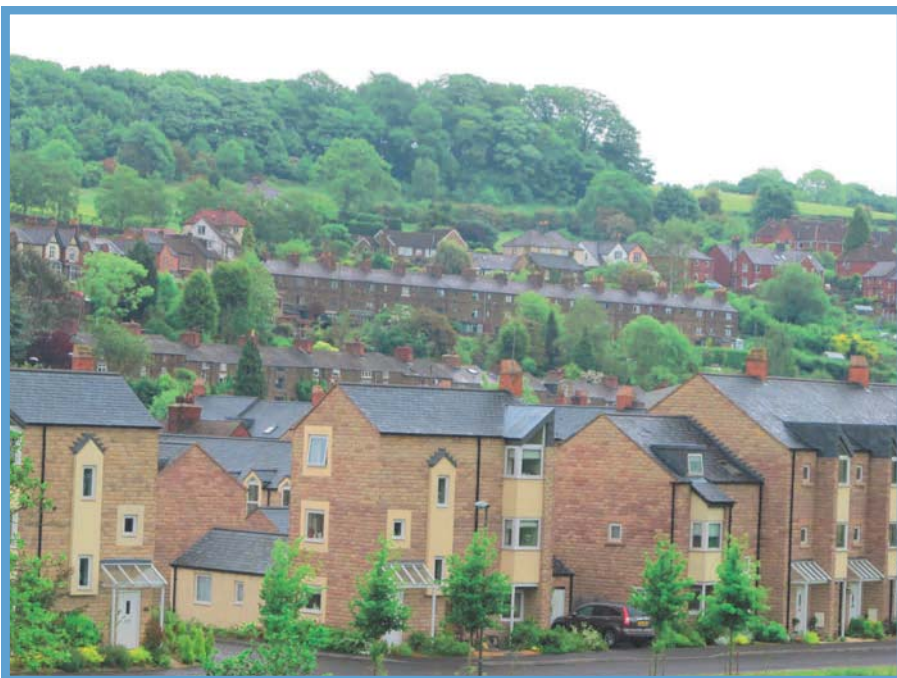
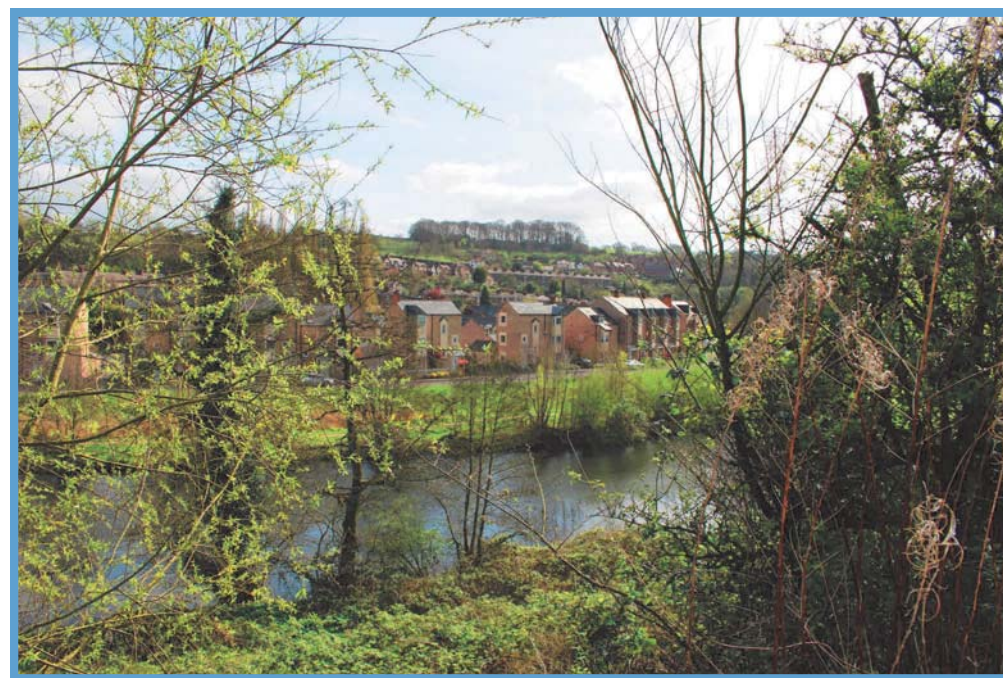
41 Hopping Hill terraces, Milford

Recent change to view (2017): No significant change however vegetation is increasing on the west bank of the river, reducing the opportunity to appreciate these views.

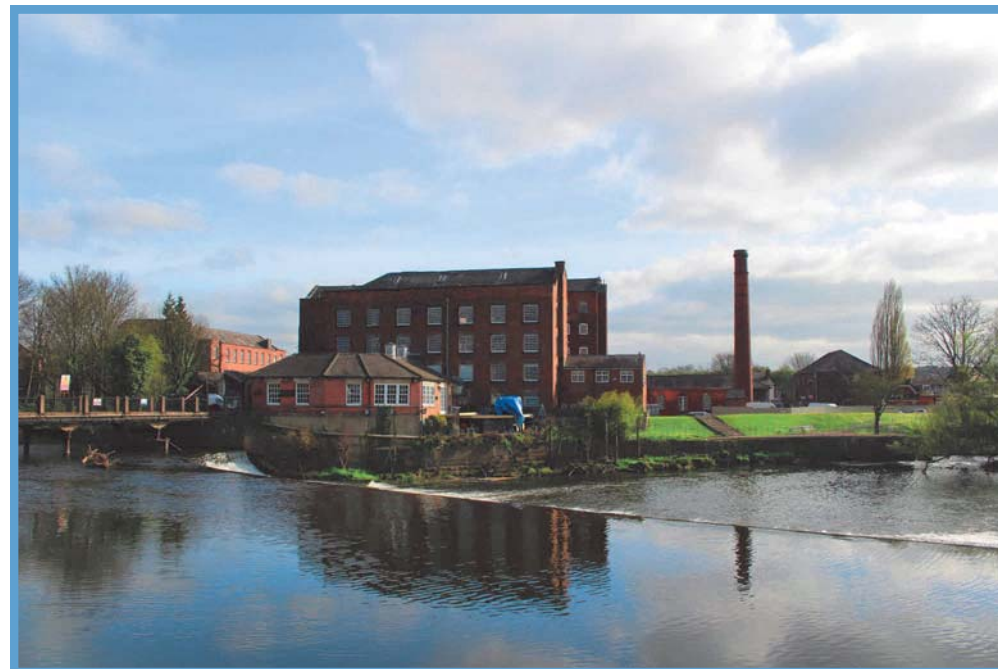
42 Darley Abbey Mills from Viewing Platform

2012 – Vegetation is beginning to obscure the view as it has in the past.

Recent change to view (2017): Work to restore and enhance the mill complex has seen considerable positive changes to the immediate settings of the buildings. The vegetation has been removed again, opening up the view.

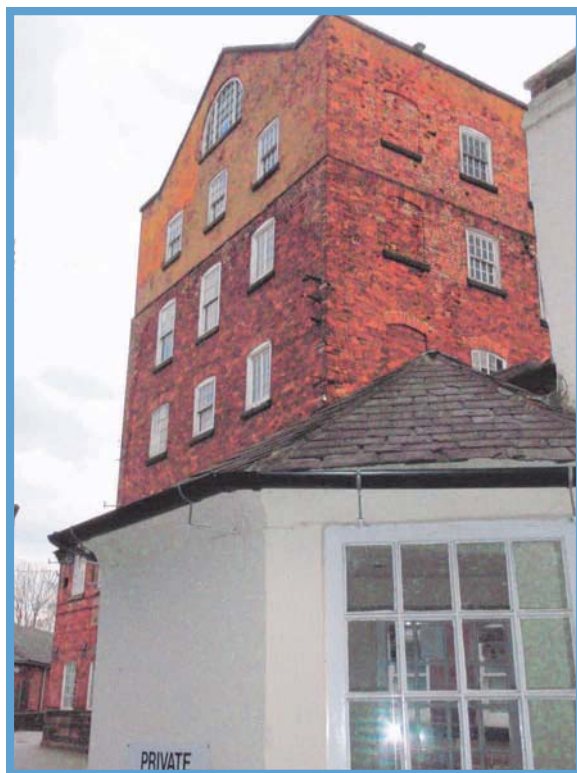
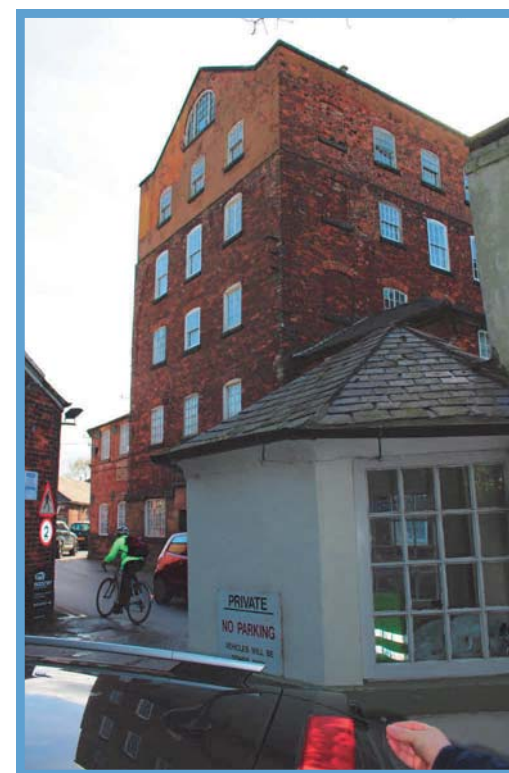
43 Toll booth, and gable end of Boars Head Mill

Description (2008): This view demonstrates the scale of Boars Head Mill. The toll booth (c.1783) by the river bridge is in need of repair and the mills themselves need to be found sustainable new uses which are compatible with the protection of their character and appearance.

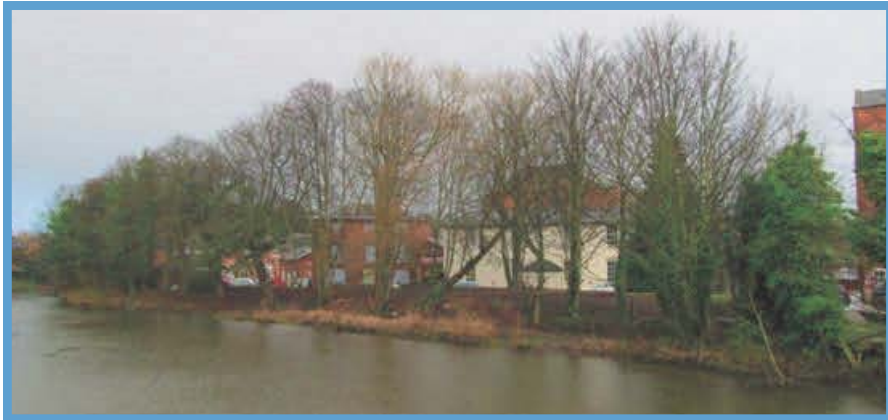
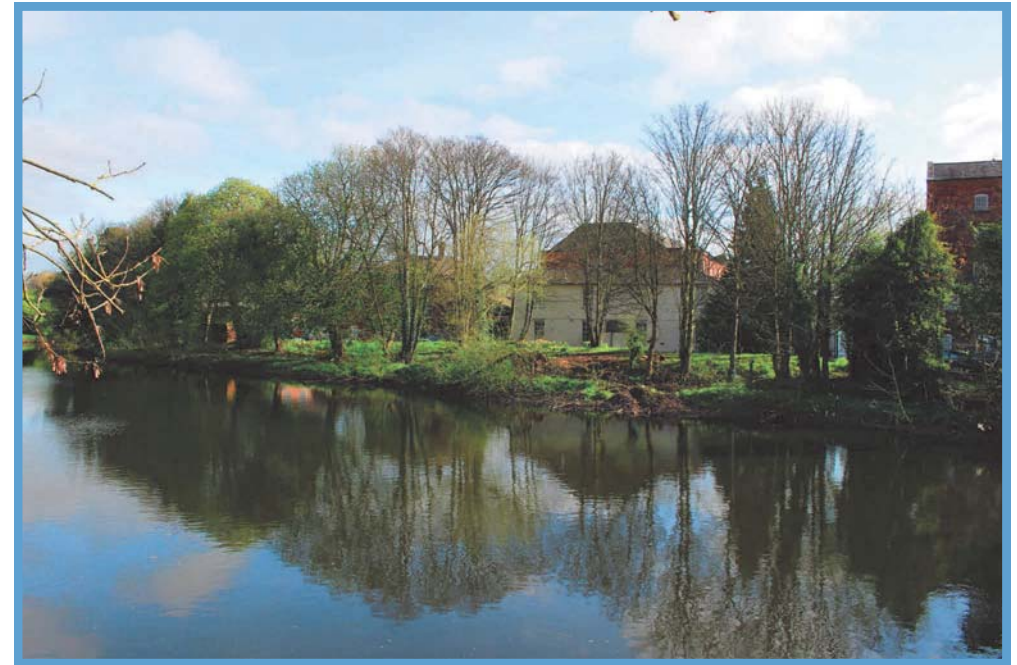
44 Darley Abbey Mills from the west (new photo)

Recent change to view (2017): Restoration work has been carried out on the mill manager's house. This area continues to improve.

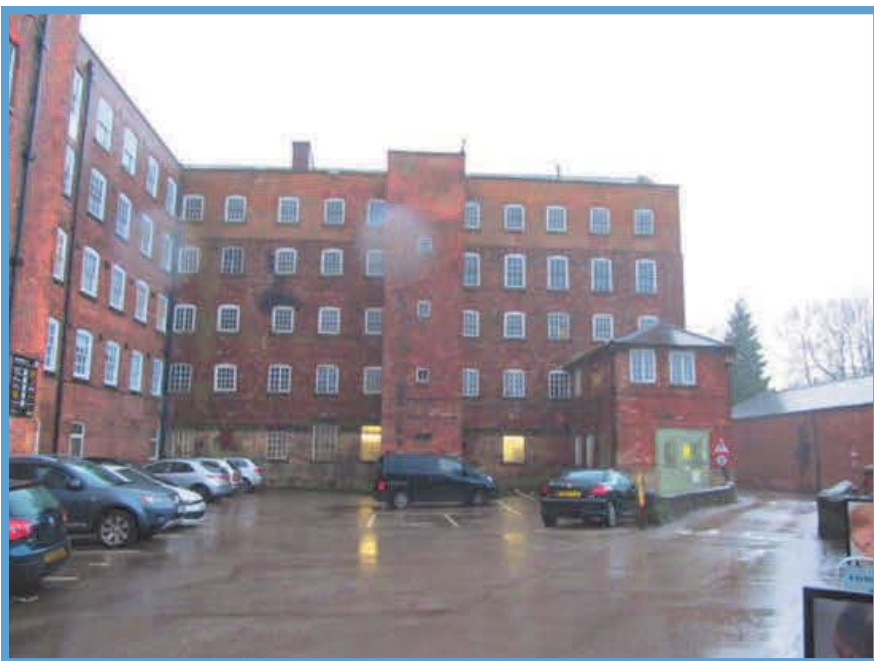
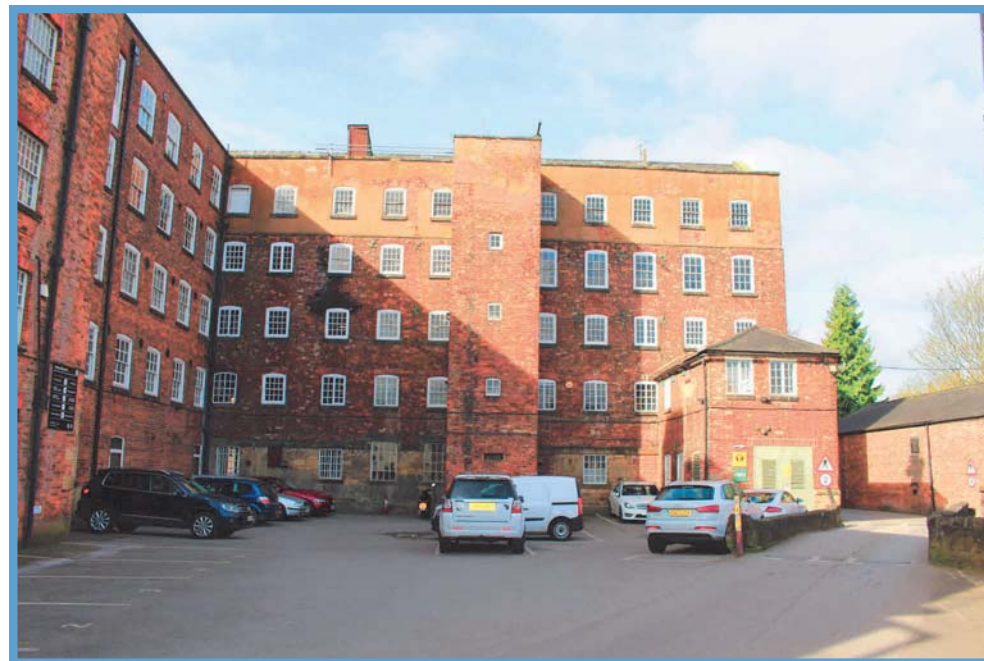
45 Long and Middle Mill, Darley Abbey (new photo)

Recent change to view (2017): Restoration and reuse of these mills is continuing.

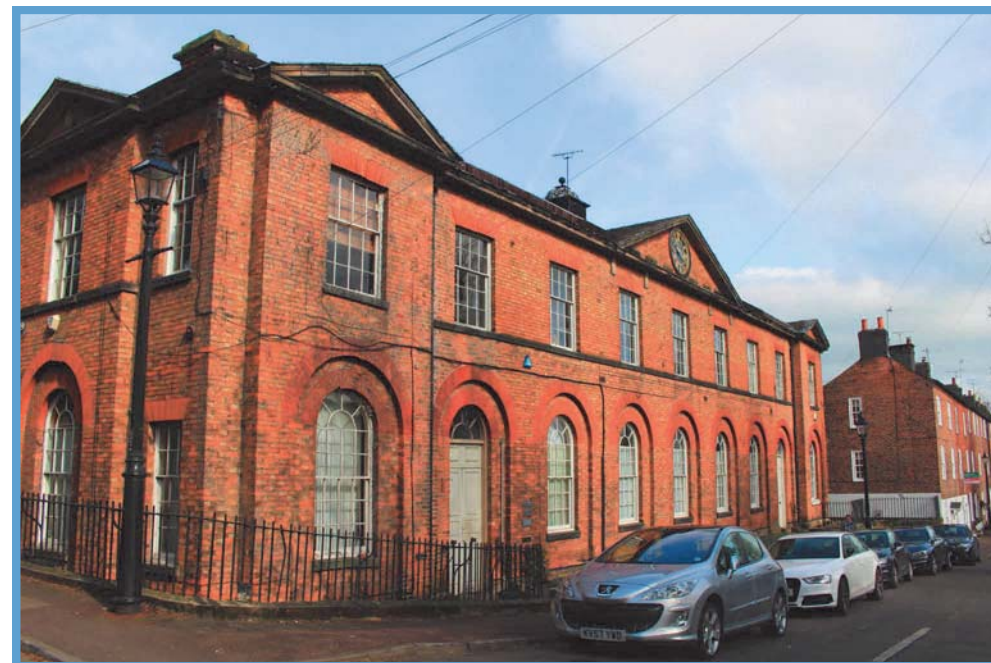
46 School and Brick Row, Darley Abbey (formerly 44)

2012 – Vegetation has been removed from the building.

Recent change to view (2017): No significant change.

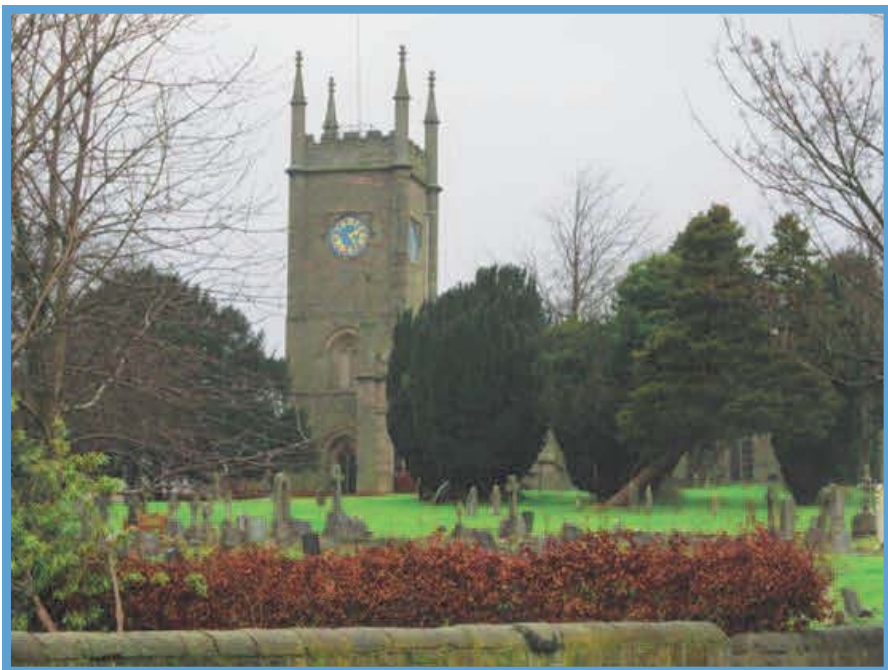
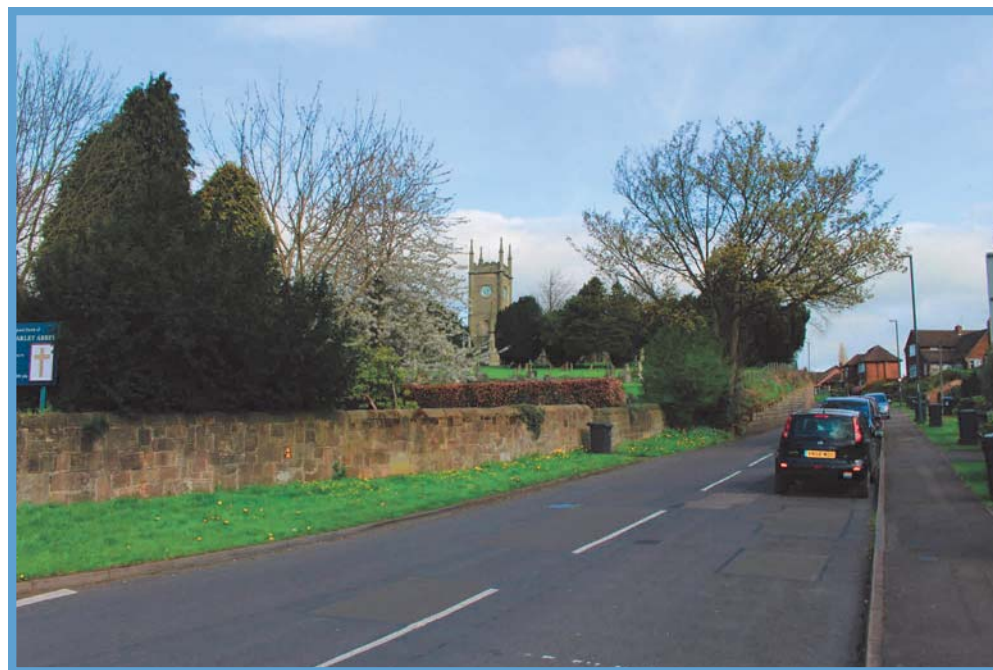
47 St Matthew's Church, Darley Abbey (new photo)

Previous recorded changes:
New viewpoint.

Recent change to view (2017): The view has been pulled back to take in the wider setting. No perceivable changes since 2014.

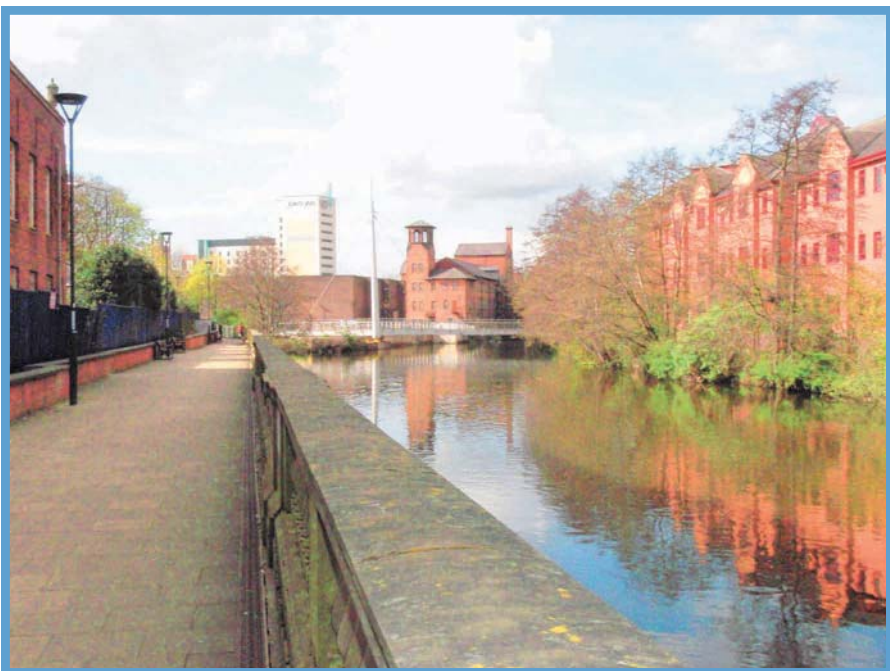
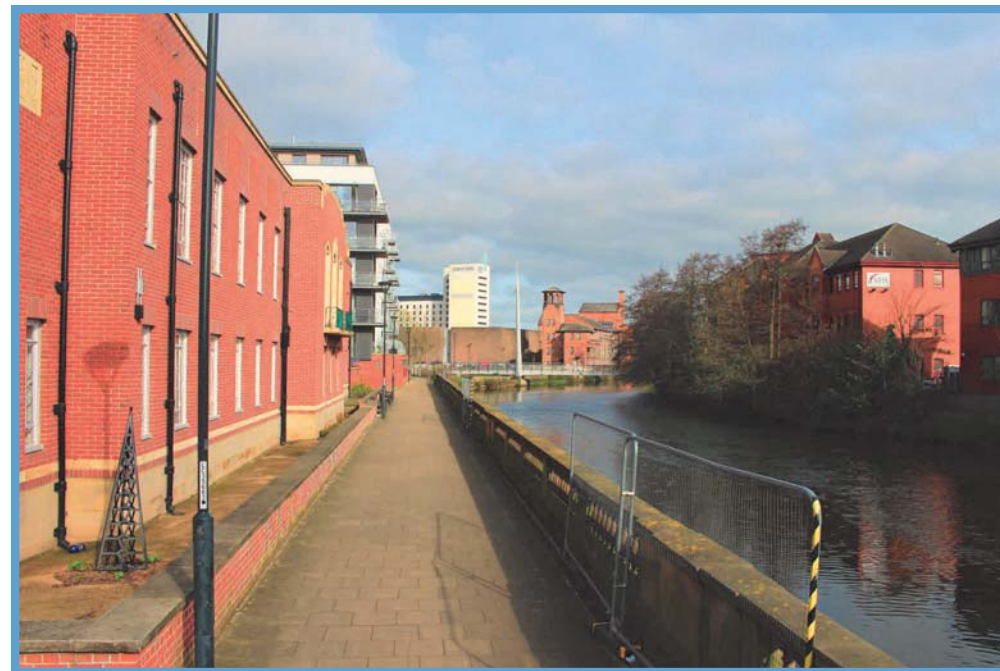
48 Silk Mill from Exeter Bridge (formerly 45)

2012 – No significant change.

Recent change to view (2017): Redevelopment of the west bank of the Derwent has introduced new build, but this does not significantly impact on the view of the Silk Mill.

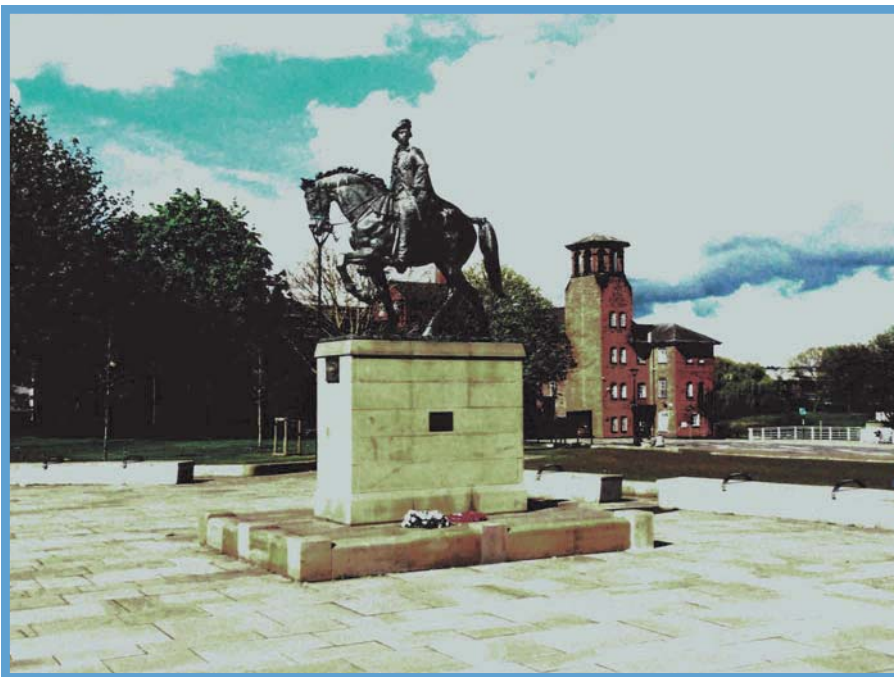
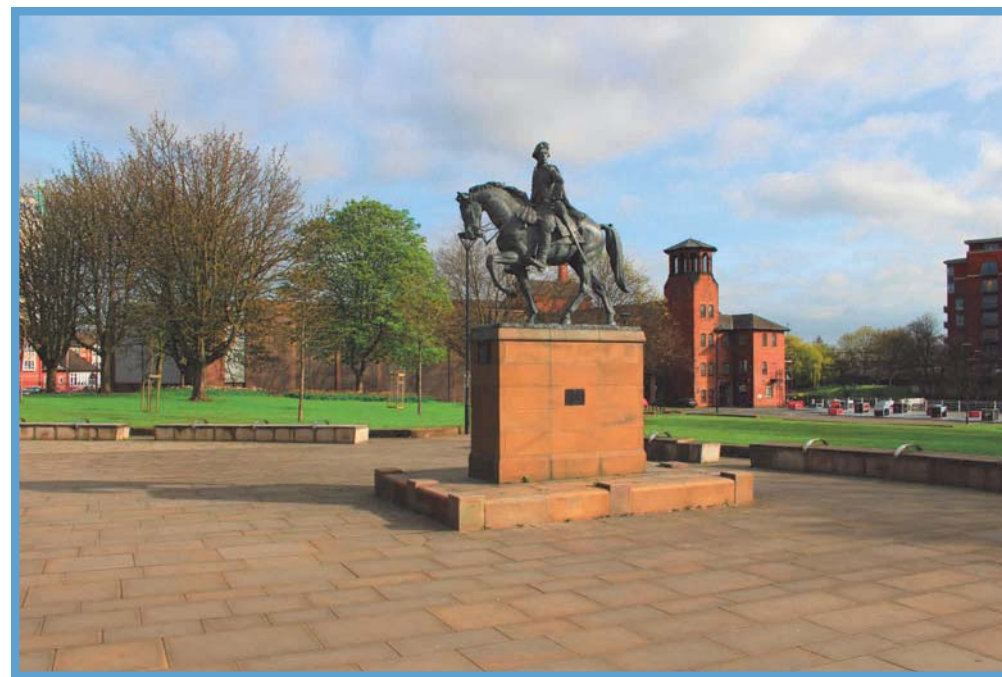
49 Silk Mill from Cathedral Green (formerly 46)

2012 – No significant change.

Recent change to view (2017): No significant change.

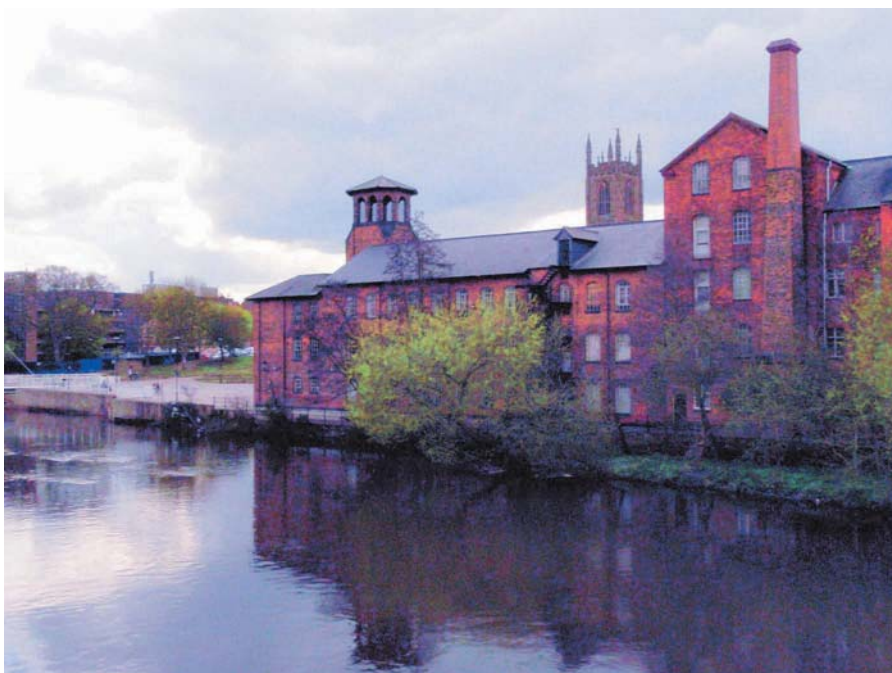
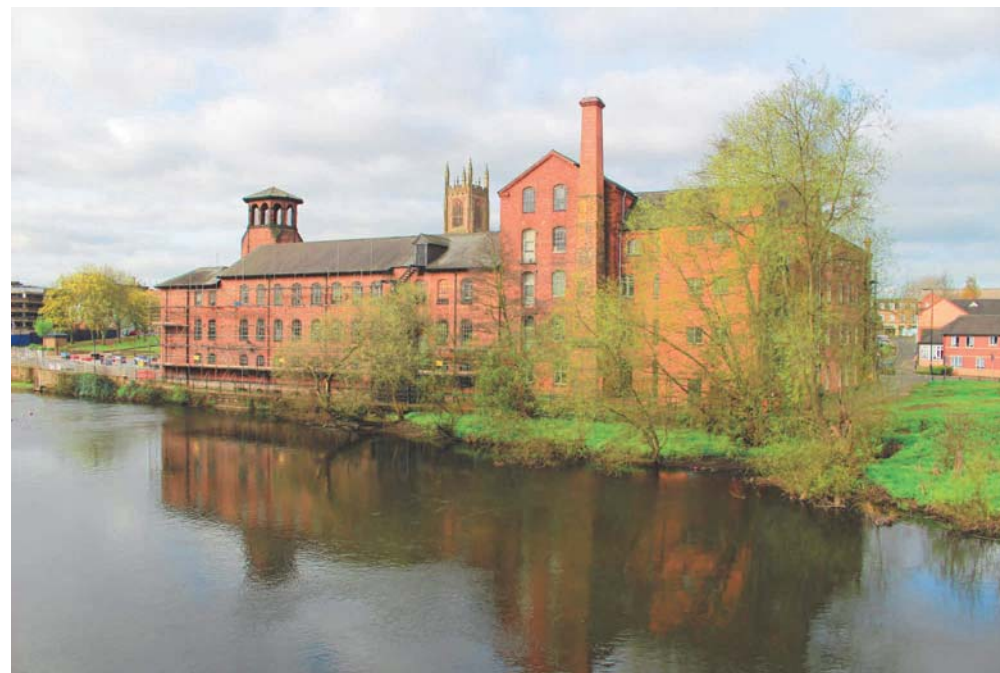
50 Silk Mill from the St Alkmund's Way flyover bridge (formerly 47)

2012 – No significant change.

Recent change to view (2017): No significant change.
