Derwent Valley Mills World Heritage Site Monitoring Views 2017

Appendix 20

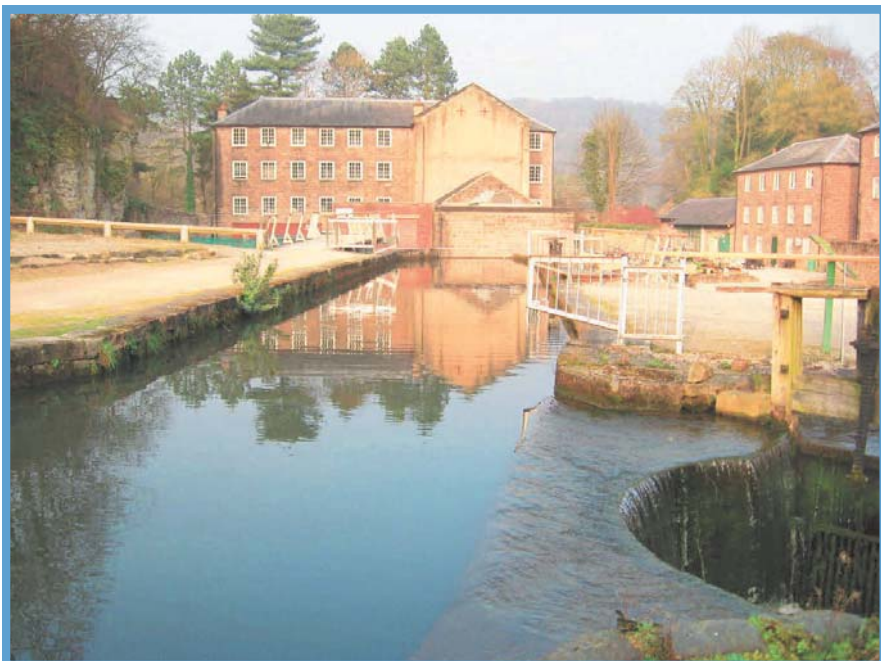
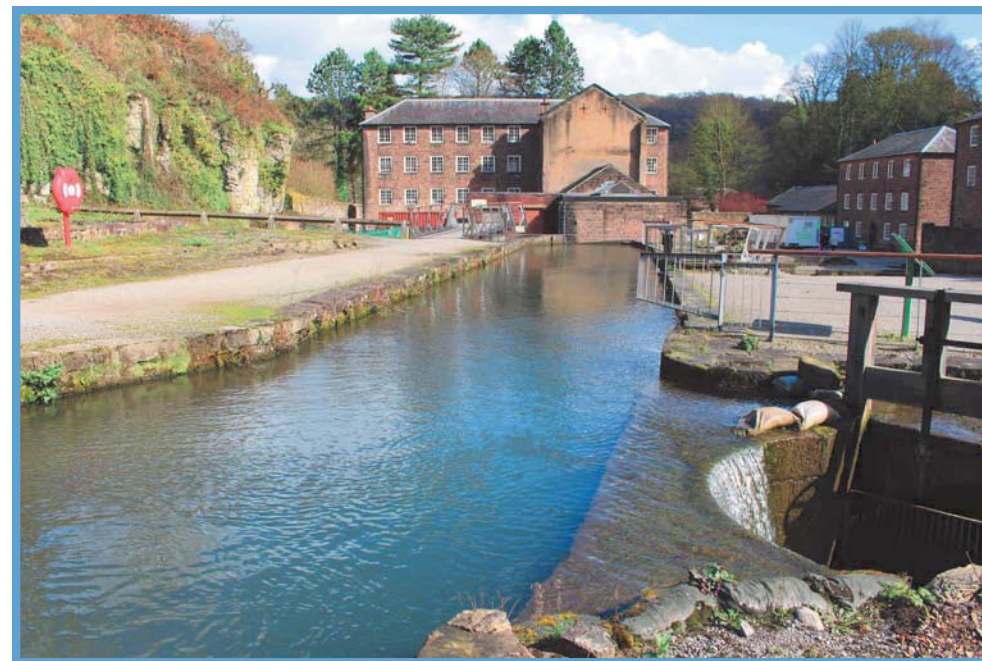
03 Cromford Mill building one with watercourse in foreground

Recent change to view (2017): No significant change.

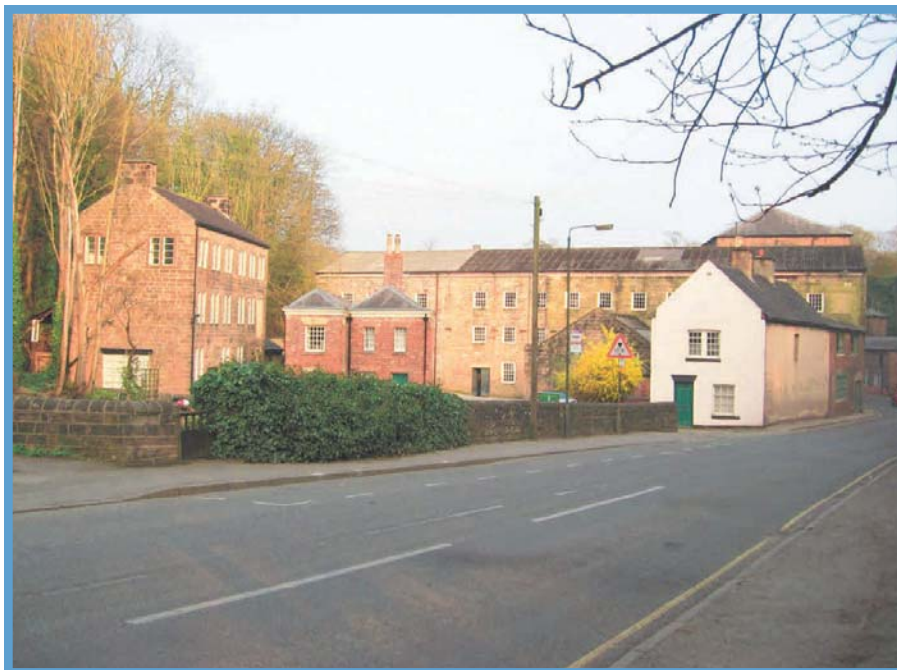
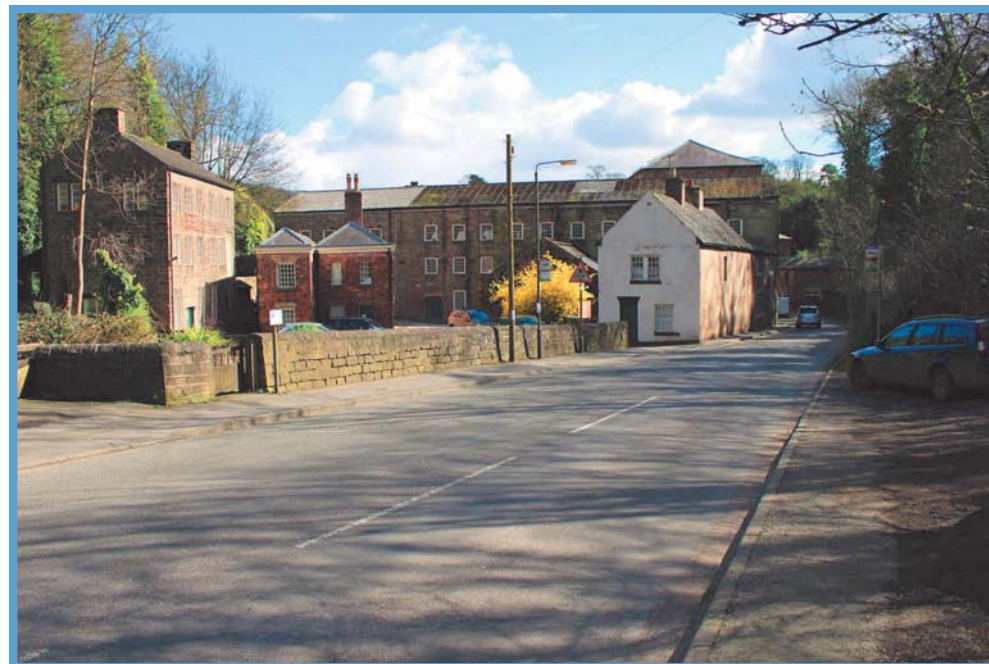
04 Cromford Mill from Mill Road

Not in the view, because it was very badly damaged in a road traffic collision in 2002 is the cast iron conduit of 1821 which spanned the road and which needs to be repaired and reinstated.

Recent change to view (2017): No significant change.

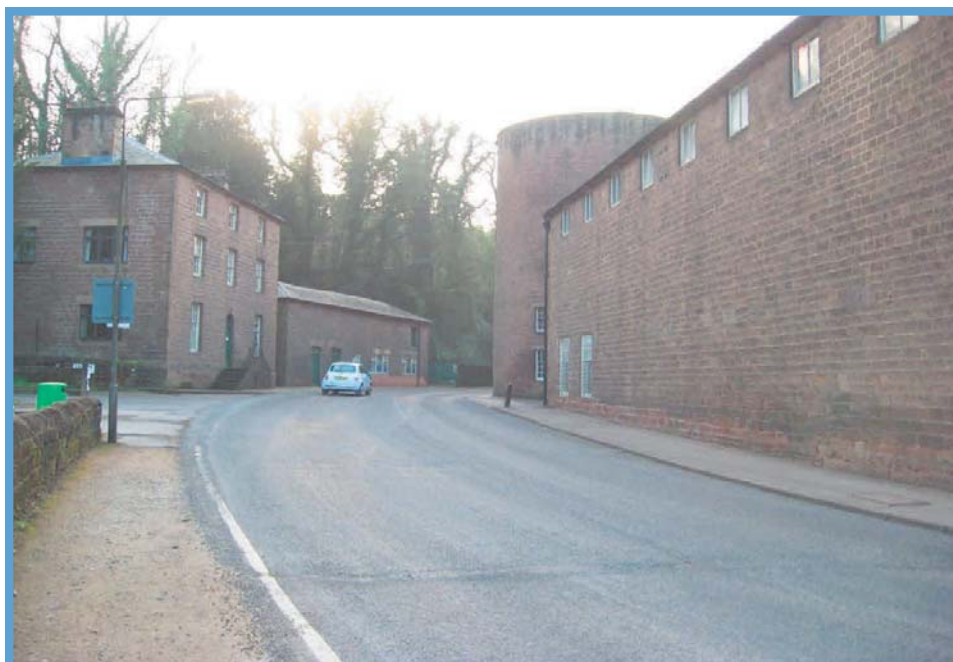
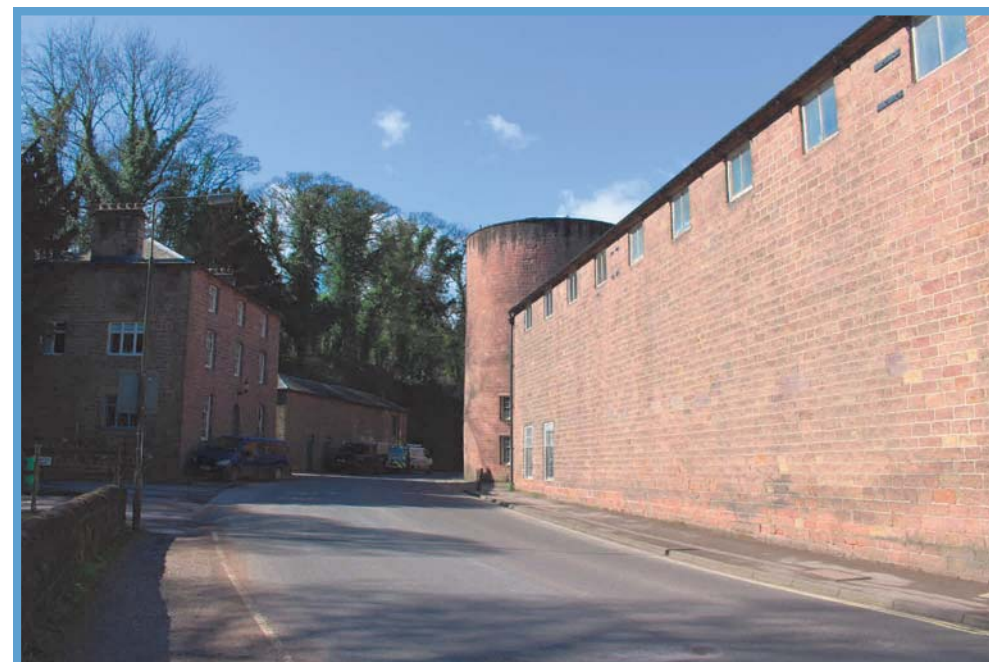
05 Cromford Mill from Mill Road looking west

Recent change to view (2017): No significant change.

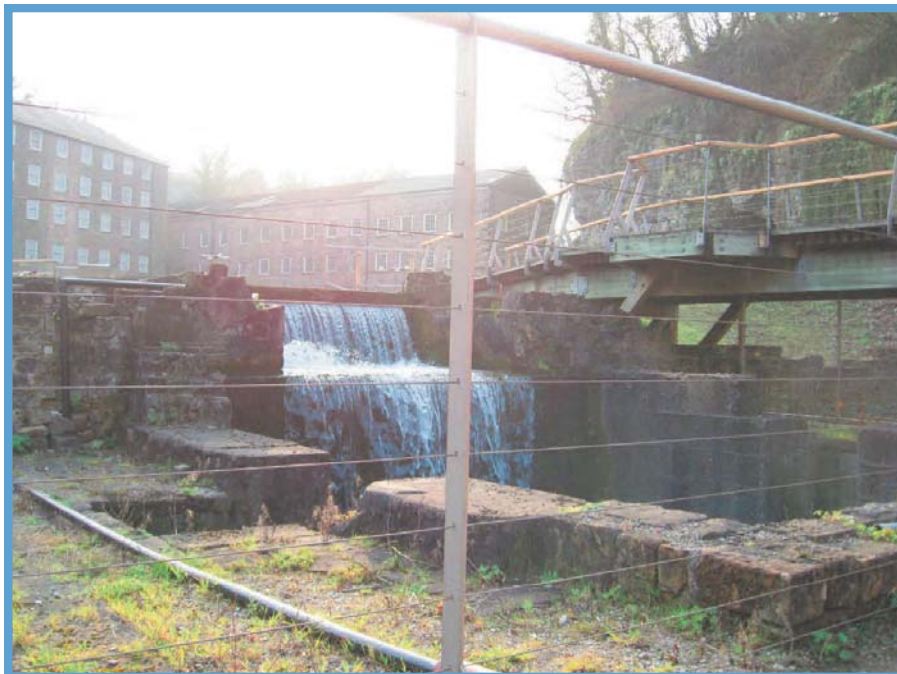
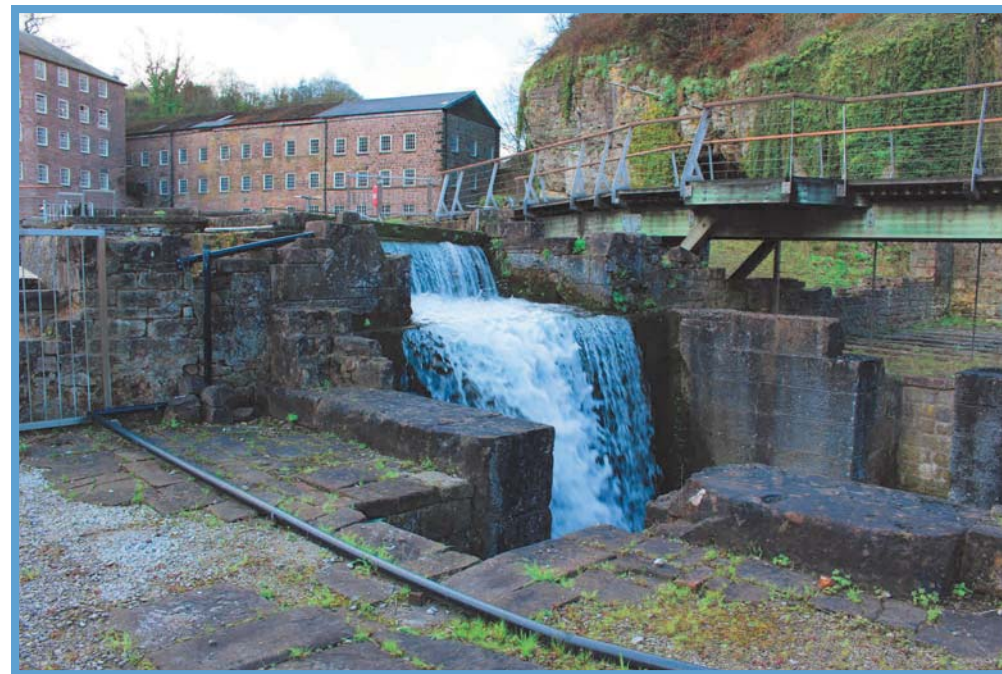
06 Cromford Mill - the first mill from the second mill wheelpit

Recent change to view (2017): No significant change.

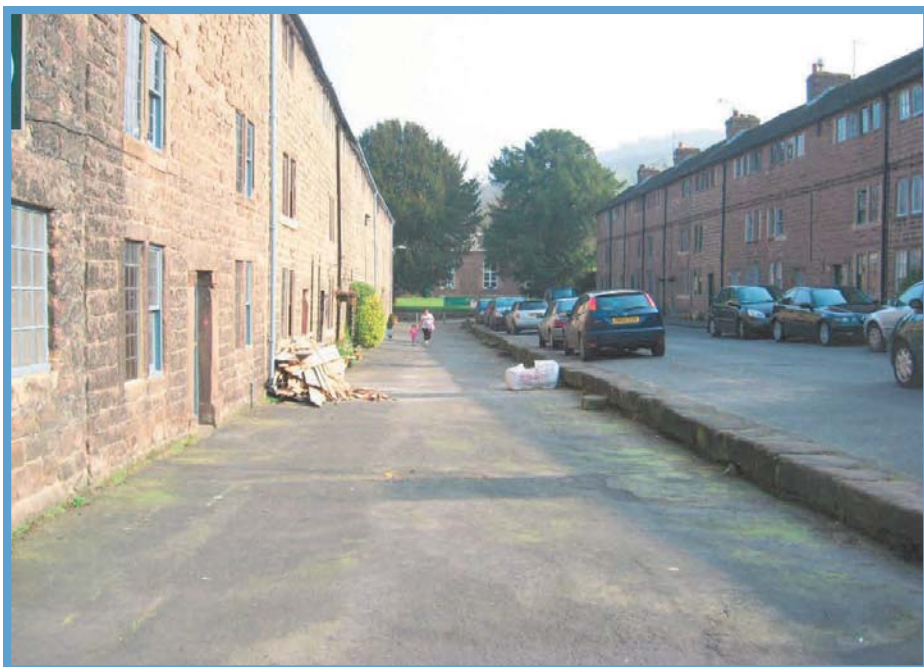
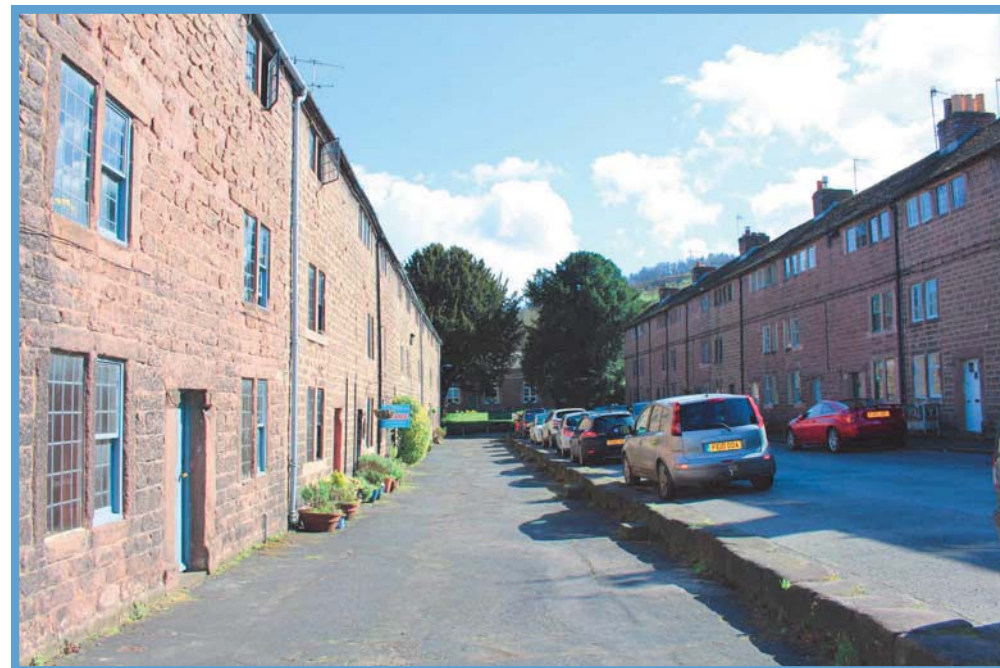
07 North Street, Cromford from Cromford Hill

The nature of the original paving has been researched and it is hoped it may be reinstated at some point. The absence of street clutter is an important quality. It would be preferable if some alternative site for resident's car parking could be found. The yew trees in the garden of the 1832 school are important.

Recent change to view (2017): No significant change.

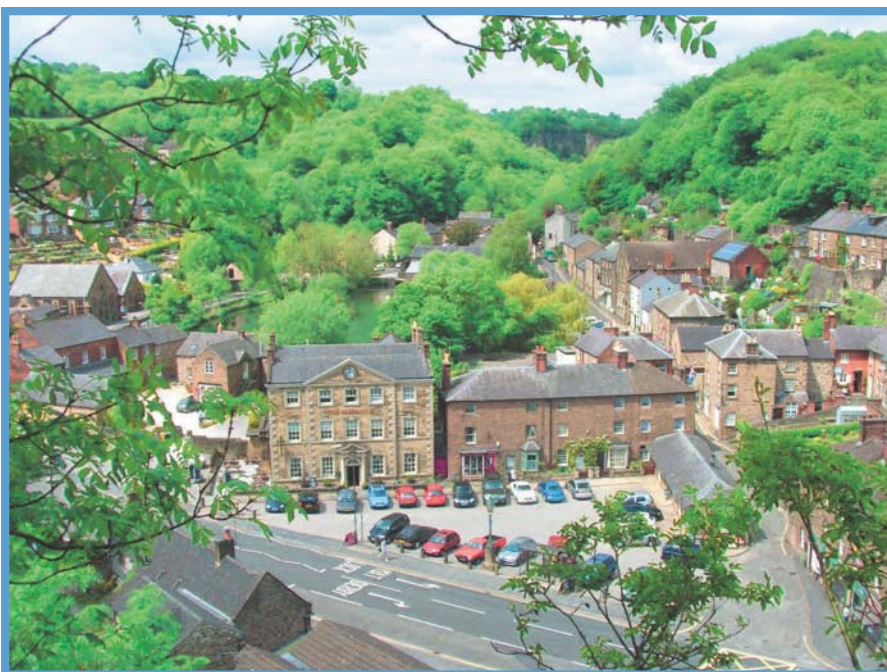
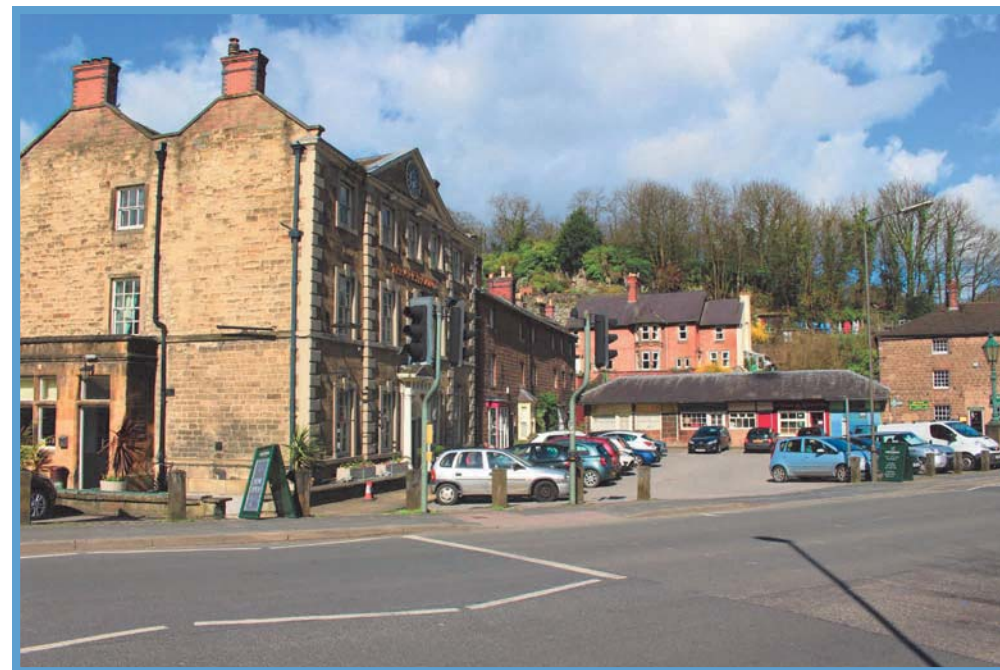
08 Cromford Market Place

Recent change to view (2017): No significant change.

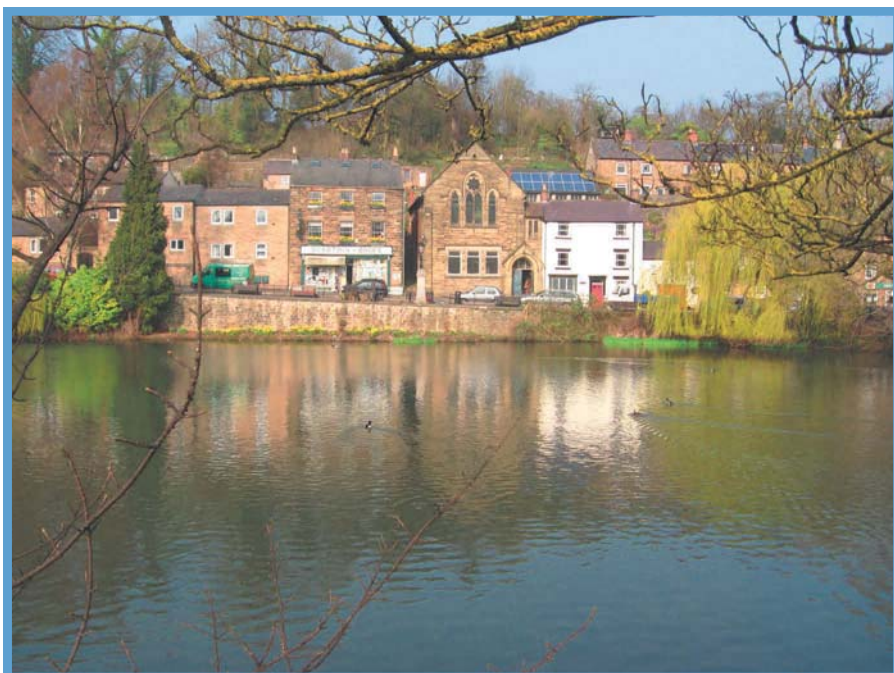
09 Cromford Mill Pond and Scarthin

2012 – Solar panels have appeared—highly prominent in this view.

Recent change to view (2017): No significant change.

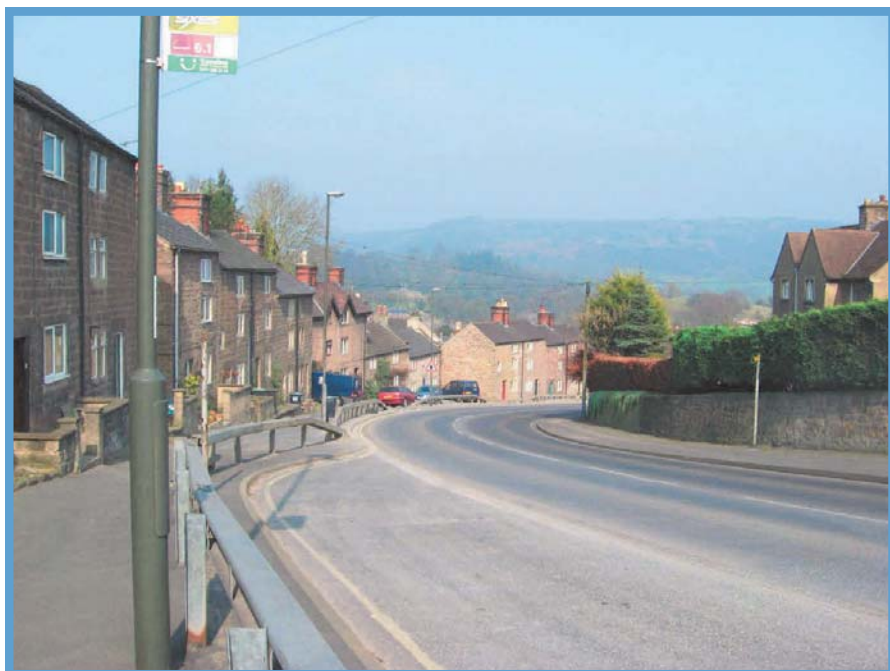
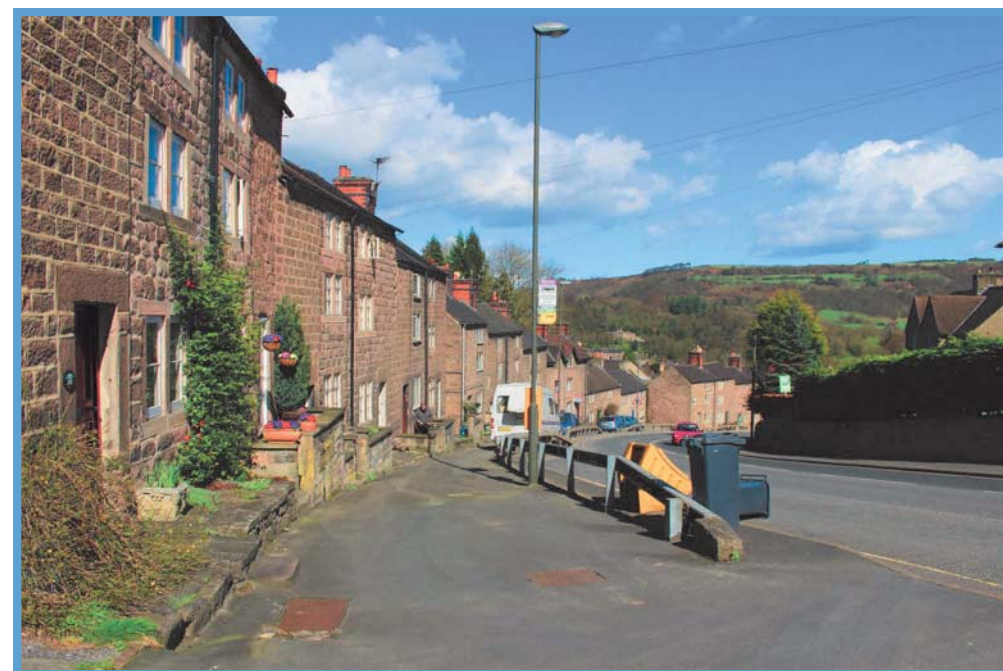
10 Looking down Cromford Hill to Willersley Castle and the landscape of Riber hillside beyond

Description (2008): The late 18th century and early 19th century millworkers' cottages which line Cromford Hill are an important part of the historic village. A number of the houses have inappropriate modern doors, windows and roof coverings and it is desirable these be replaced with more sympathetic alternatives based on historic patterns. The dramatic scenic setting is very important. The car parking and crash barriers are regrettable.

Recent change to view (2017): No significant change.

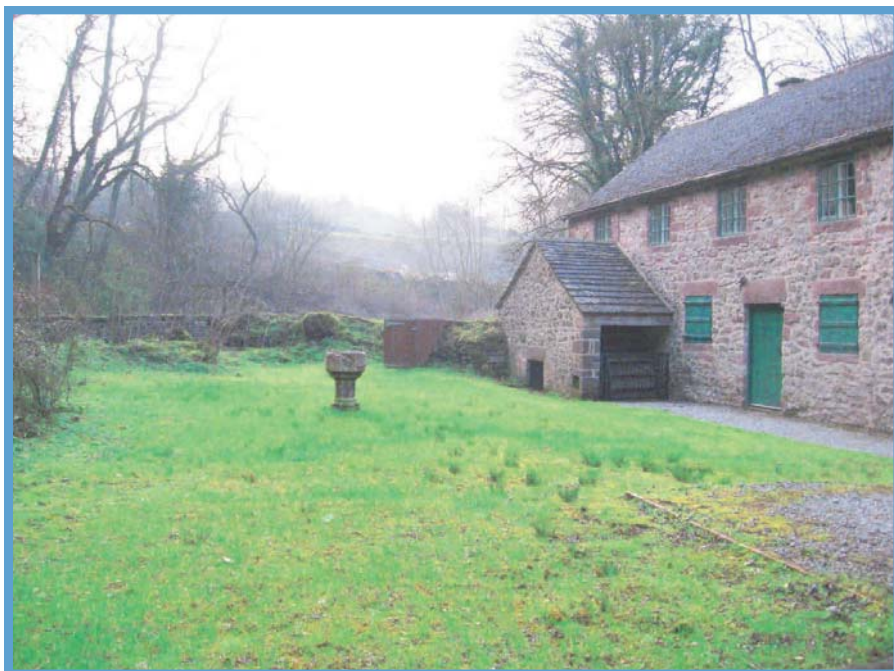
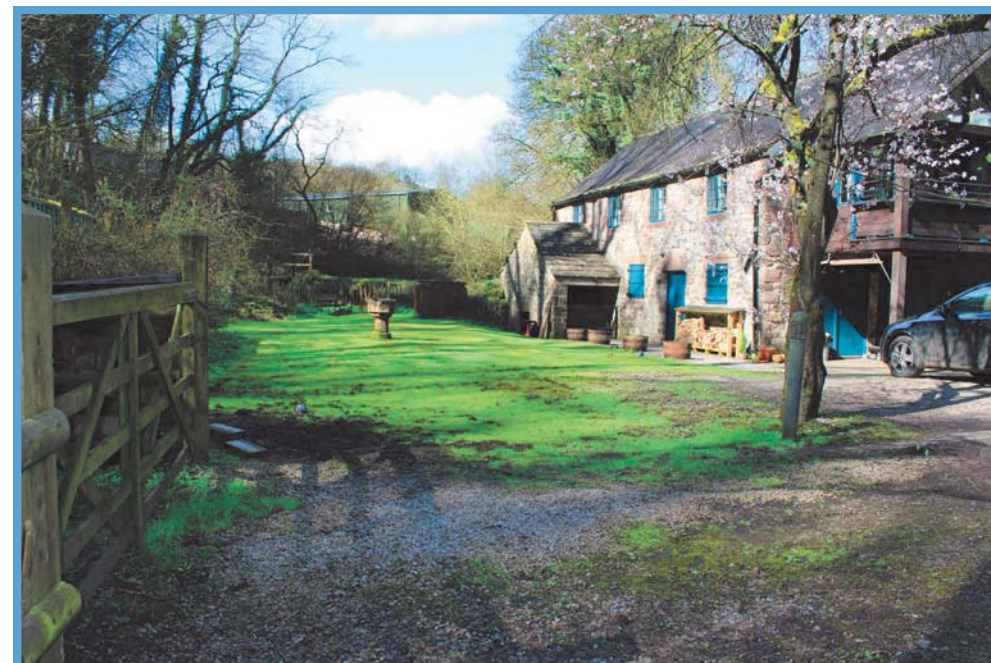
11 Slinter Cottage and millpond with Dunsley Mill behind

2012 – Dunsley Mill site, buildings currently demolished but awaiting redevelopment.

Recent change to view (2017): New build on the Dunsley Mill site is as recessive as possible so has no great impact on this view. Ownership changes for Slinter Cottage have not so far produced changes of any note.

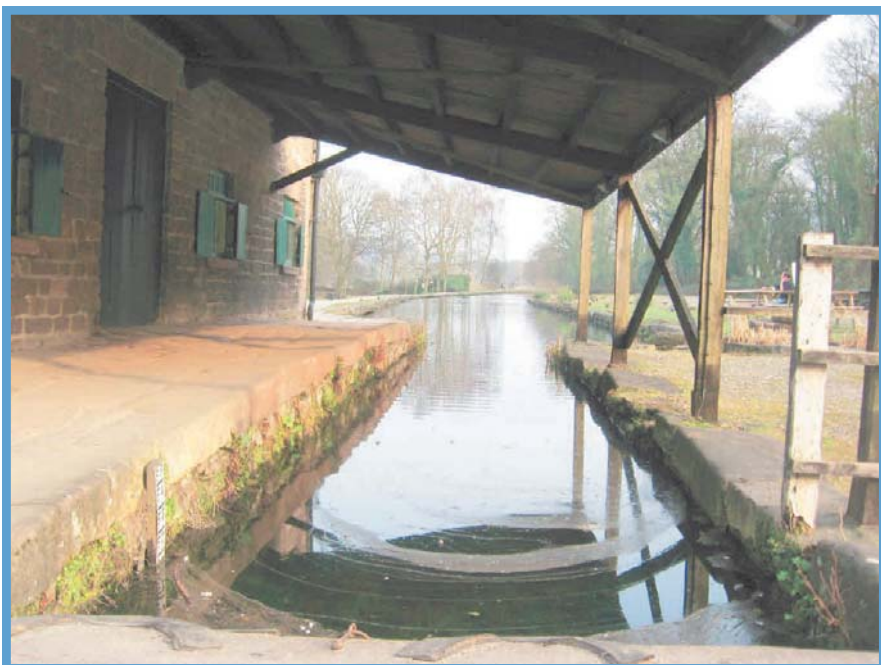
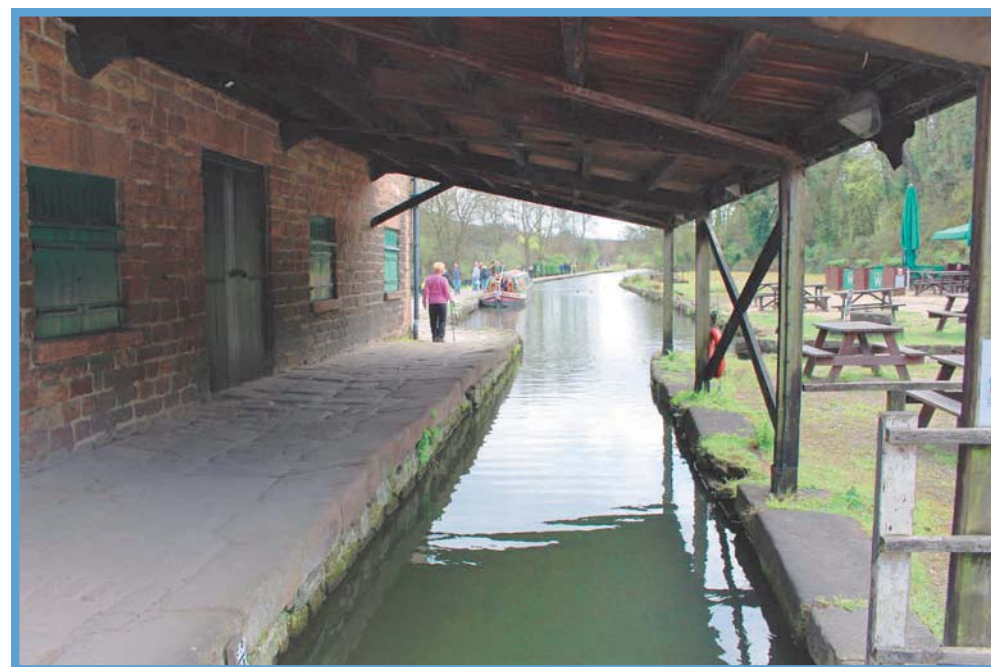
12 Cromford Canal Wharf from the Gothic Warehouse

Recent change to view (2017): No significant change.

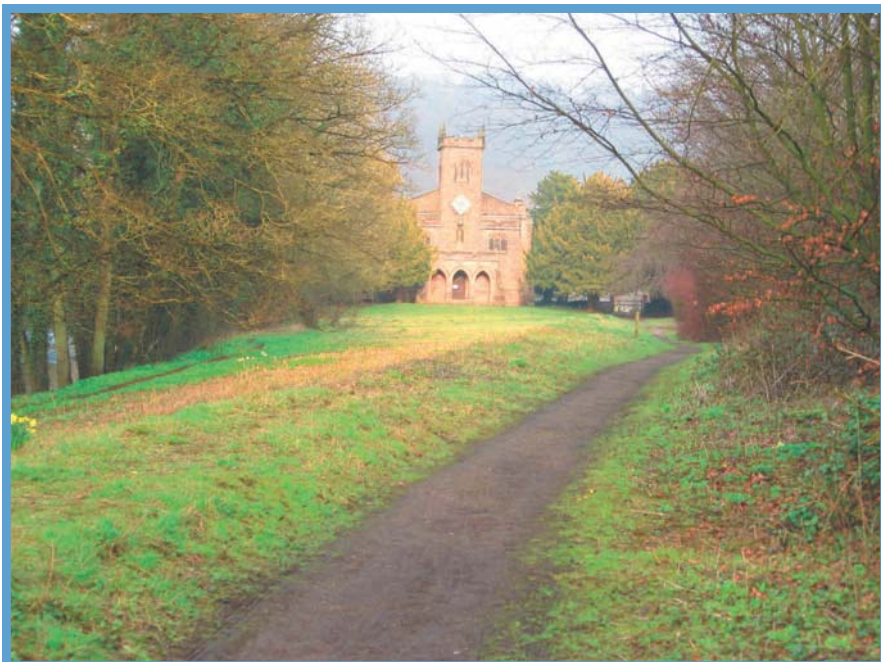
13 The Derwent riverbank looking towards St Mary's Church

Recent change to view (2017): Tree growth is beginning to obscure the view of the church.

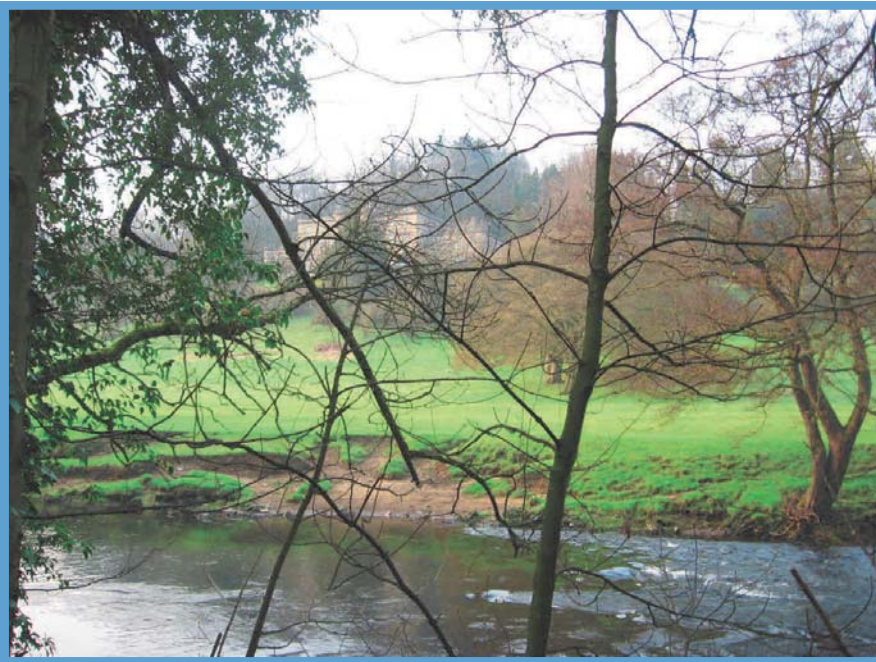
14 Willersley Castle and Park from the south bank of the River Derwent

2012 – Vegetation incrementally increasing and impacting on view.

Recent change to view (2017): Removal of some trees is helping to restore this lost view

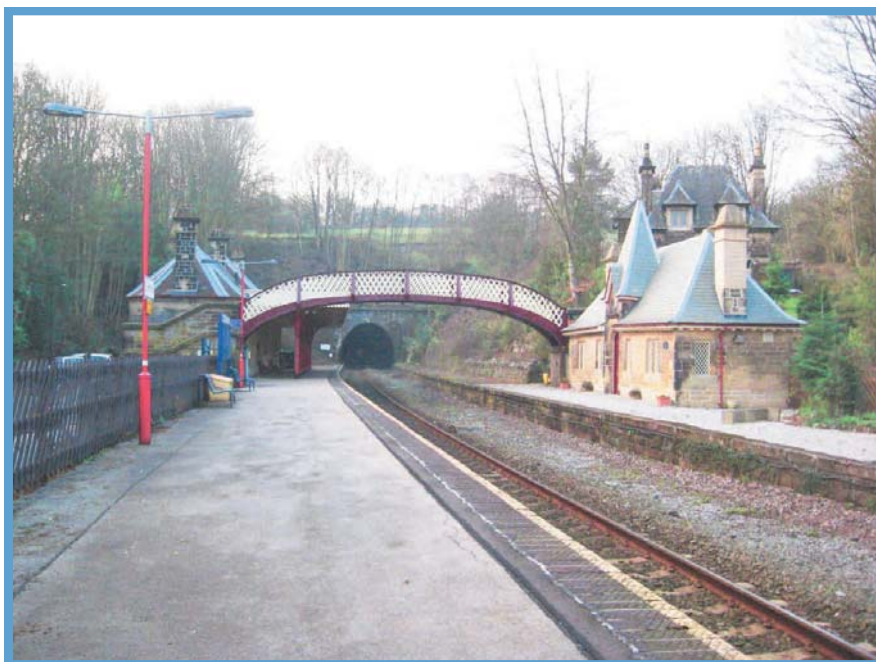
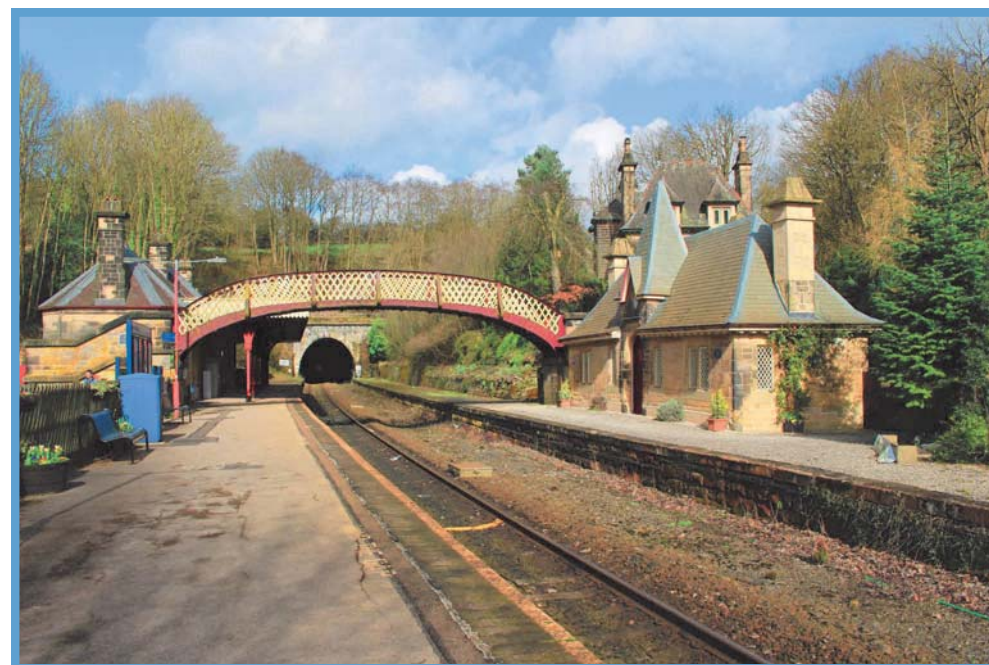
15 Cromford Station with stationmaster's house

Description (2008): The fact that the extravagantly designed 19th century railway buildings and footbridge at Cromford have survived is very important, but for many years the platform buildings have been empty, unused and falling into disrepair. Their repair with the reinstatement of lost architectural detail and their reuse as a holiday let (upside) and office suite/World Heritage Portal (downside) in 2008-9 is a major achievement.

2010 – The repair of the two platform buildings during 2009 delivered major objectives of the Management Plan with regard to ‘buildings at risk’ and economic development. The down platform building, restored by the Arkwright Society, is let as a suit of offices and the up platform building, restored by Mr Tim Collis and Mr Ryan Phelps, is as a holiday home.

Recent change to view (2017): No significant change since repair work was completed.

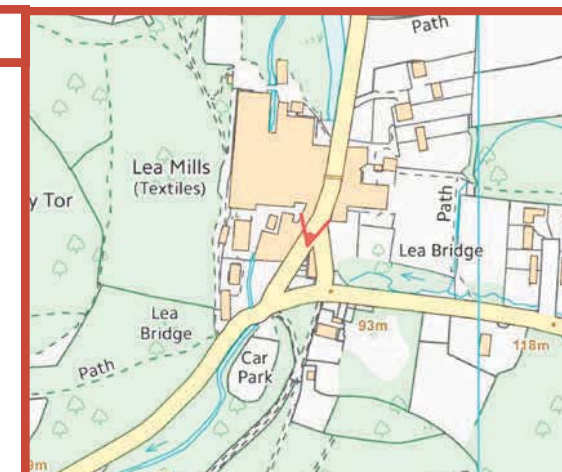
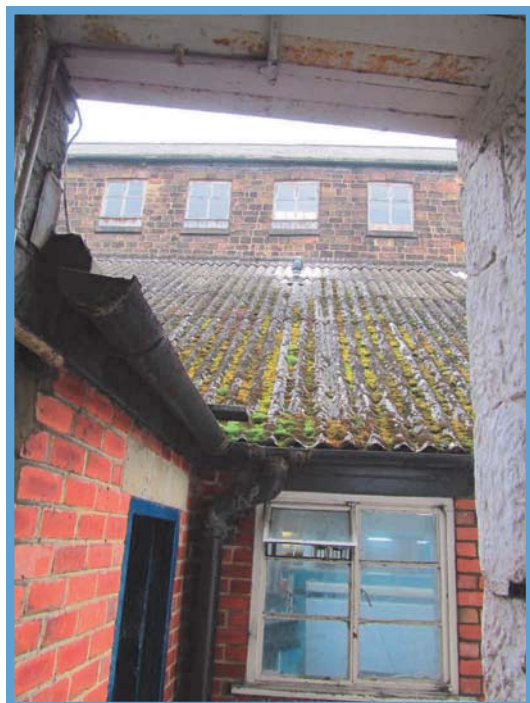
18 The Smedley Mills at Lea

Recent change to view (2017): Reroofing of the original 1783 mill has been completed successfully.

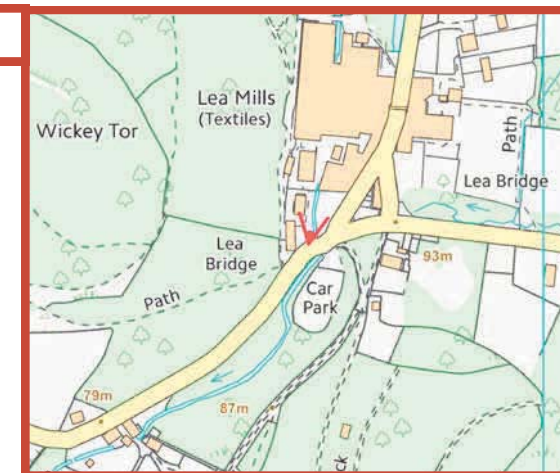
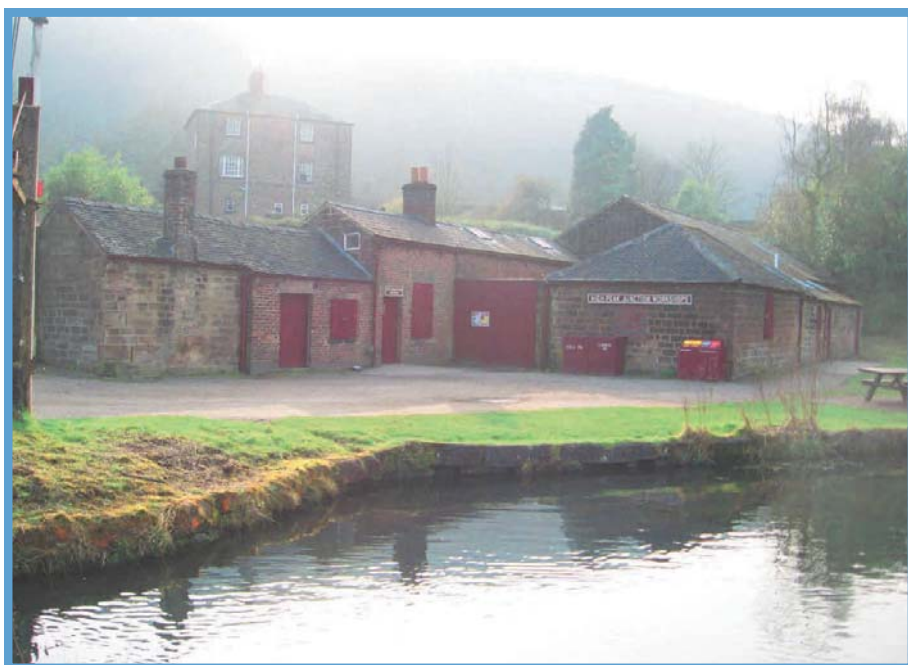
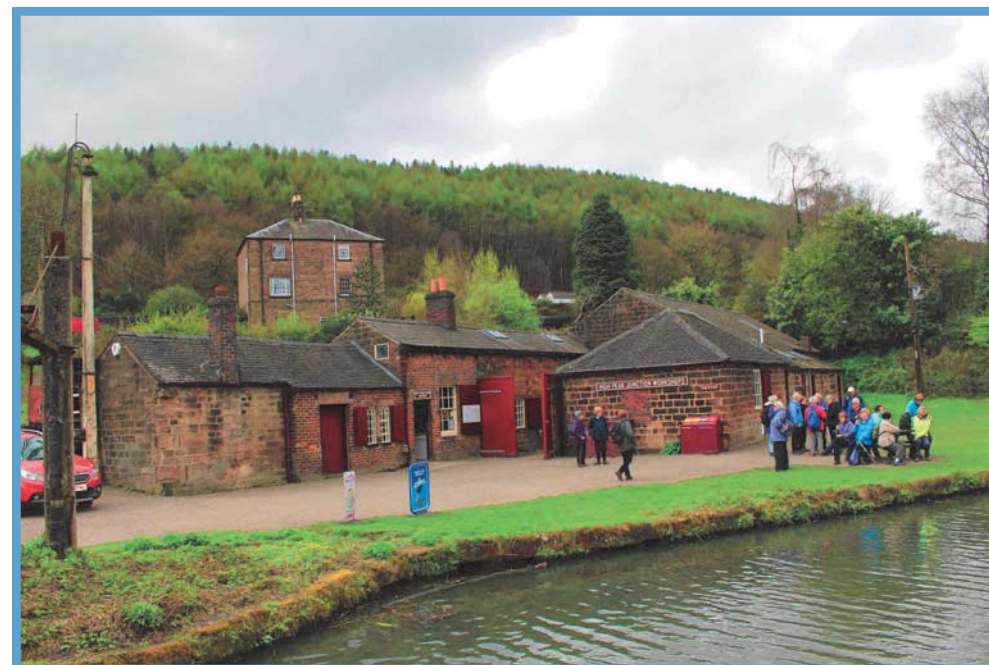
19 High Peak Junction from the canal

2012 – Trees previously to the rear of these buildings have been removed and the Agents House and Loco House beyond can be more easily distinguished.

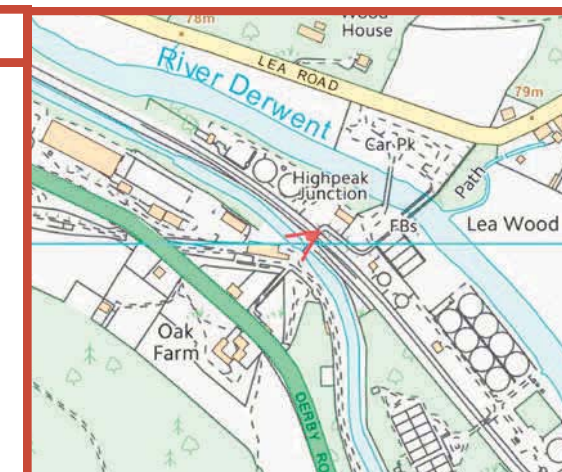
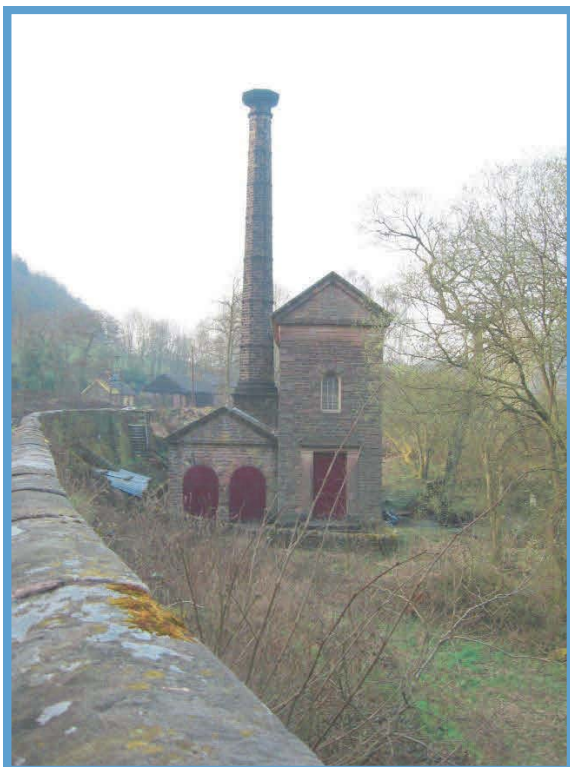
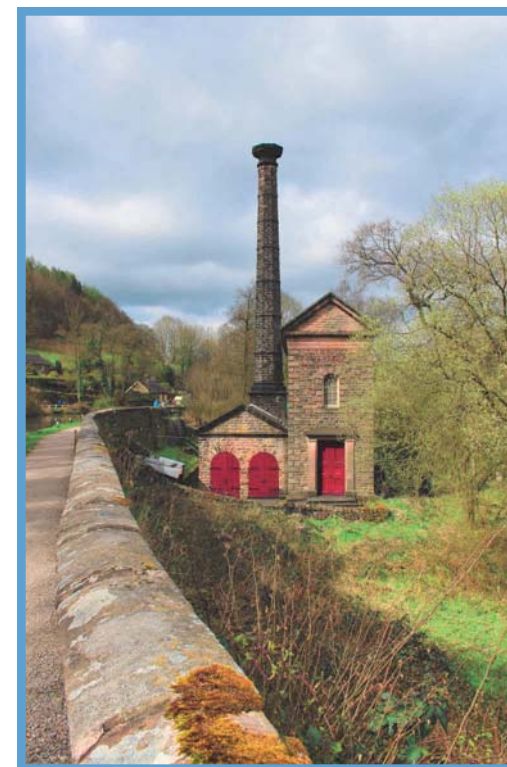
20 Leawood Pumphouse

Recent change to view (2017): Tree growth is increasing around the building and on the canal wall.

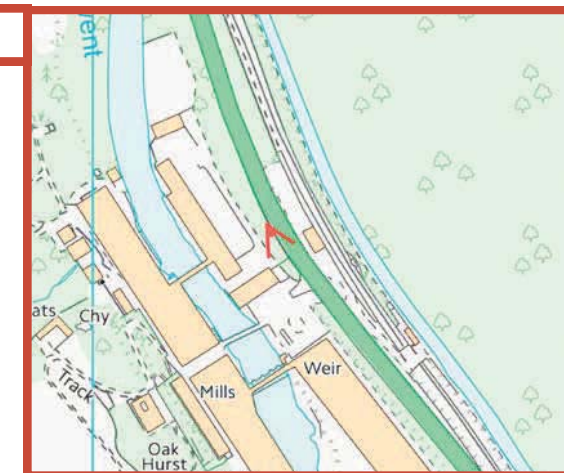
22 Belper's East Mill from the A6 looking south

Description (2008): The East Mill is a major landmark within the World Heritage Site. Its present condition is a matter of great concern. From this viewpoint its setting is largely as it was when built. The wall predates the mill and forms the boundary of the River Gardens. It was raised in the winter of 1905/6 to reduce the risk of falling for onlookers leaning over the wall. Vegetation has penetrated and damaged this wall.

2010 – Although no significant change is visible to this landmark mill it continues to deteriorate. Removal of trees as part of the River Gardens renovations has improved the view of the East Mill.

Recent change to view (2017): The building continues to deteriorate with an increase in vegetation growth.

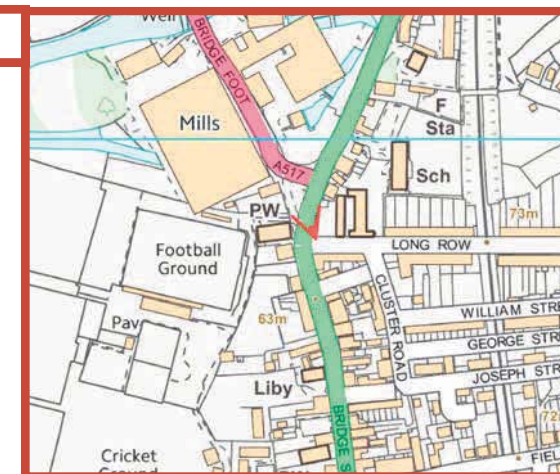
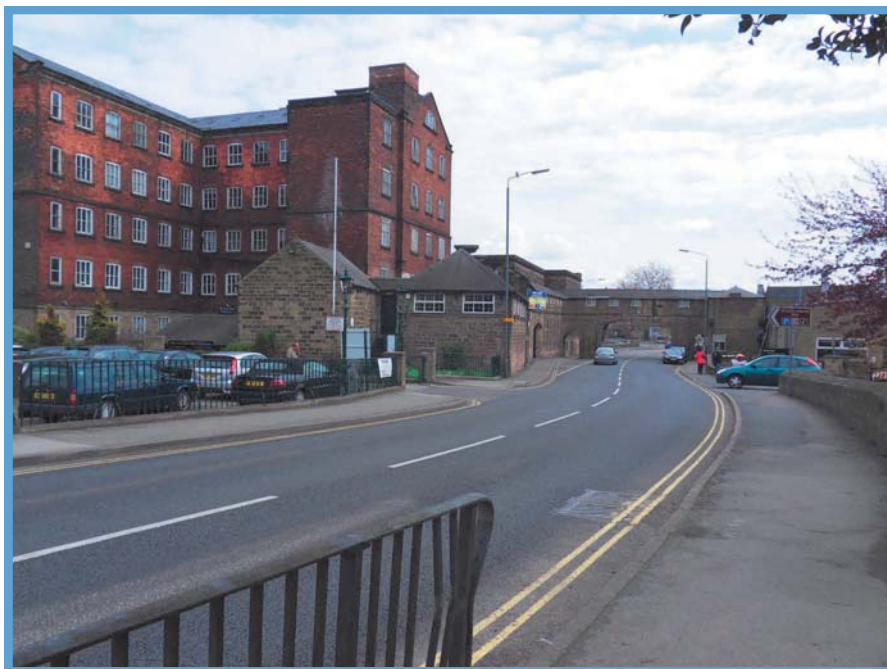
24 Gangway and North Mill

Description (2008): From this viewpoint the Gangway (footbridge) of c 1795 and the North Mill of 1804 are seen well together. Their setting is damaged by undistinguished 20th century industrial buildings and plant just out of sight on the right. The footbridge has suffered extensive damage from tall vehicles. Bridge collision warning signs were installed in 2007 to reduce the risk of further damage, but whilst a busy A-road continues to go under the bridge, the risk remains.

2010 – The scaffolding facilitated some very limited repairs, but the need for major repairs remain a Management Plan priority.

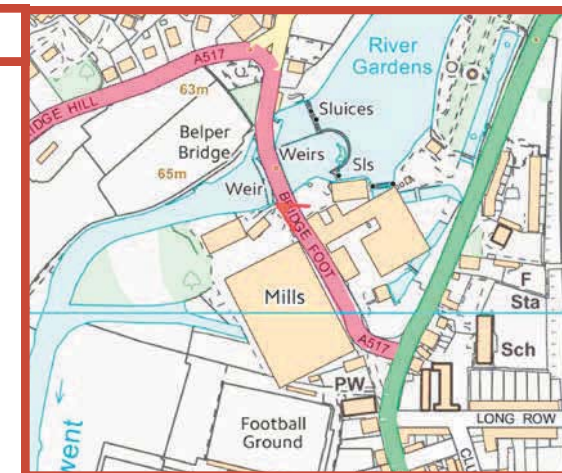
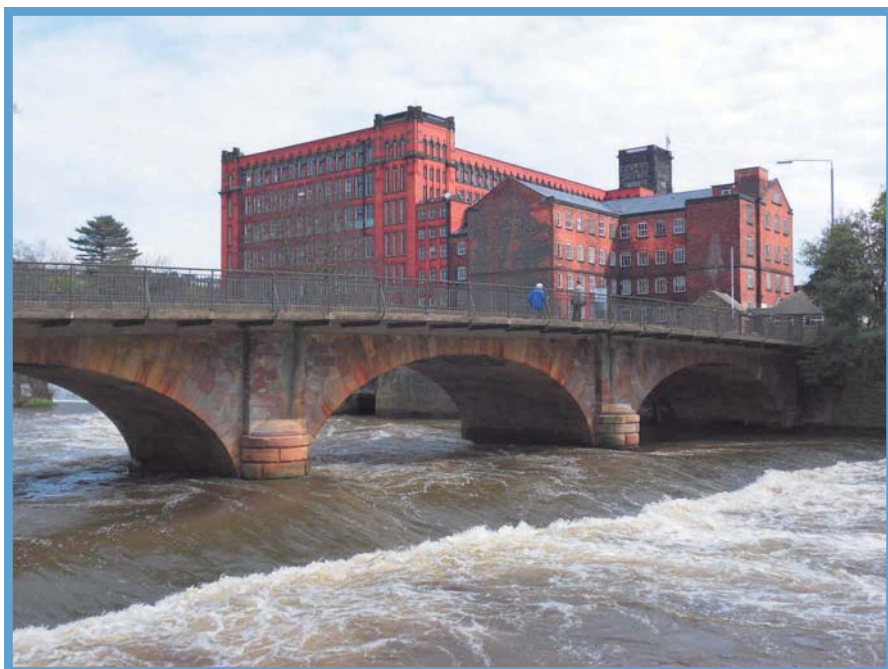
25 North and East Mills with river bridge in foreground

The poor condition of both mills and the weir are causes for concern.

Recent change to view (2017): No visible significant changes but the rock weir continues to deteriorate and may collapse in a future flooding event.

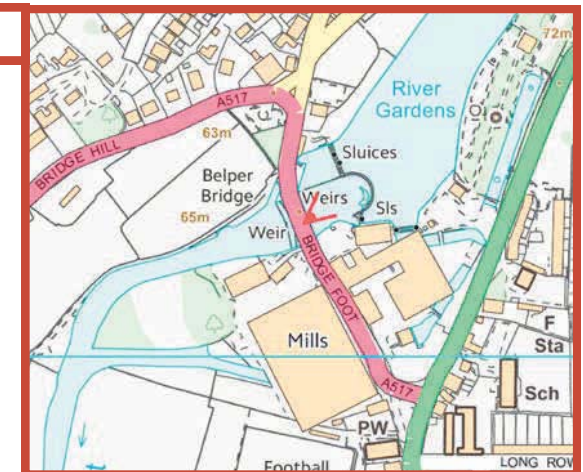
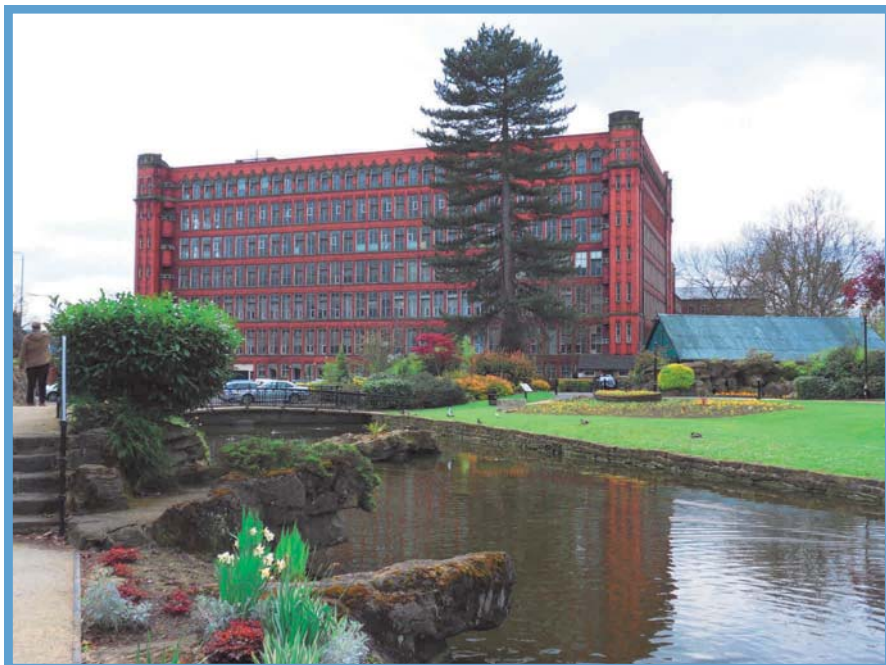
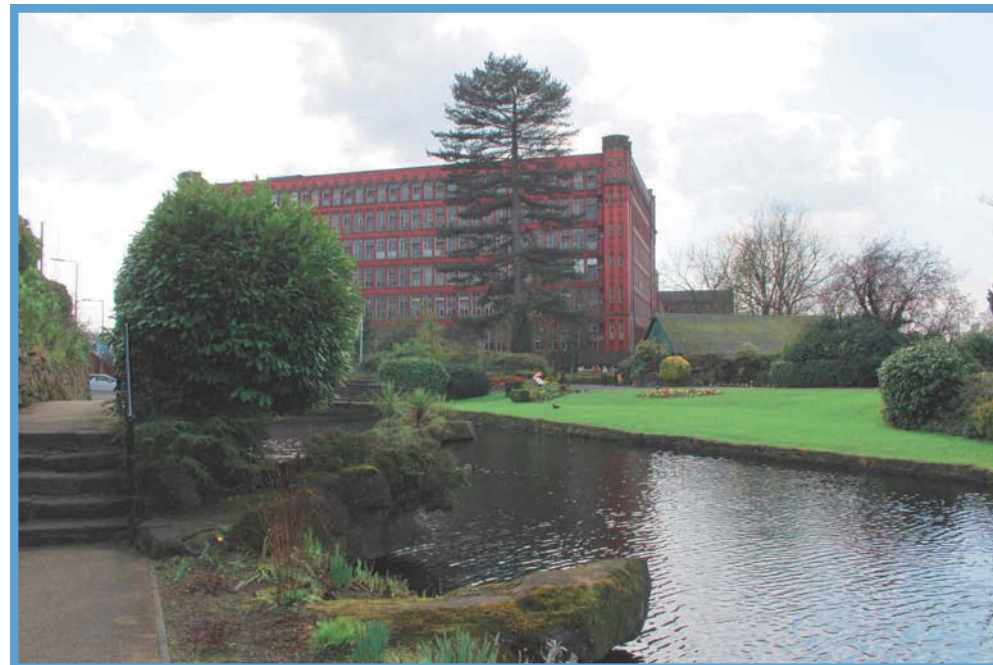
27 East Mill from River Gardens

Recent change to view (2017): The vegetation in the gardens is becoming more established reducing the impact of the mill on this scene.
