Derwent Valley Mills World Heritage Site Monitoring Views 2017

Appendix 20

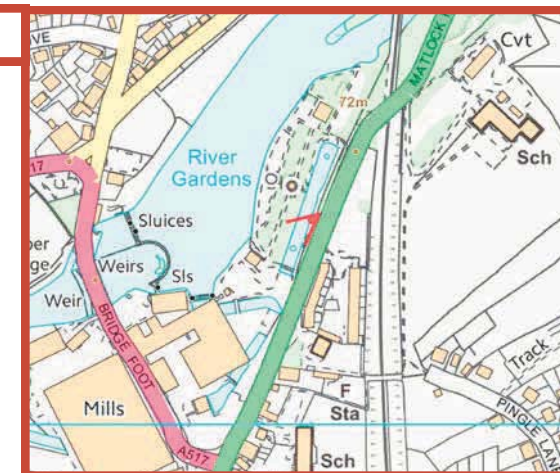
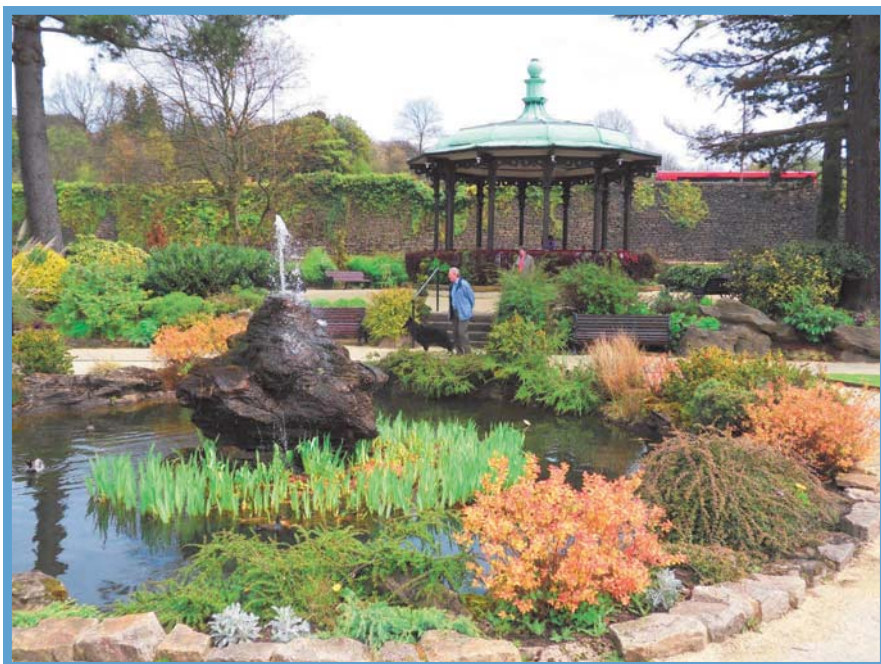
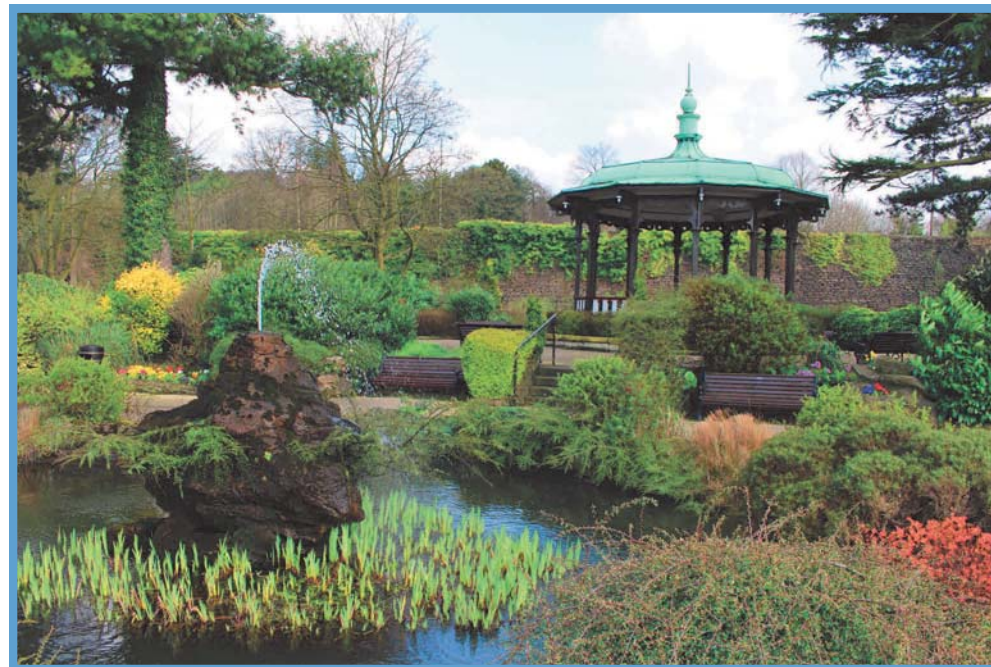
28 River Gardens fountain and bandstand

Recent change to view (2017): The finial has been restored to the bandstand but the ivy on the back wall continues to increase.

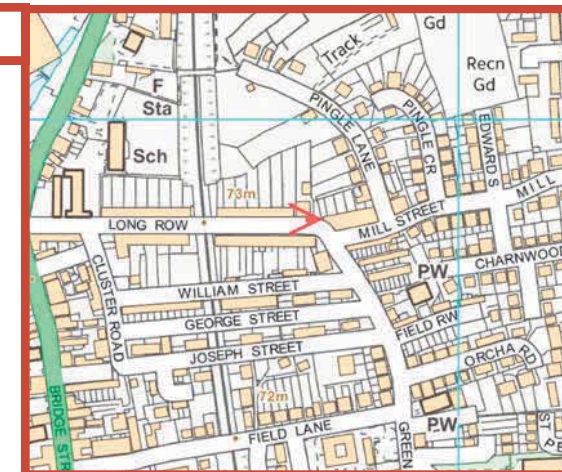
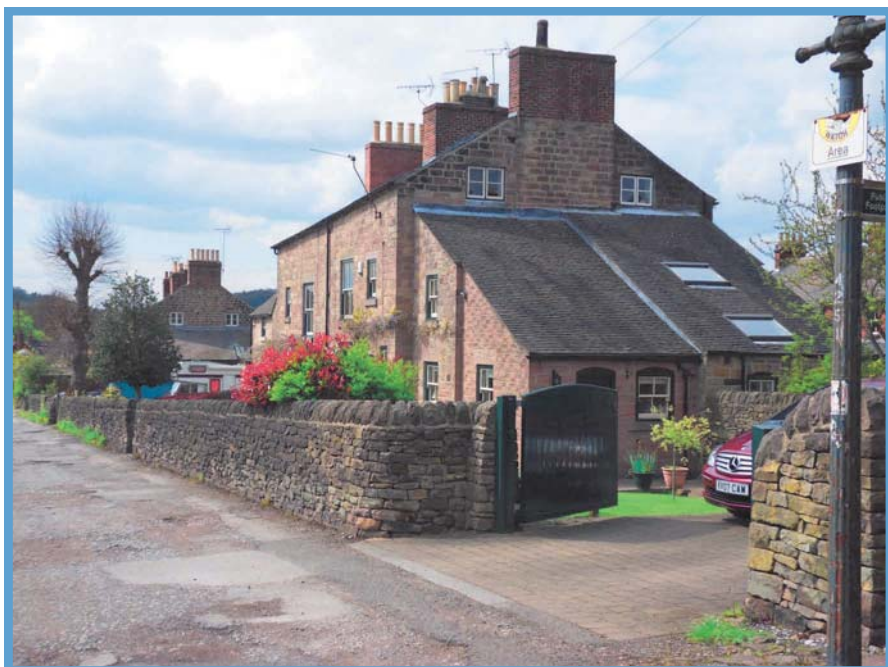
31 Cluster Houses on Joseph Street, Belper

Description (2008): The historic setting of these distinctive houses of 1805 is important, namely stone boundary walls and a Telford like road construction. The latter is in a poor state and is vulnerable to further deterioration. A World Heritage objective is the repair of the best surviving areas of road surface and the restoration of the remainder. An important characteristic of this historic scene is the absence of kerbs, street signs and other modern street clutter.

Recent change to view (2017): No significant change but the road continues to deteriorate.

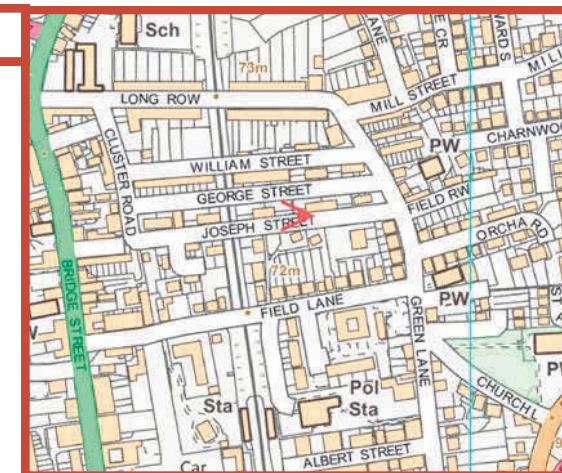
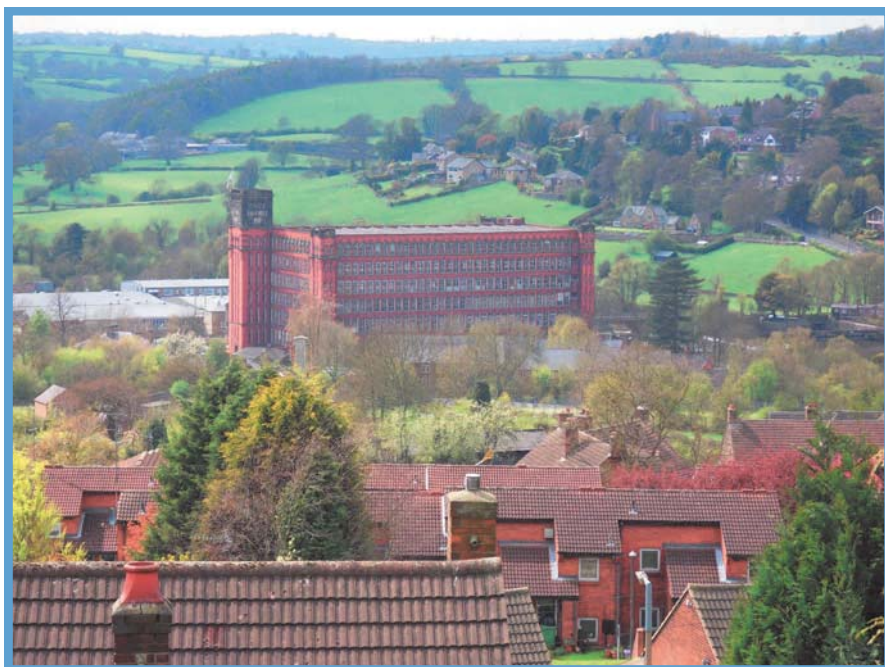
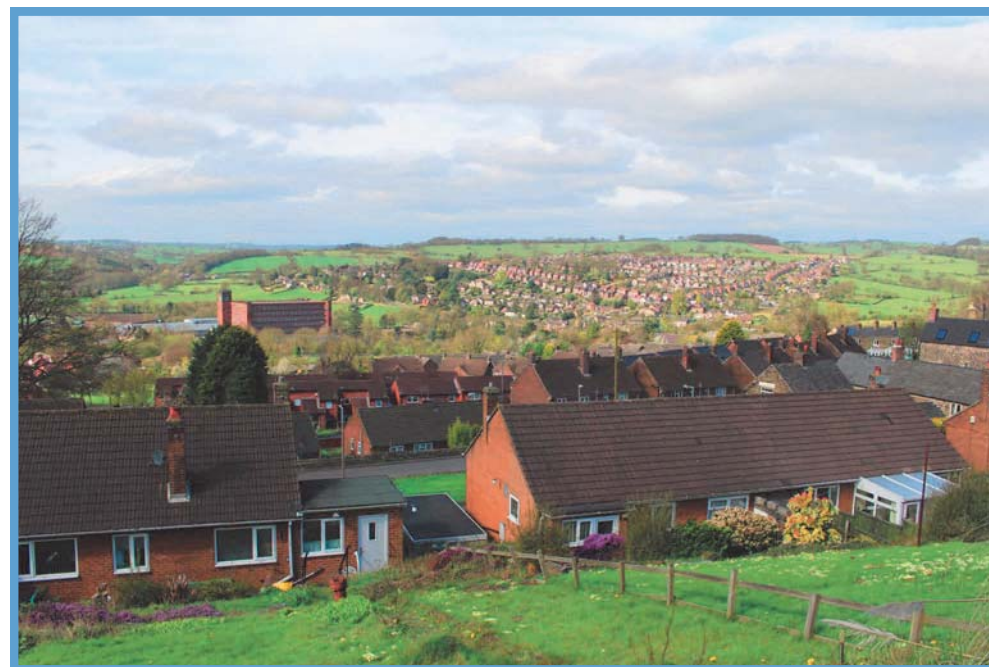
32 East Mill and Bridge Hill from Chesterfield Road, Belper

Description (2008): The East Mill may be seen from a number of viewpoints, including from the rising land on the east side of the town. Here the mill is seen against unspoilt pastoral countryside. It is because the land rises steeply to the east that this part of the town is included within the Buffer Zone, to ensure tall structures are not allowed to impinge negatively upon the setting of the World Heritage Site. (2017 This view is no longer zoomed in on the mill complex but includes the wider landscape setting).

Recent change to view (2017): No significant change. New development proposals threaten the landscape setting of the mills in this view.

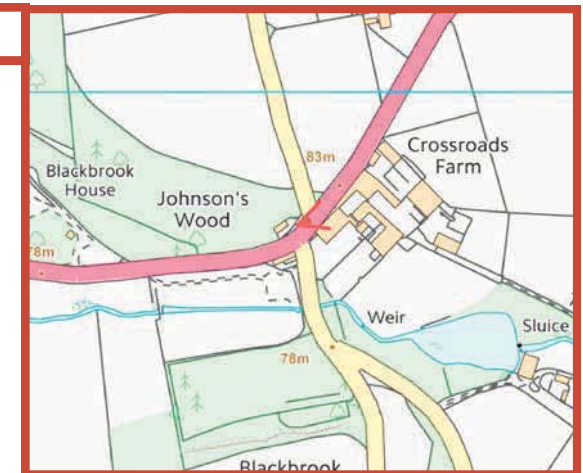
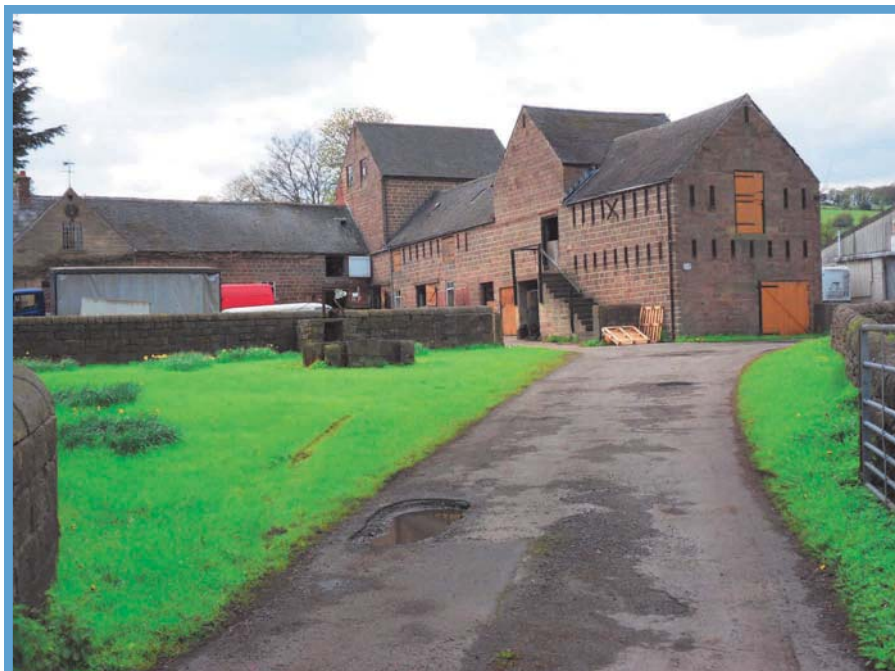
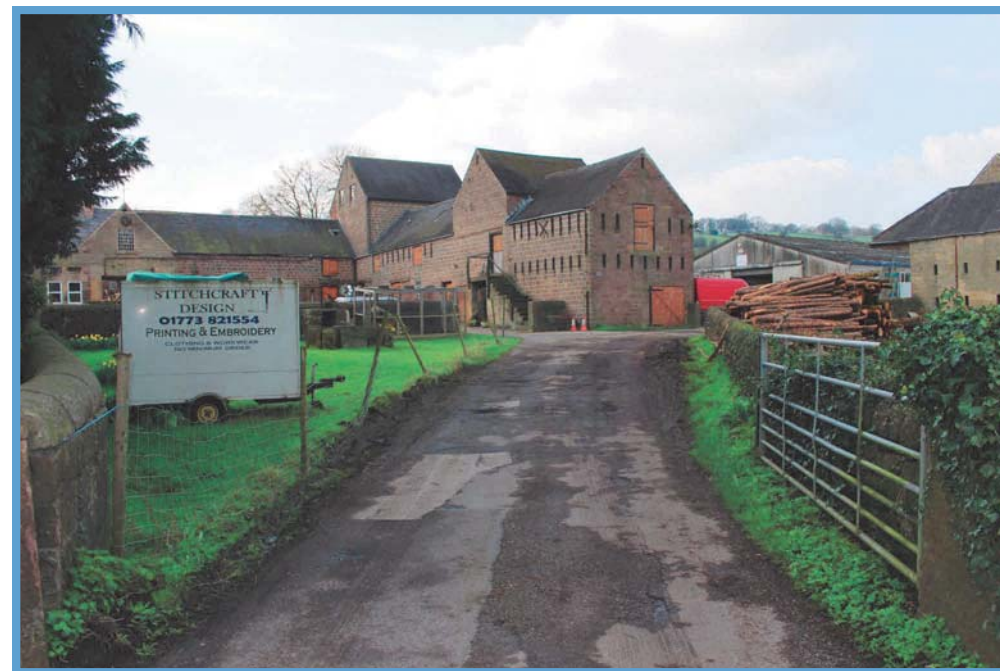
34 Dalley Farm

Recent change to view (2017): A fire in 2015 had a significant impact on the buildings to the left of this view but they have been fully restored. The advertising trailer on the left hand side unfortunately blocks the view to some degree.

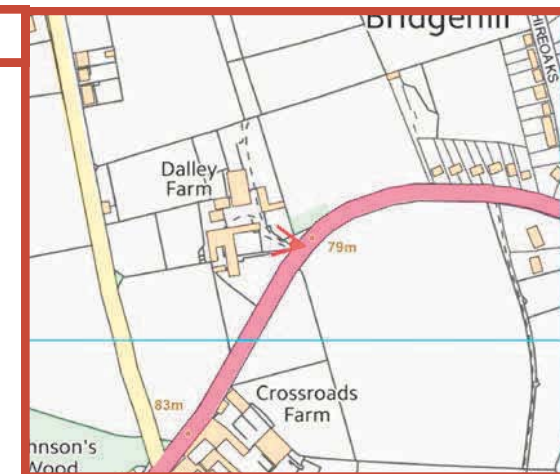
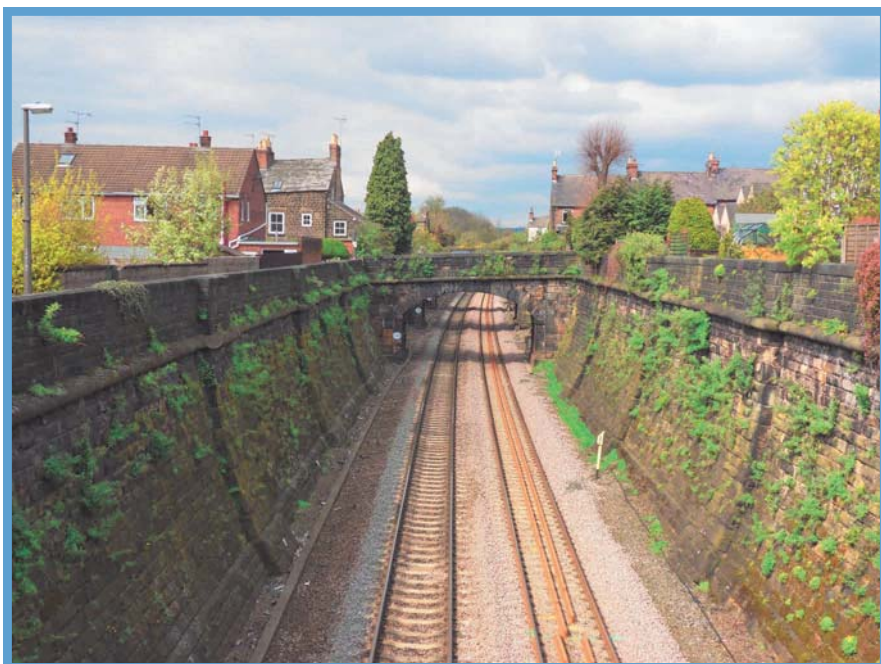
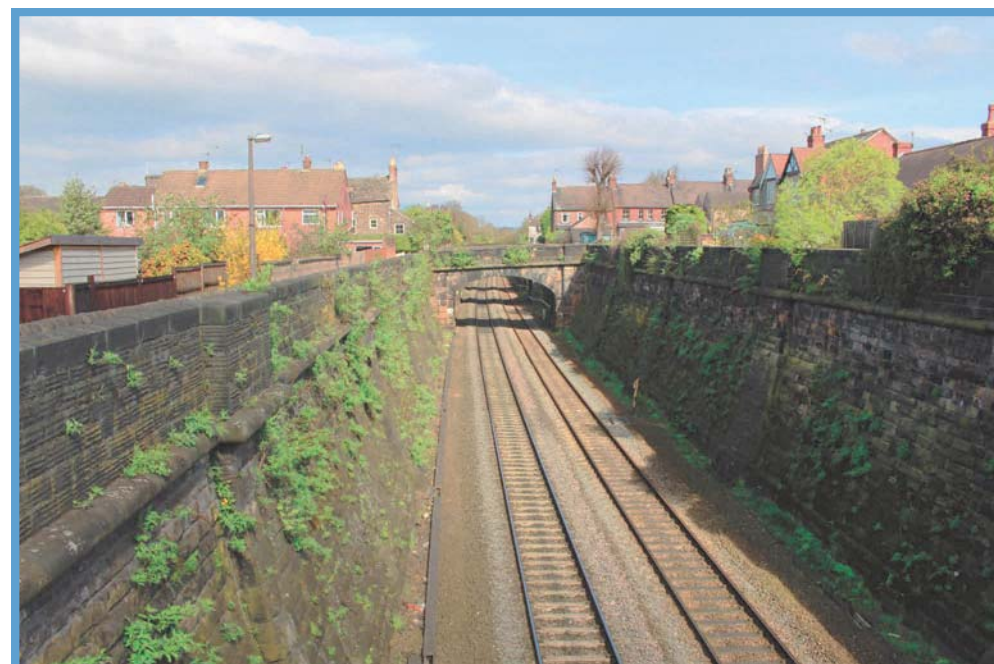
35 Rail cutting and bridges from Field Lane, Belper

Description (2008): This impressive engineering structure designed and built by George and Robert Stephenson needs regular and careful maintenance to prevent damage resulting from vegetation getting established in masonry joints.

Recent change to view (2017): Vegetation is beginning to take a significant hold on this cutting again.

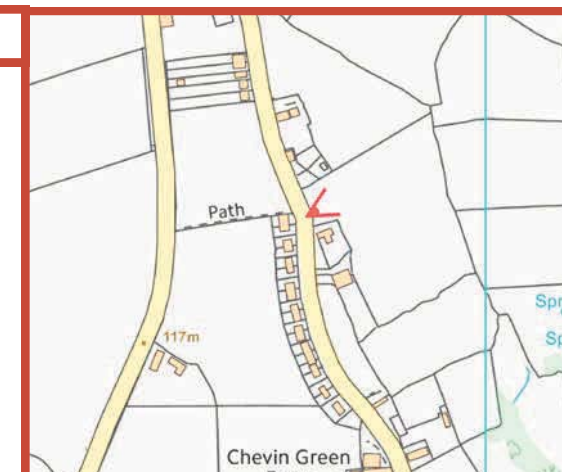
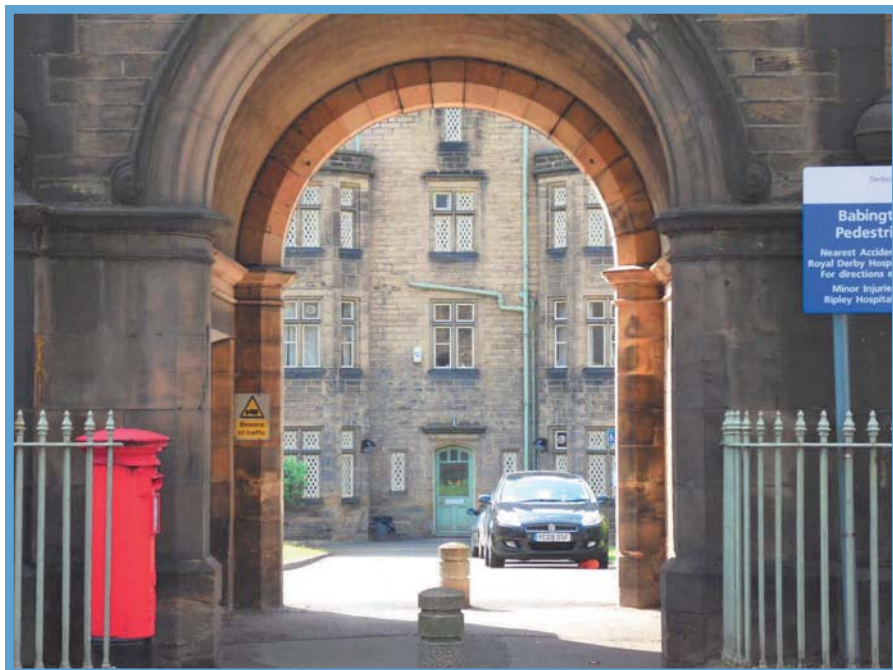
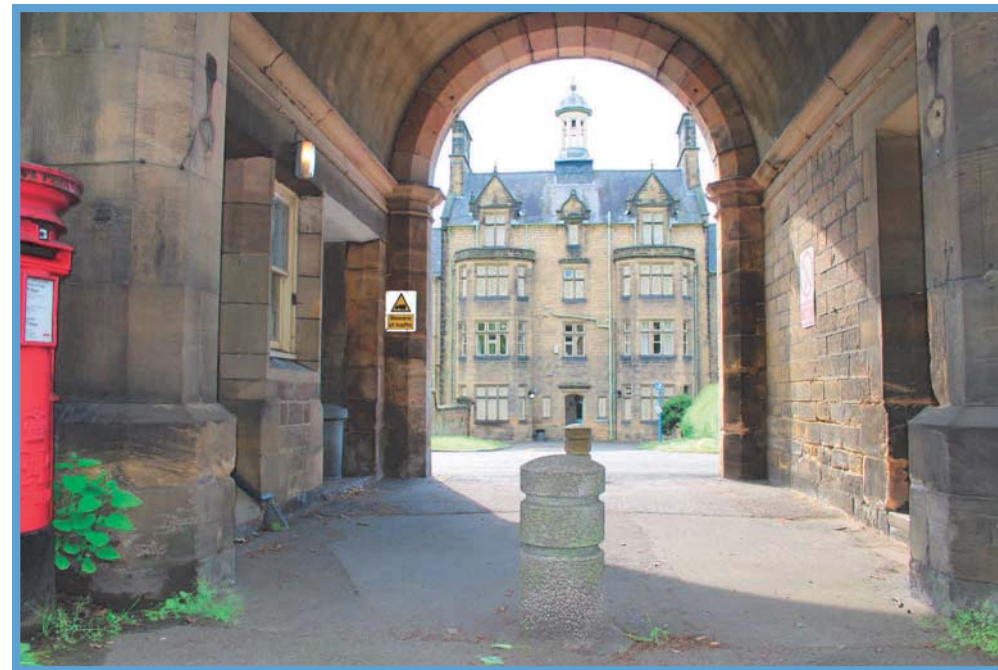
37 Belper Workhouse (Babington Hospital) from A6

Recent change to view (2017): No significant change. A proposed change of ownership and use could provide challenges for the future of these buildings.

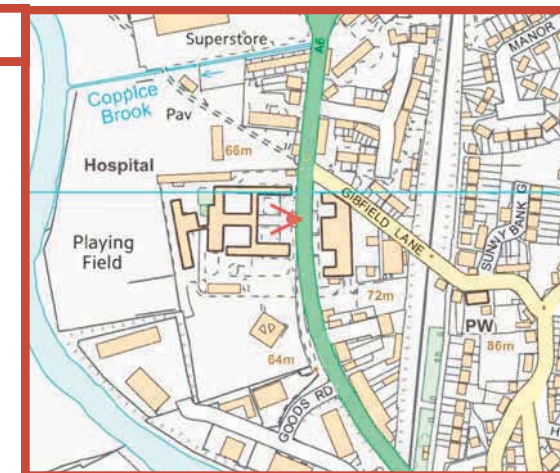
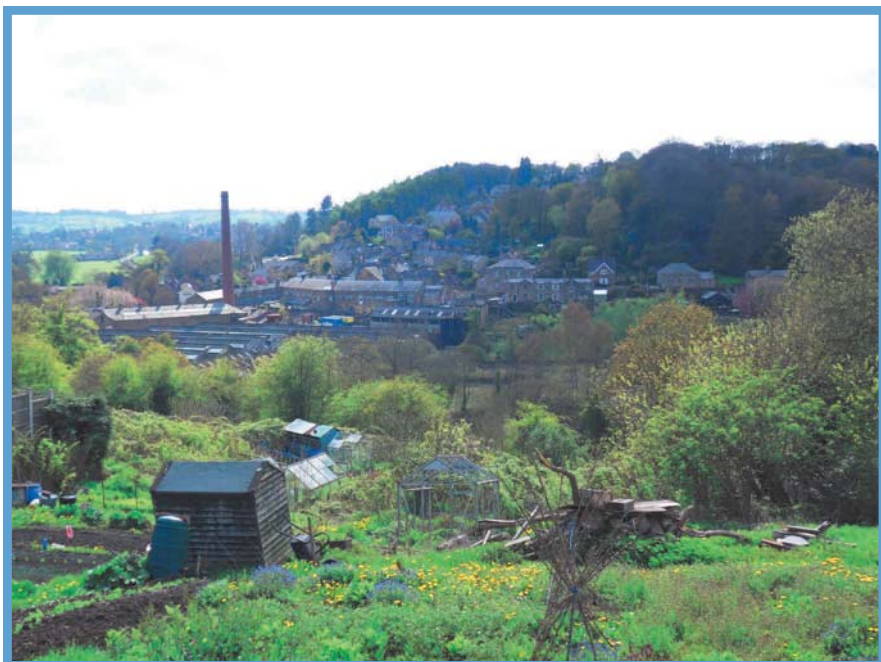
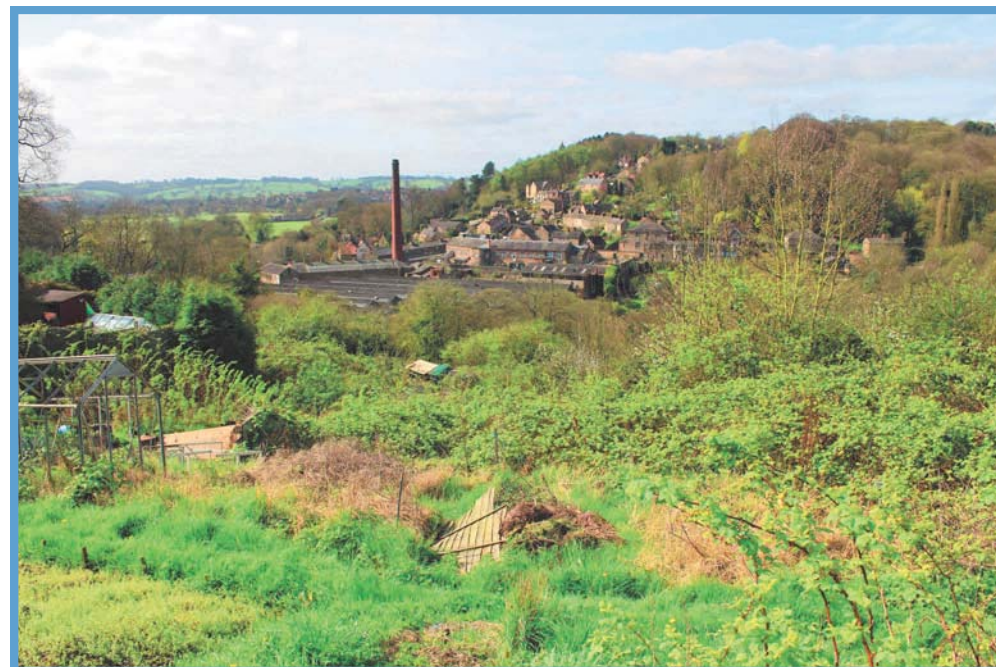
38 Milford from the east

Recent change to view (2017): No significant change although the allotments in the foreground are less tended than in the past.

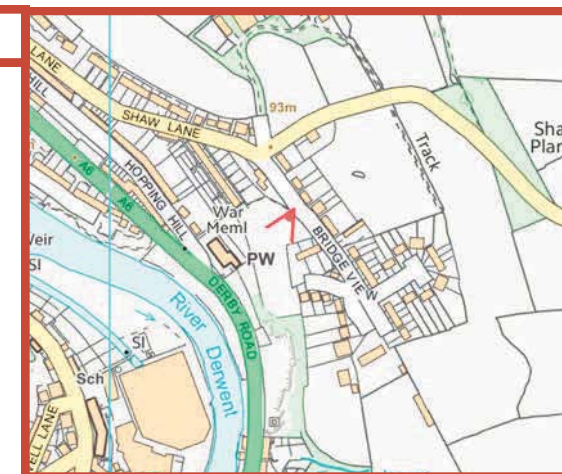
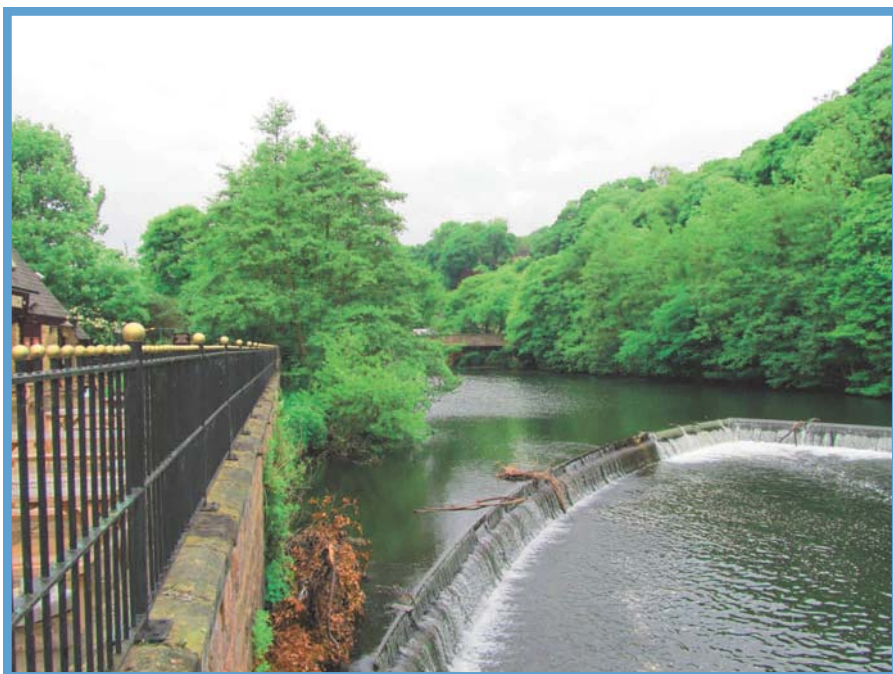
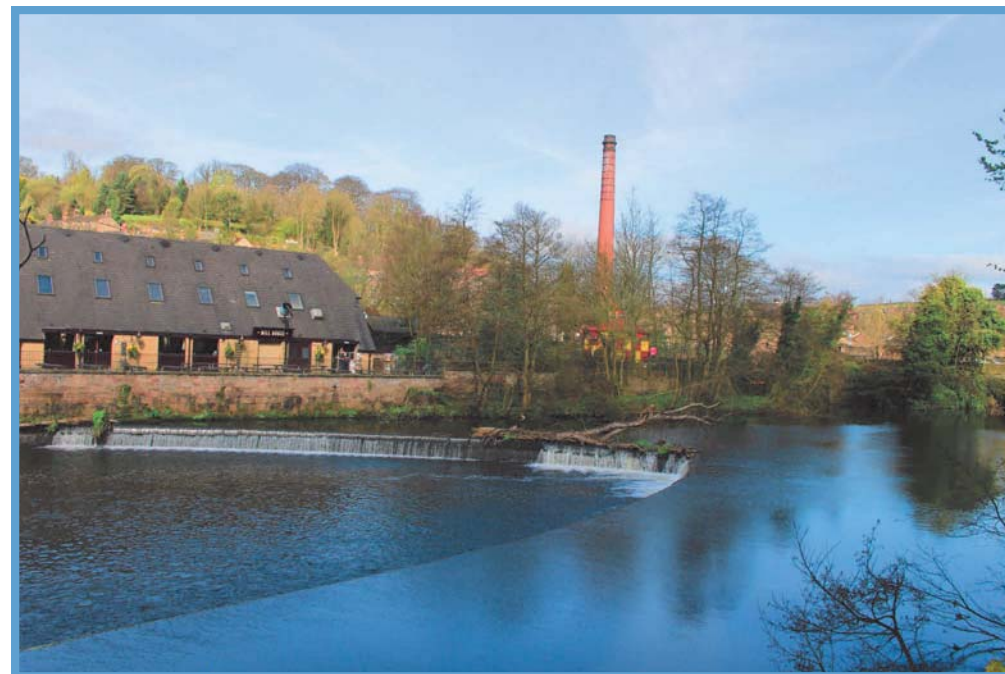
39 The weir at Milford

Recent change to view (2017): Trees in the foreground have been removed, restoring the view.

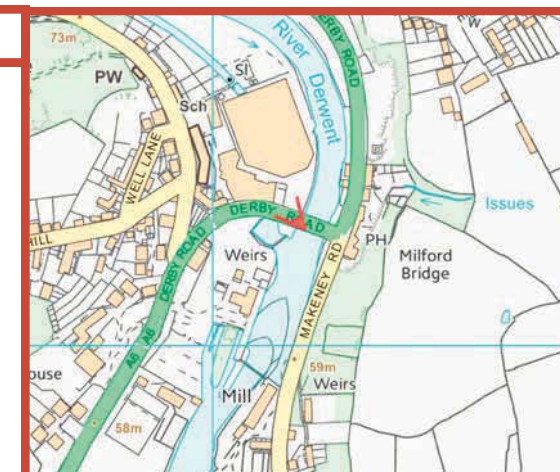
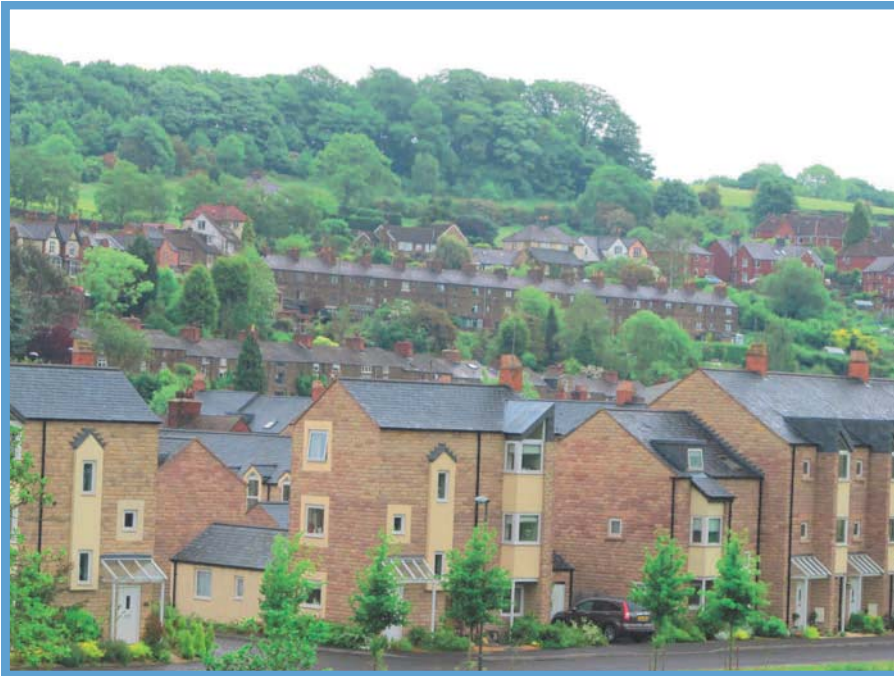
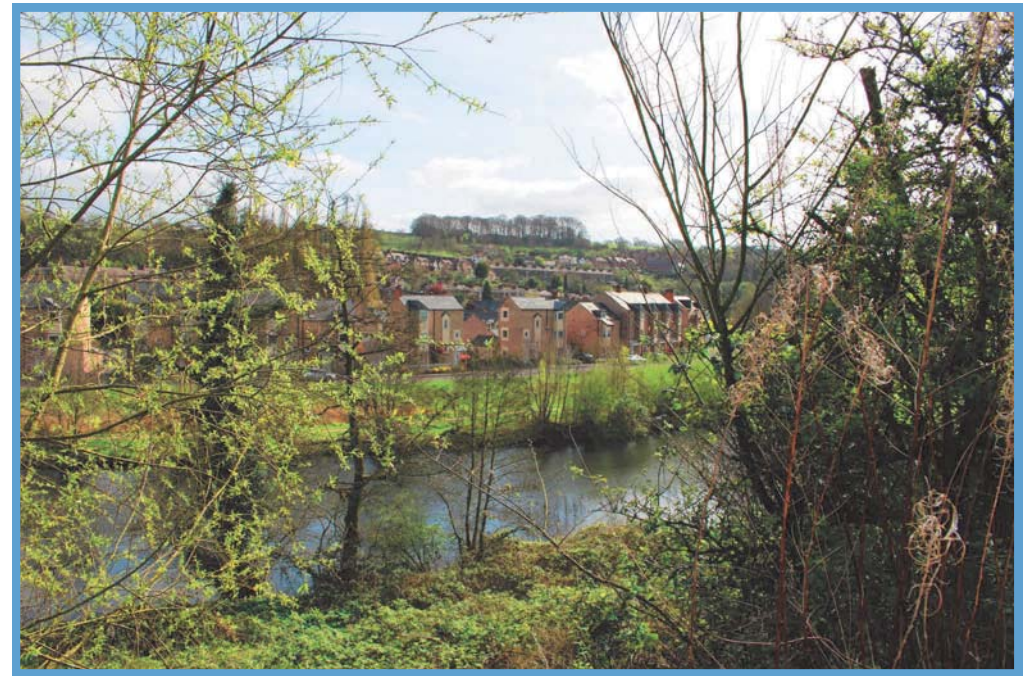
41 Hopping Hill terraces, Milford

Recent change to view (2017): No significant change however vegetation is increasing on the west bank of the river, reducing the opportunity to appreciate these views.

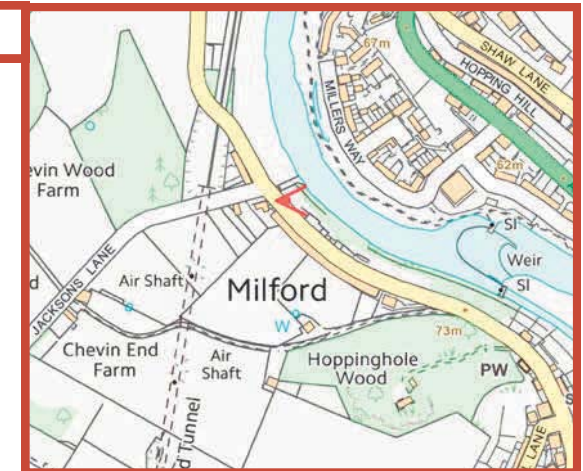
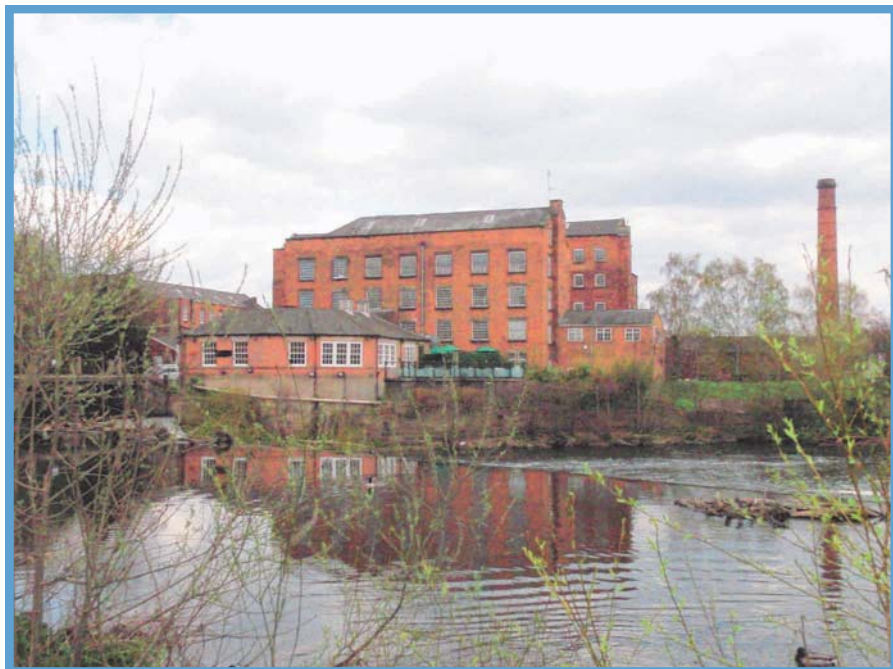
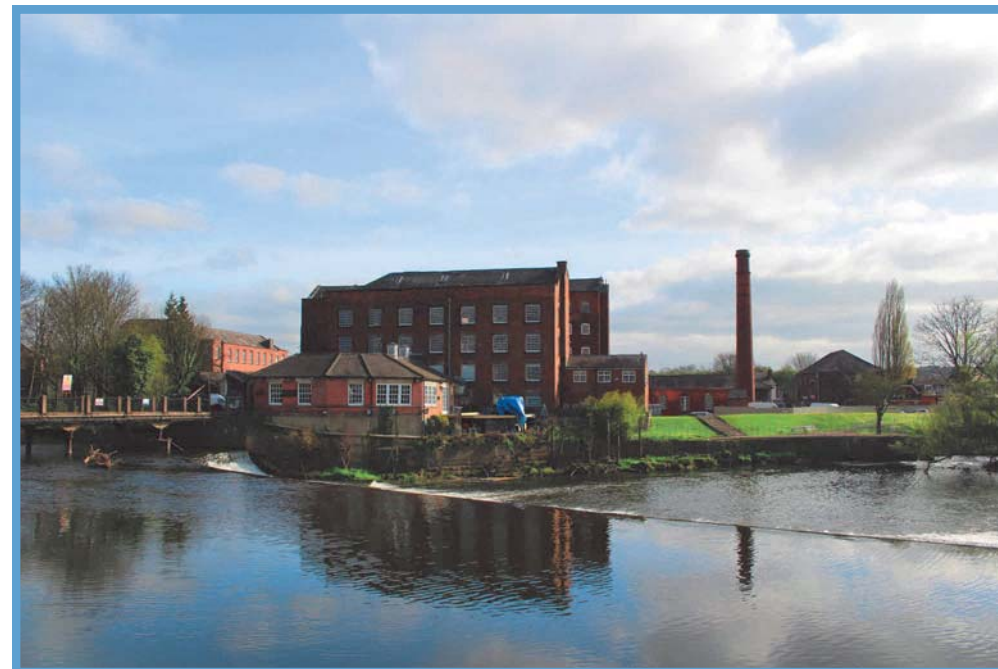
42 Darley Abbey Mills from Viewing Platform

2012 – Vegetation is beginning to obscure the view as it has in the past.

Recent change to view (2017): Work to restore and enhance the mill complex has seen considerable positive changes to the immediate settings of the buildings. The vegetation has been removed again, opening up the view.

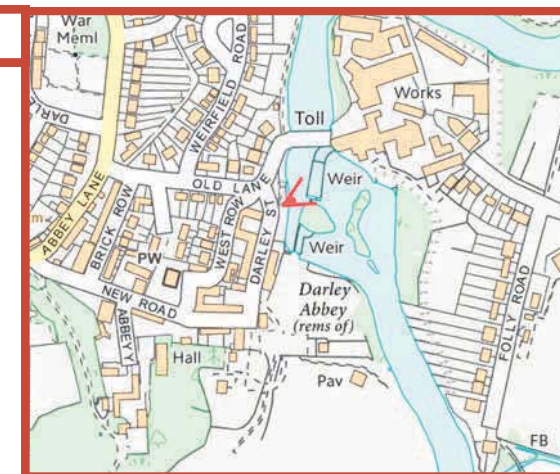
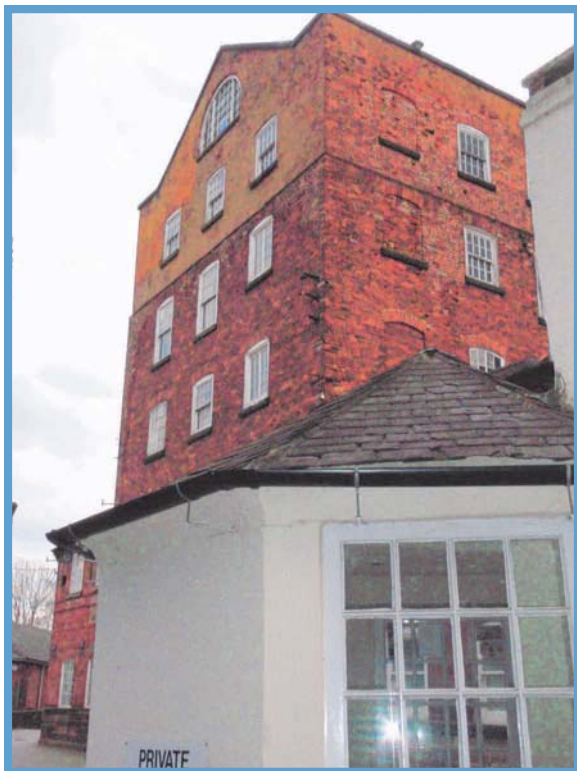
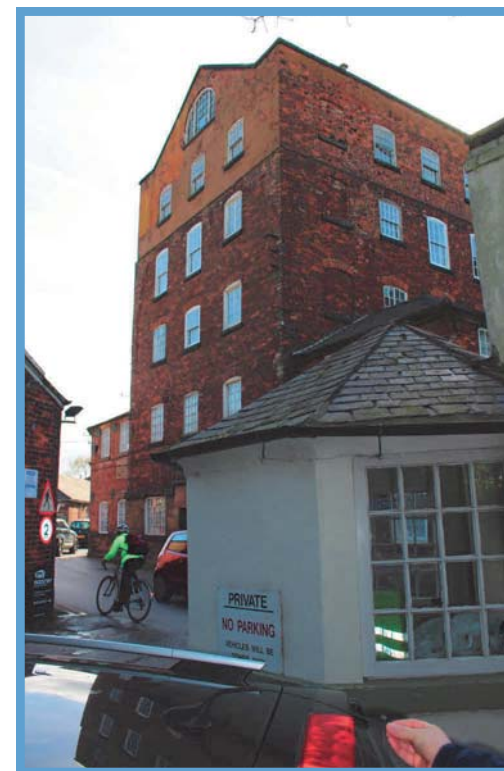
43 Toll booth, and gable end of Boars Head Mill

Description (2008): This view demonstrates the scale of Boars Head Mill. The toll booth (c.1783) by the river bridge is in need of repair and the mills themselves need to be found sustainable new uses which are compatible with the protection of their character and appearance.

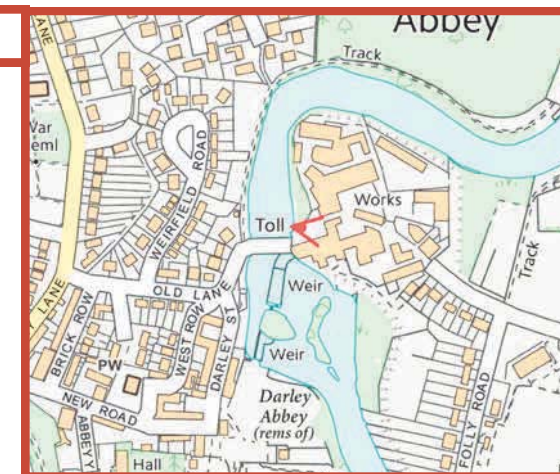
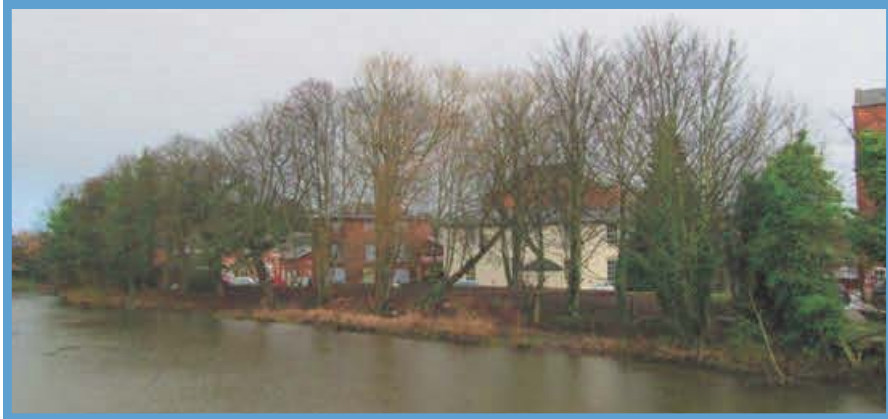
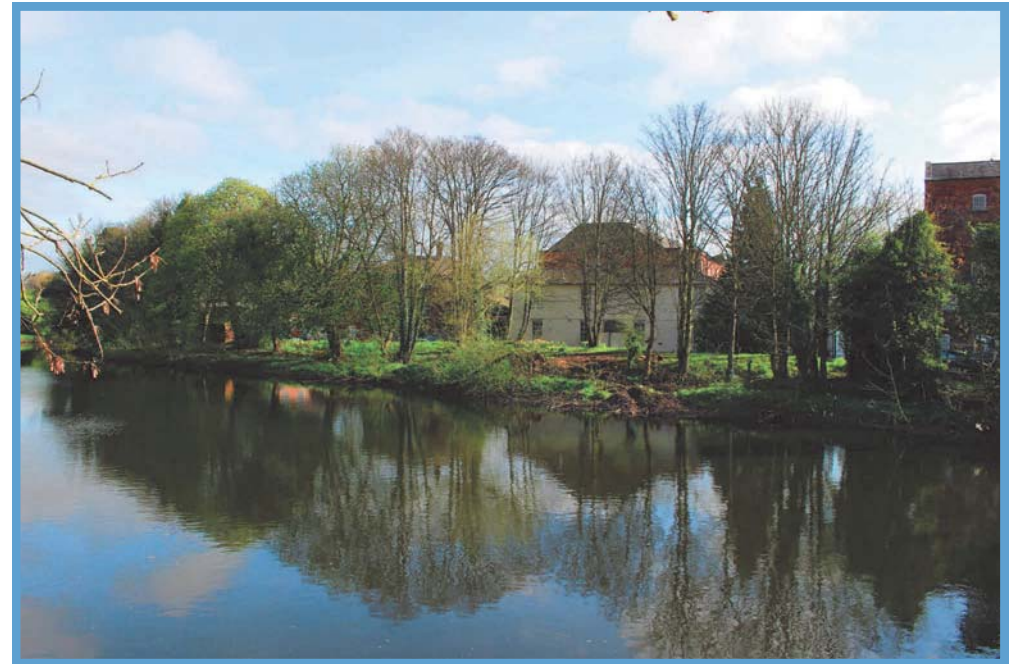
44 Darley Abbey Mills from the west (new photo)

Recent change to view (2017): Restoration work has been carried out on the mill manager's house. This area continues to improve.

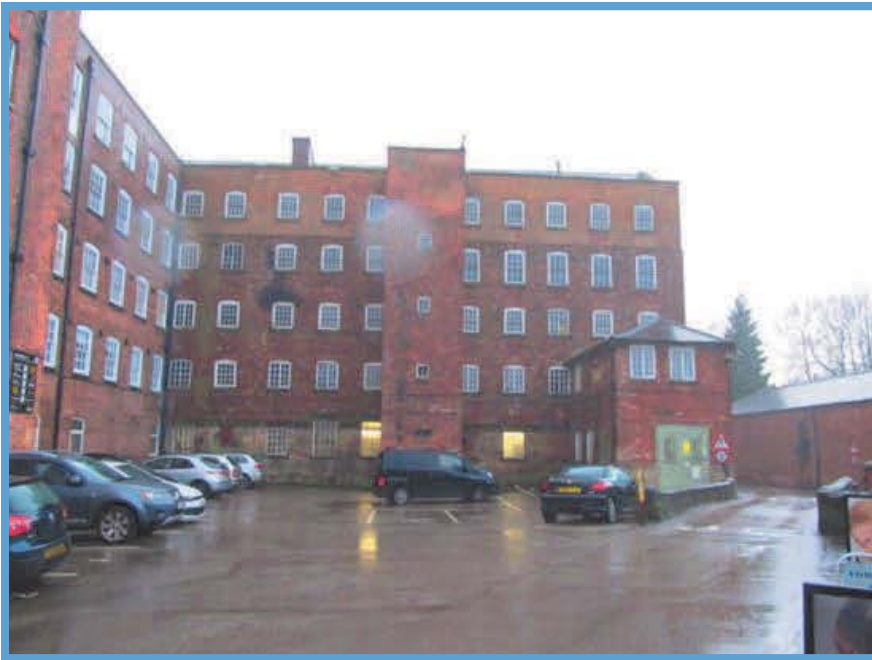
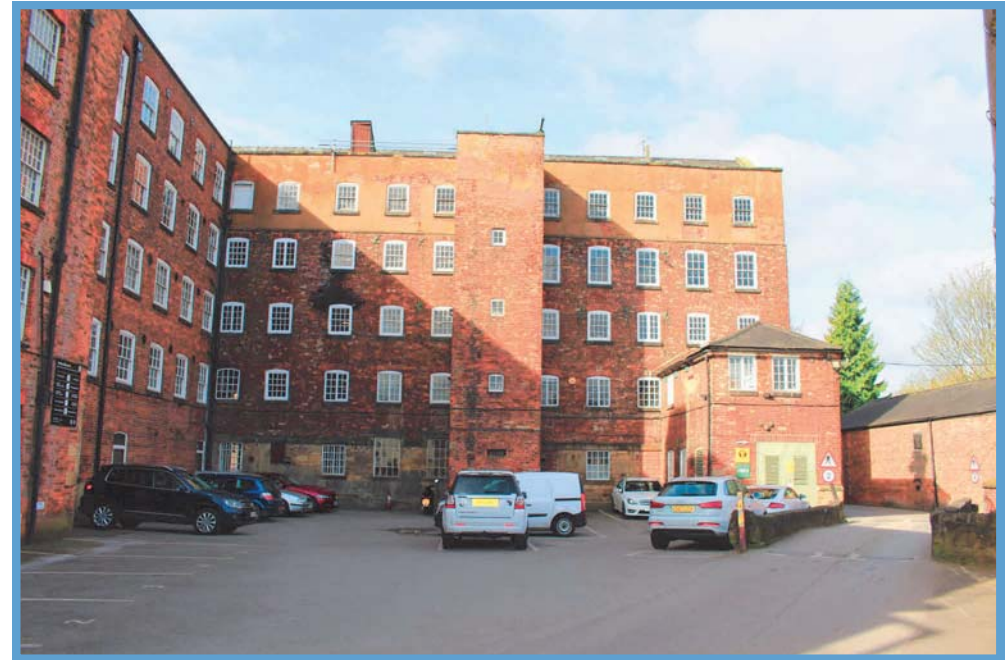
45 Long and Middle Mill, Darley Abbey (new photo)

Recent change to view (2017): Restoration and reuse of these mills is continuing.

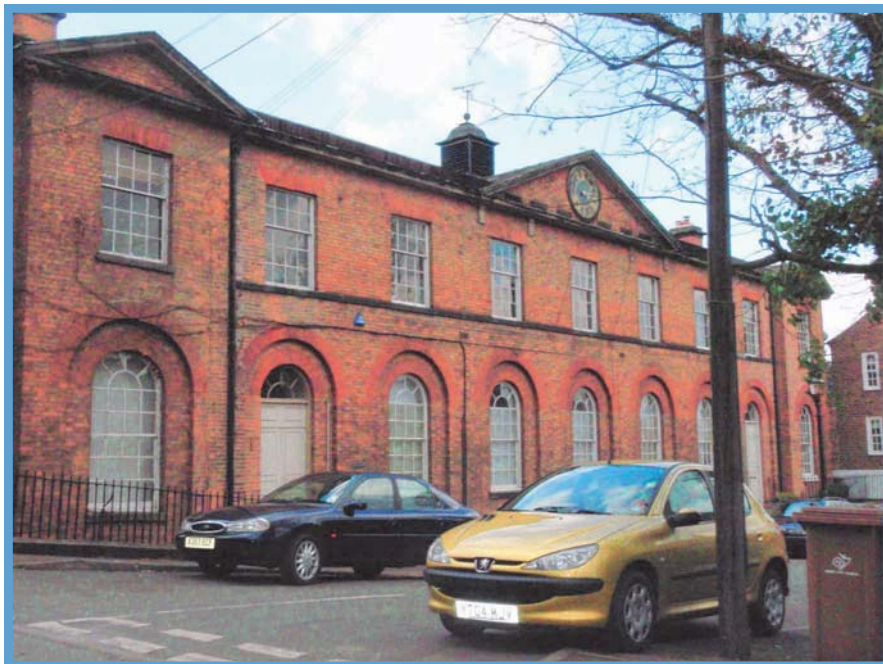
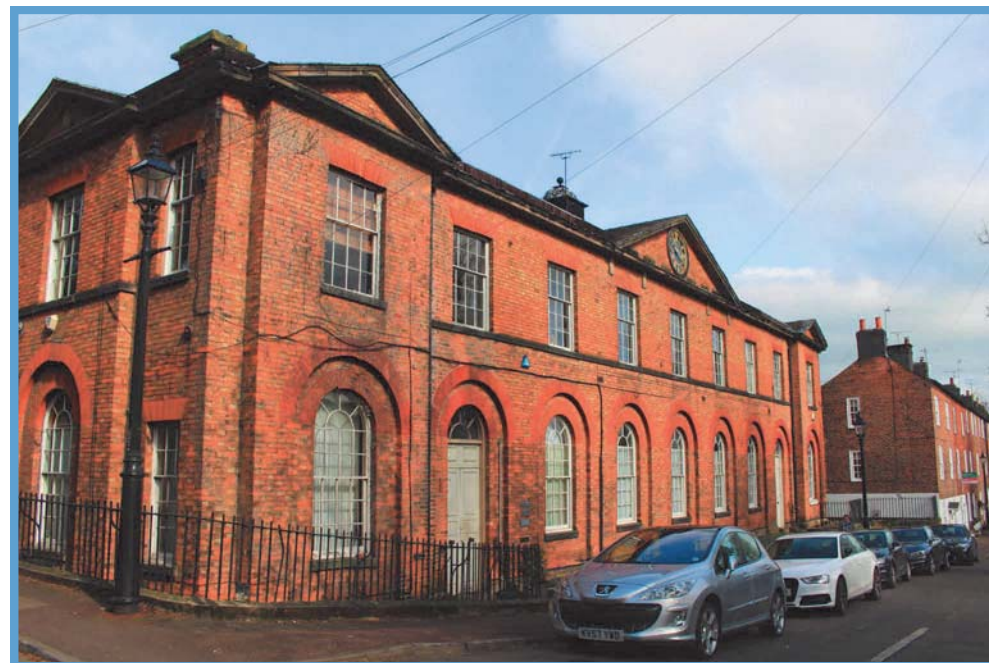
46 School and Brick Row, Darley Abbey (formerly 44)

2012 – Vegetation has been removed from the building.

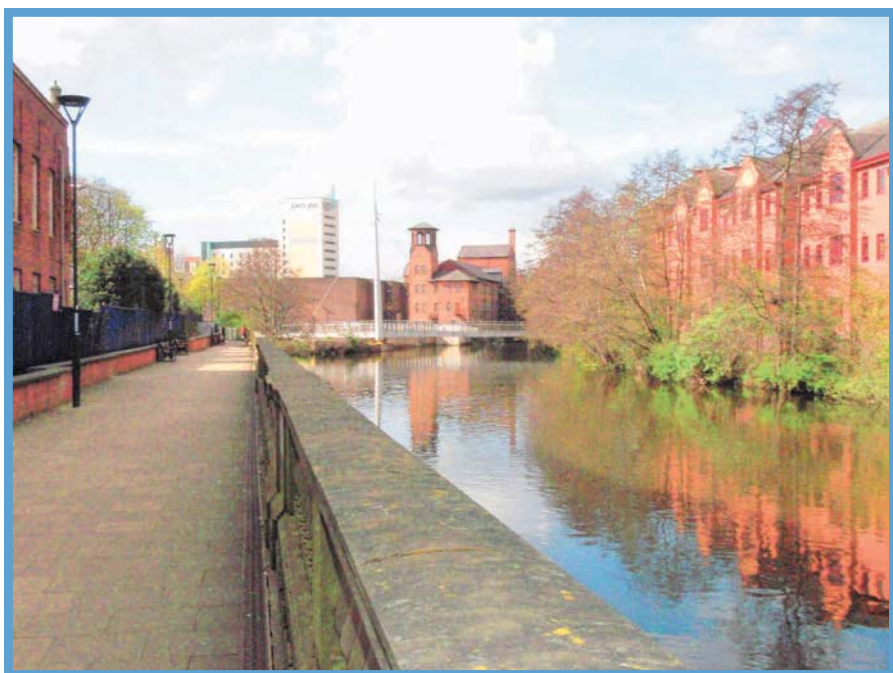
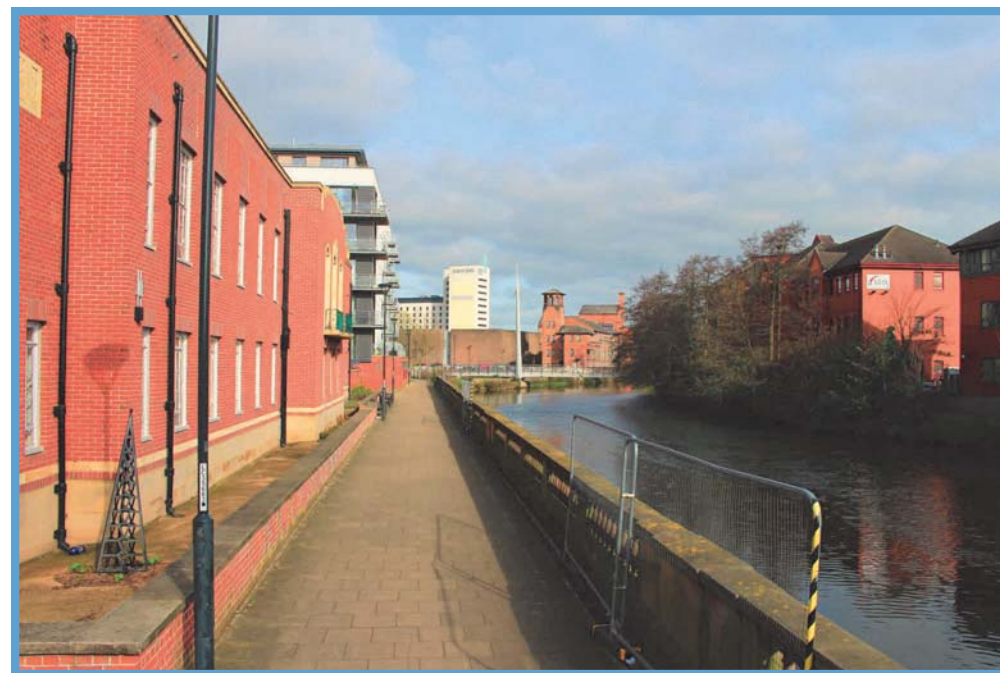
48 Silk Mill from Exeter Bridge (formerly 45)

Recent change to view (2017): Redevelopment of the west bank of the Derwent has introduced new build, but this does not significantly impact on the view of the Silk Mill.
