Derwent Valley Mills World Heritage Site Monitoring Views 2022

Appendix 20

Images from North to South

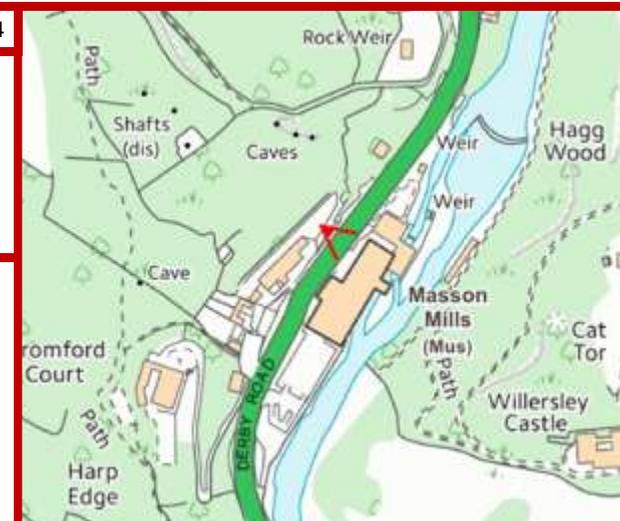
Recent change to view (2022)

Vegetation growth continues, with removal or management now clearly needed. Closure of the museum and neighbouring retail site in Spring 2020 increases the need to monitor this unused structure.

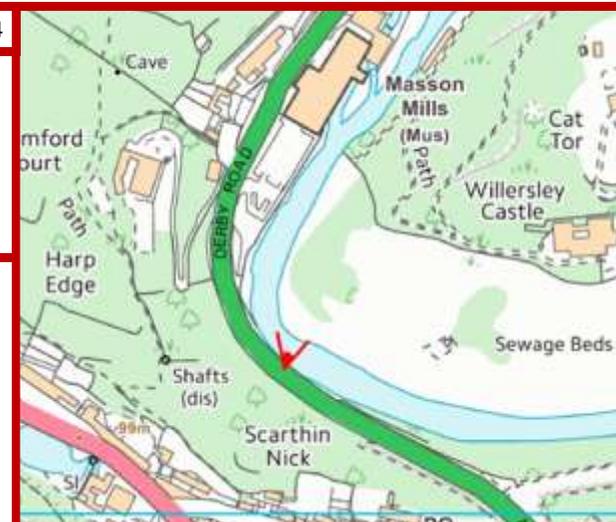
Recent change to view (2022)

Vegetation growth continues, with no perceivable management on either bank.

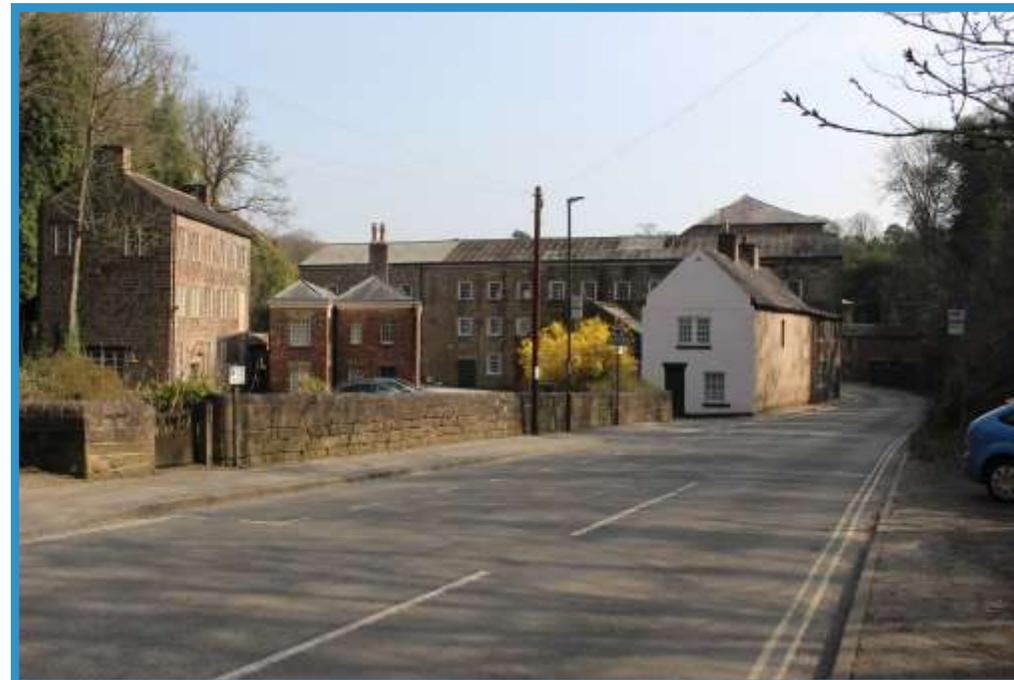
2022

Not in the view, because it was very badly damaged in a road traffic collision in 2002 is the cast iron conduit of 1821 which spanned the road and which needs to be repaired and reinstated.

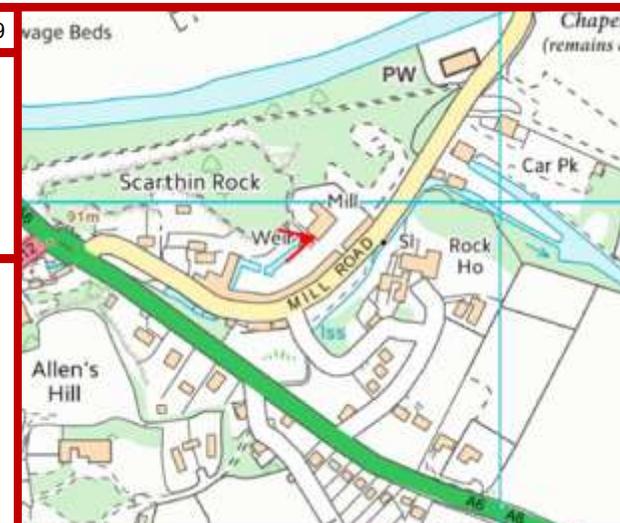
Recent change to view (2022)

Waterwheel models have been added, to better interpret and explain the different types used for power generation in the early factories.

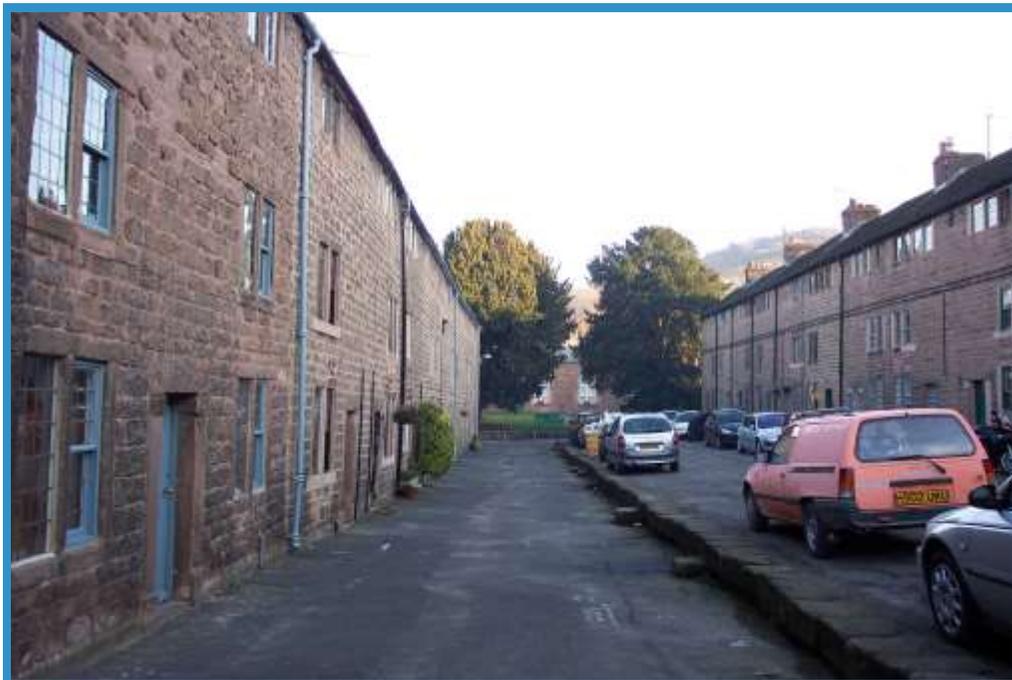
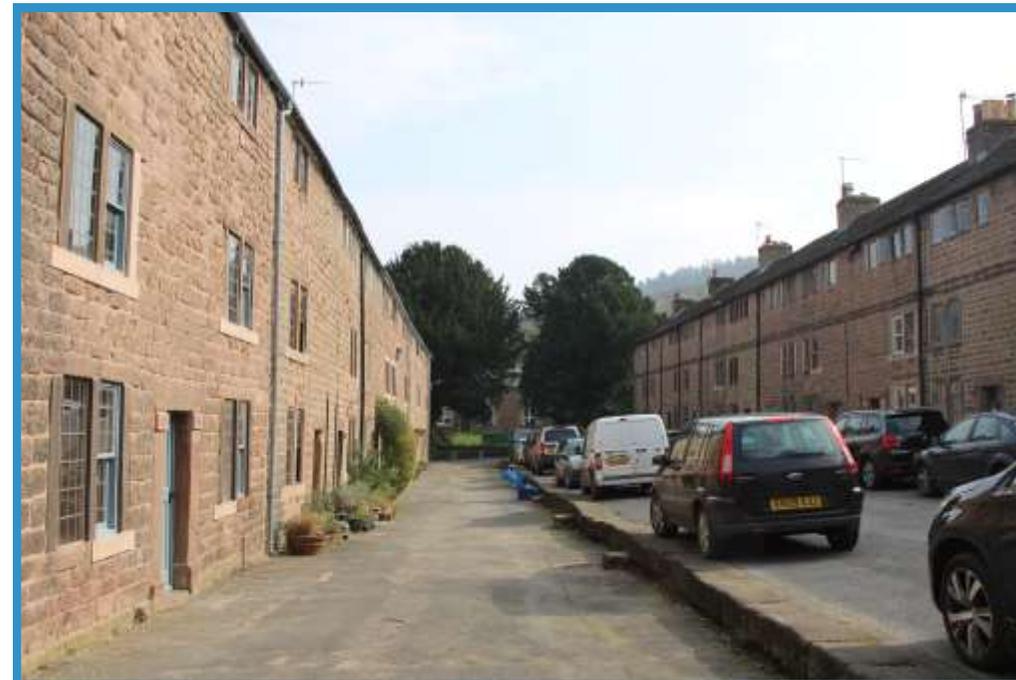
07 North Street, Cromford from Cromford Hill

A remarkable street made up of two terraces of relatively unaltered three storey mill workers houses built in 1776. The nature of the original paving has been researched and it is hoped it may be reinstated at some point. The absence of street clutter is an important quality. It would be preferable if some alternative site for residents' car parking could be found. The yew trees in the garden of the 1832 school are an important feature.

No significant change

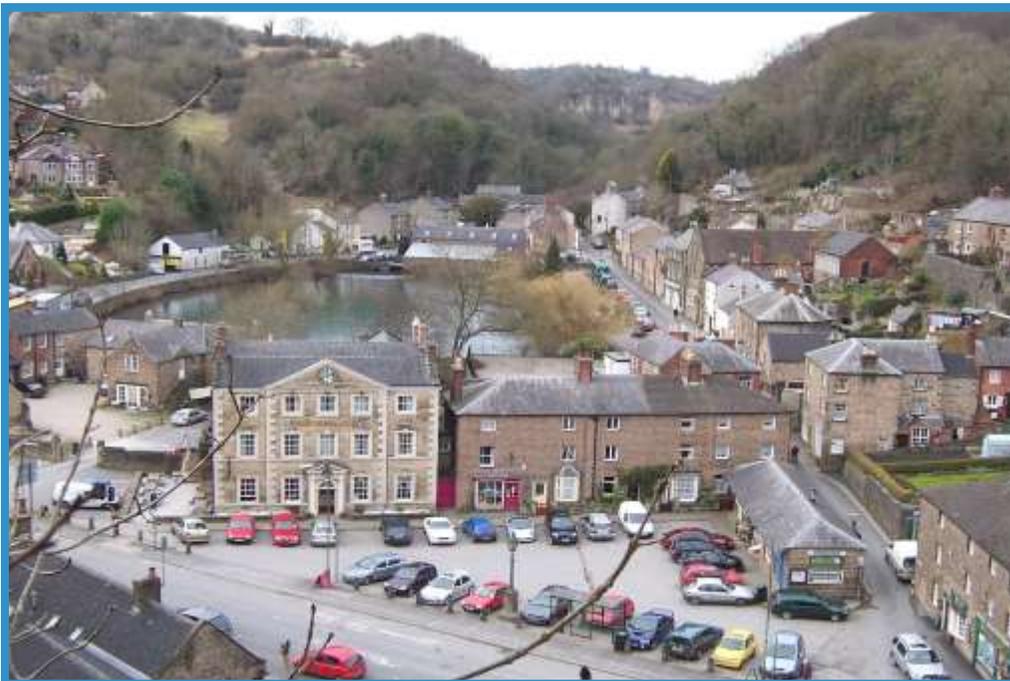
08 Cromford Market Place

Additional signage has been added to the side wall of the Greyhound Hotel. Additional outside seating provision has been introduced to meet measures to reduce Covid-19 transmission.

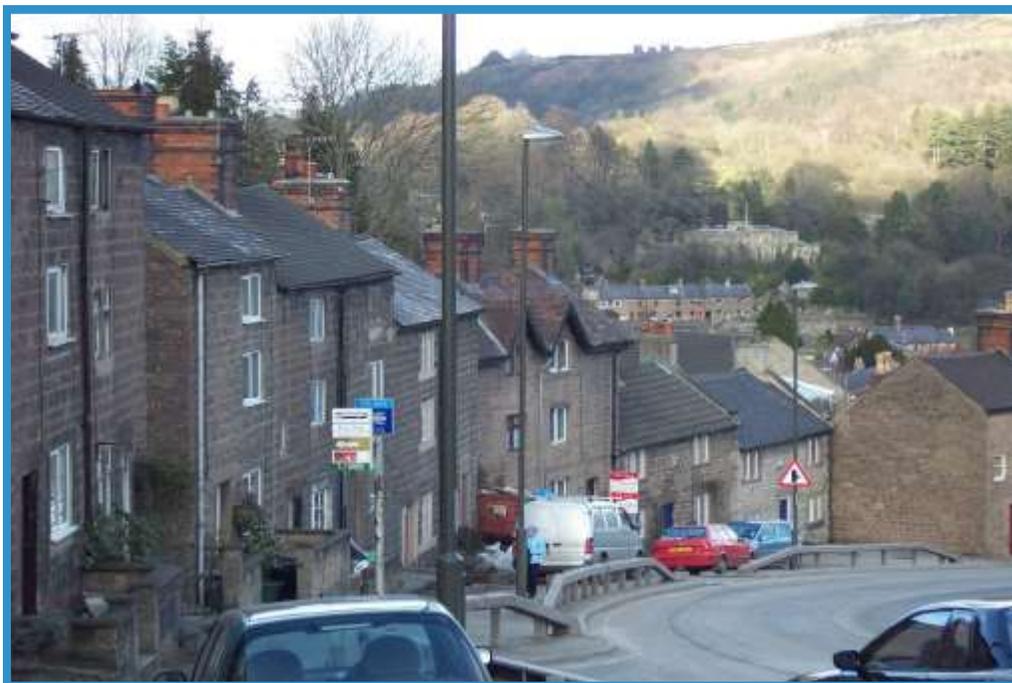
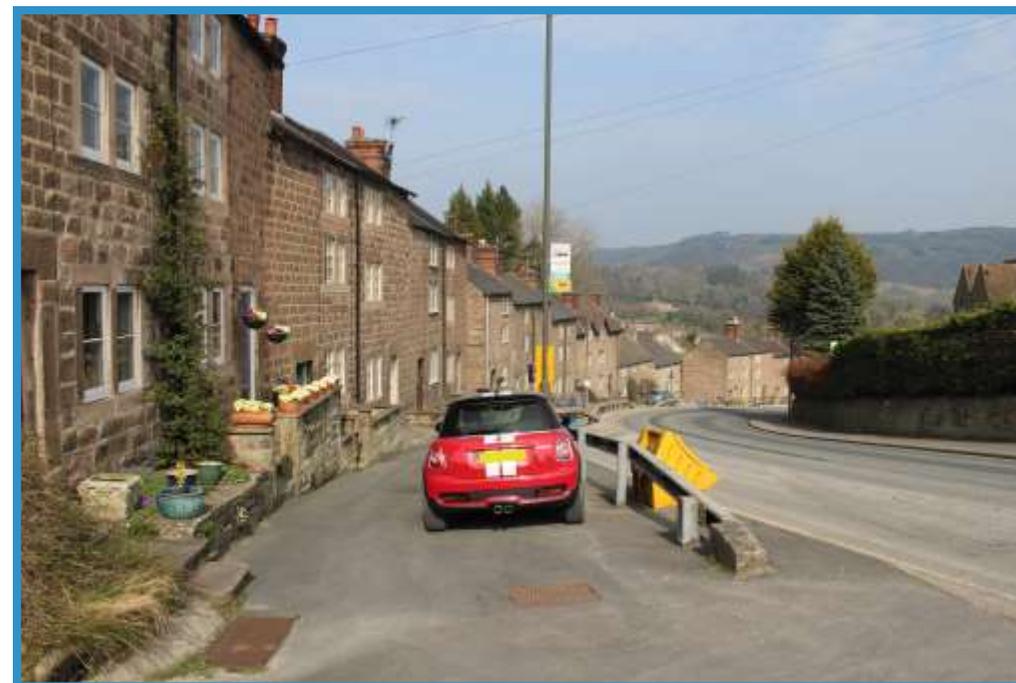
10 Looking down Cromford Hill to Willersley Castle and the landscape of Riber hillside beyond

The late 18th century and early 19th century millworkers' cottages which line Cromford Hill are an important part of the historic village. A number of the houses have inappropriate modern doors, windows and roof coverings and it is desirable these be replaced with more sympathetic alternatives based on historic patterns. The dramatic scenic setting is very important. The car parking and crash barriers are regrettable.

No significant change.

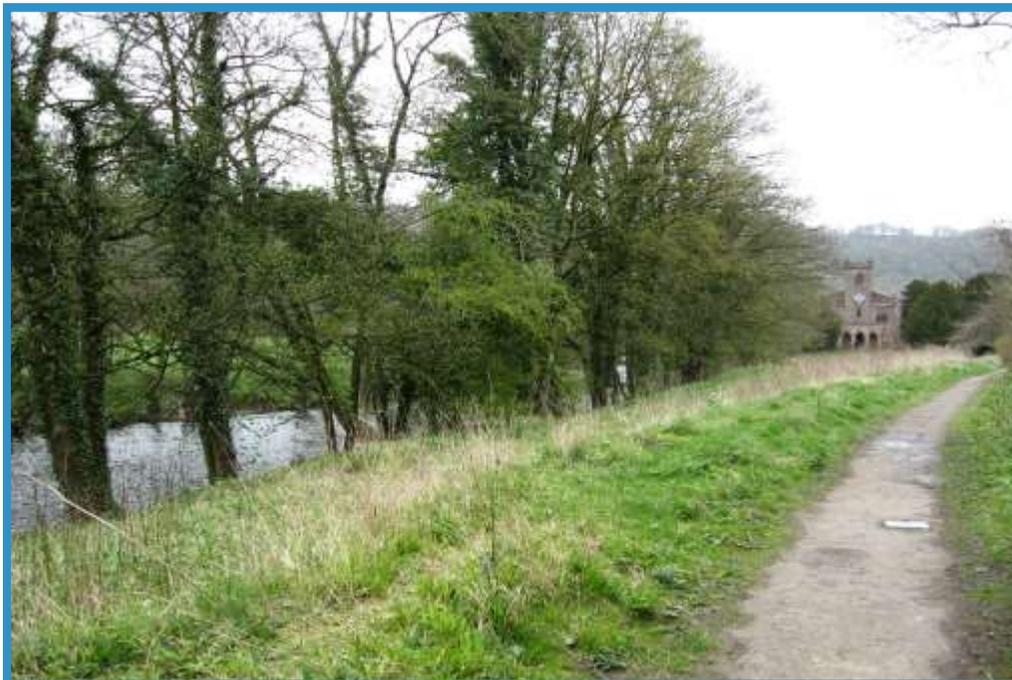
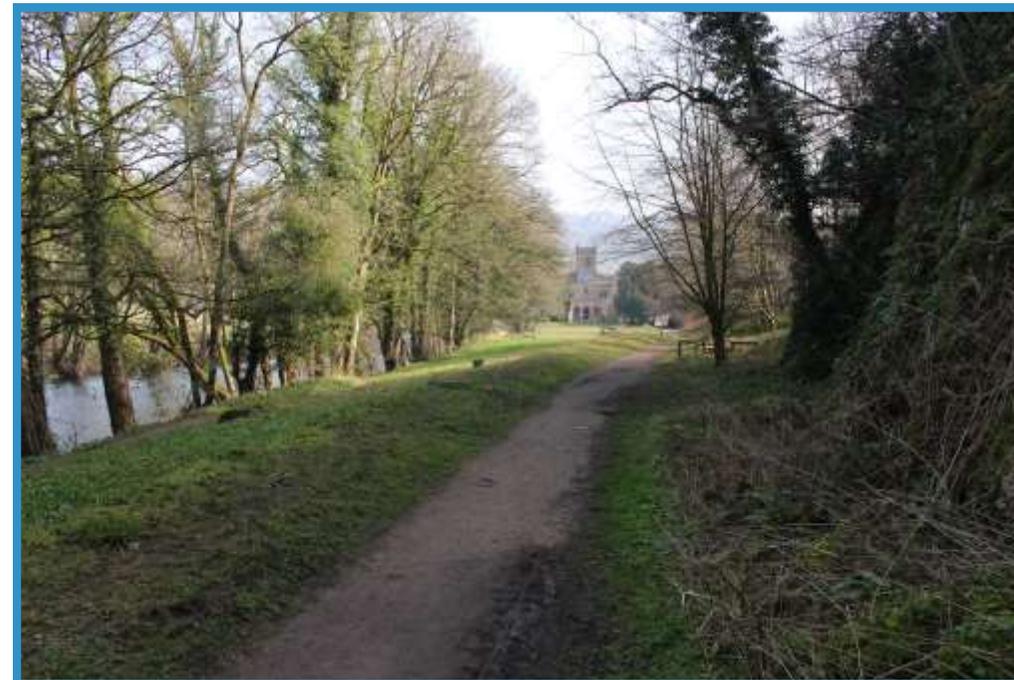
13 The Derwent riverbank looking towards St Mary's Church

Tree growth continues to slowly reduce the view of St Mary's Church.

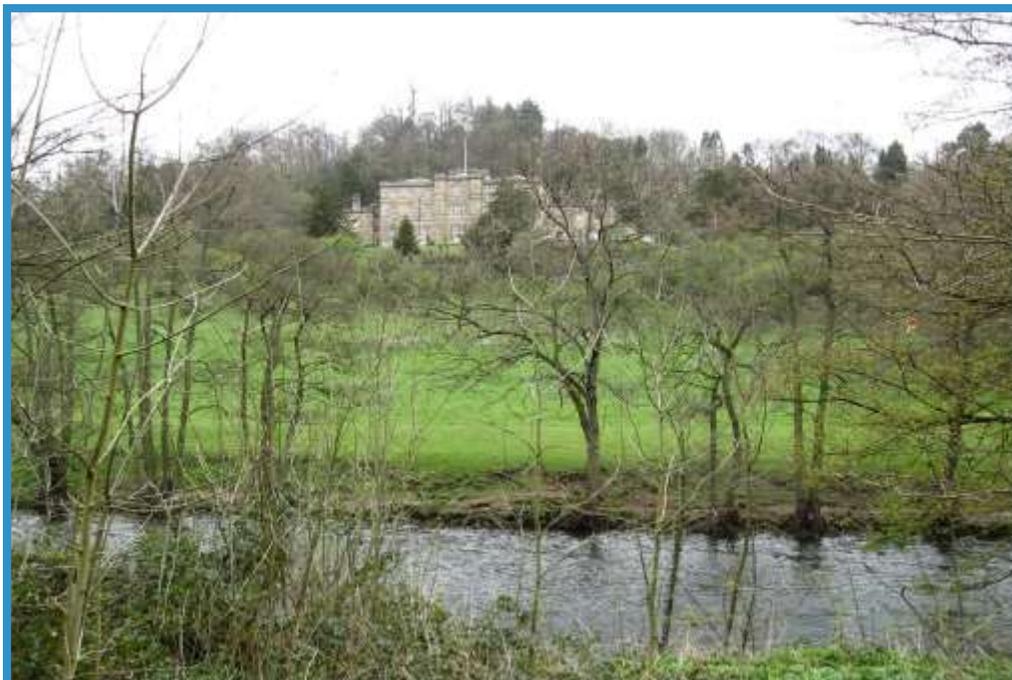
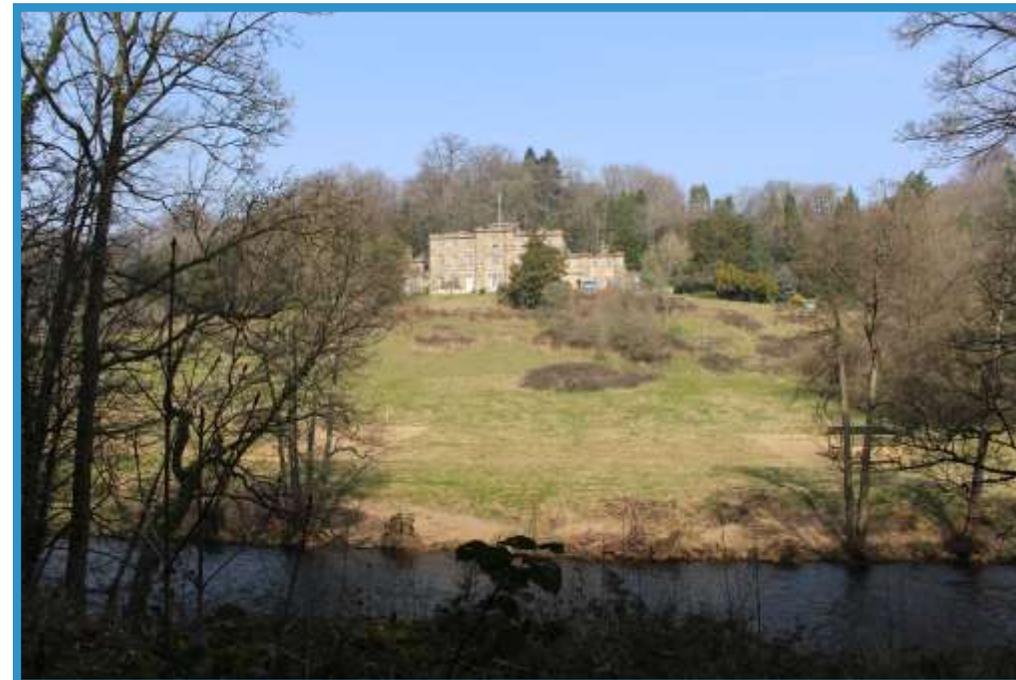
14 Willersley Castle and Park from the south bank of the River Derwent

Archery ranges and other lightweight wooden structures have been introduced into the designed landscape, without planning permission, by the new owners of Willersley Castle, as part of its re-use as an activity centre for children.

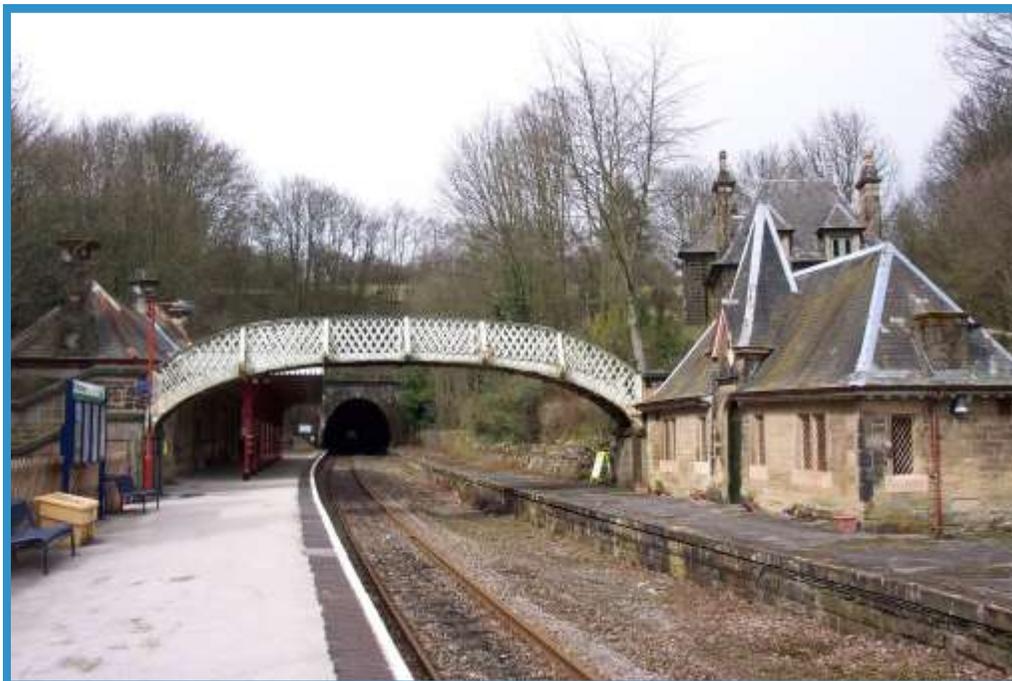
15 Cromford Station with stationmaster's house

Low-level vegetation is beginning to take hold in front of the former up-platform. The conifer bush on the south side of the up-platform building is also slightly reducing the impact of this unusual structure. Platform clutter has increased on the down-platform.

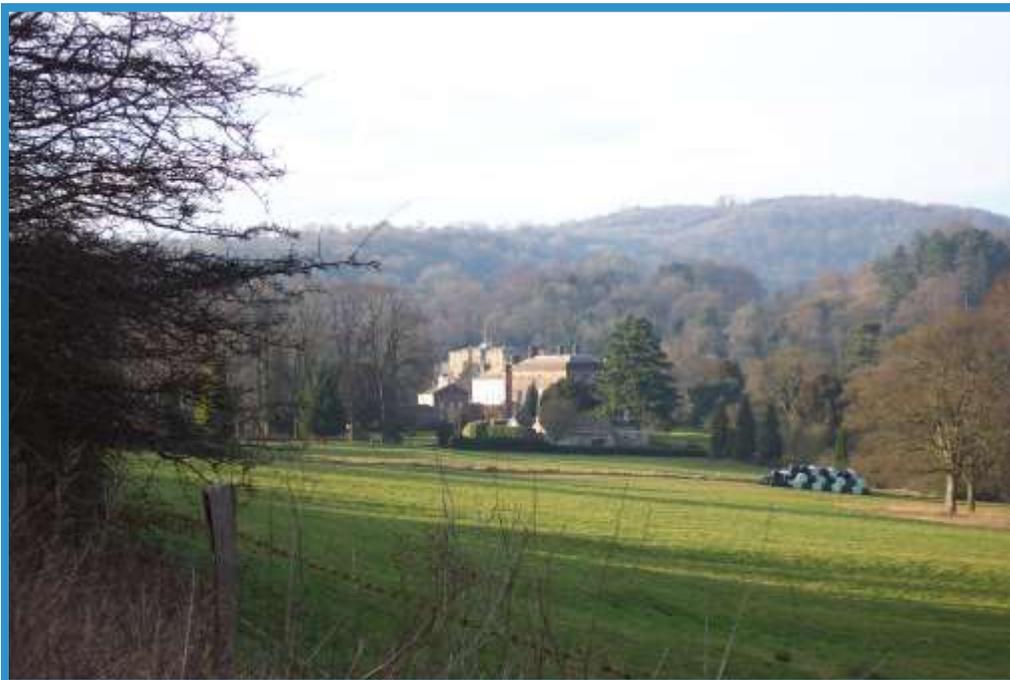
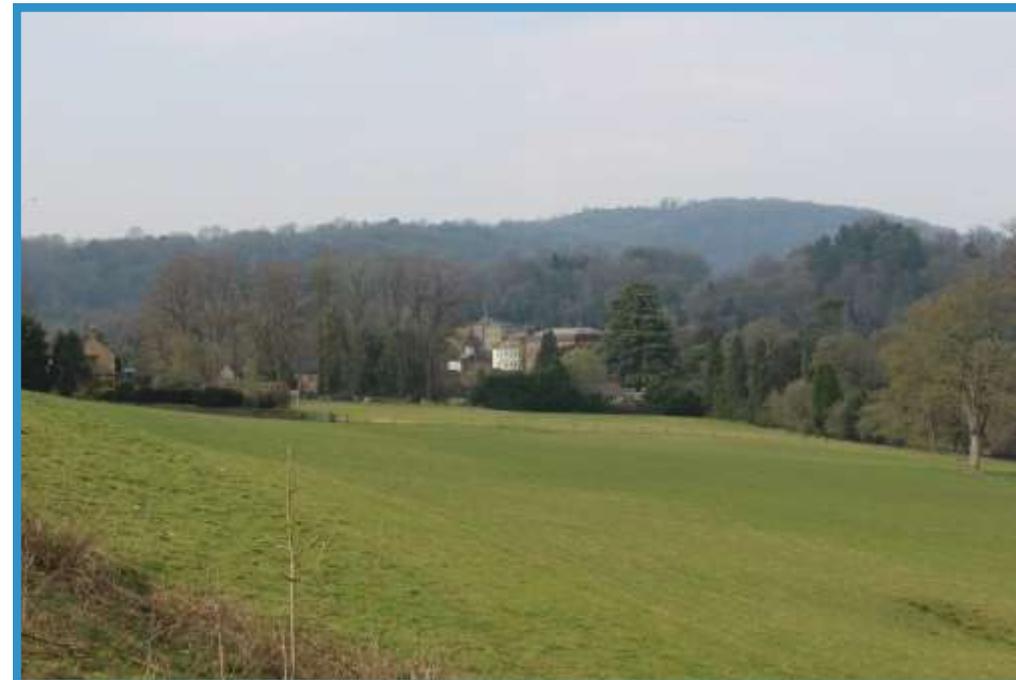
16 Rock House, with Willersley Castle in the background, from the A6

No significant change. Planning applications for new housing continue to be resisted.

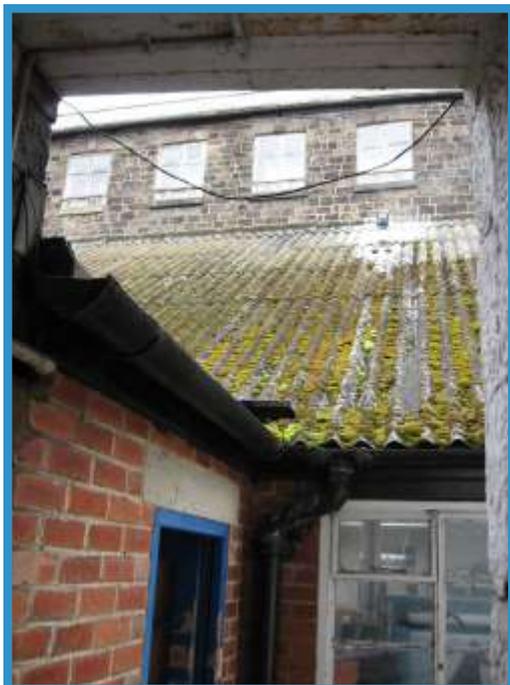
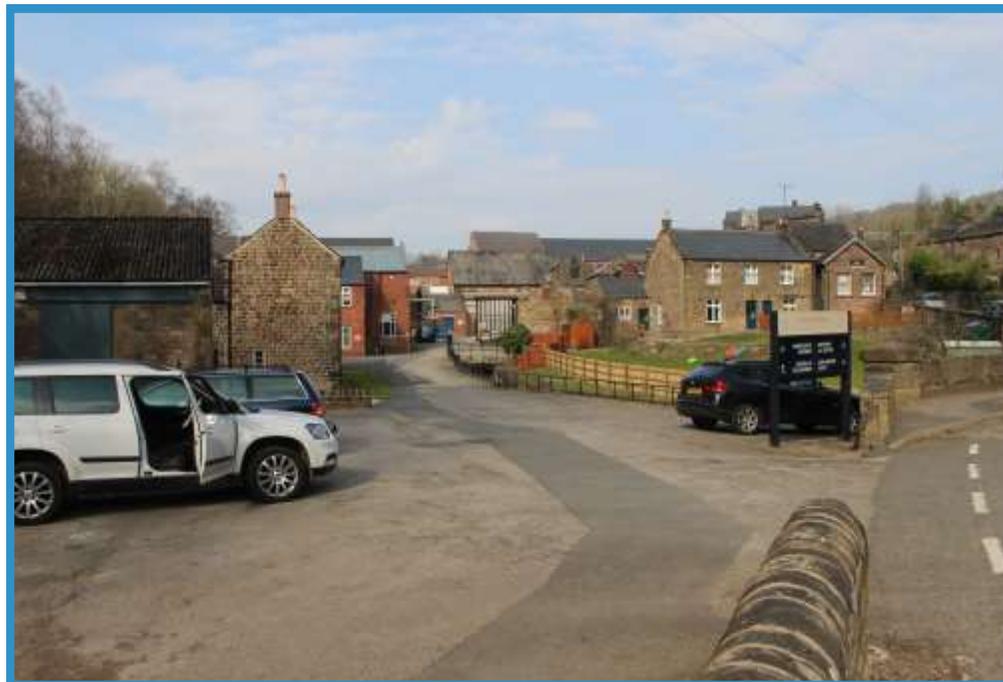
18 The Smedley Mills at Lea

The millworkers' cottages on the left have been fully restored to a high specification.

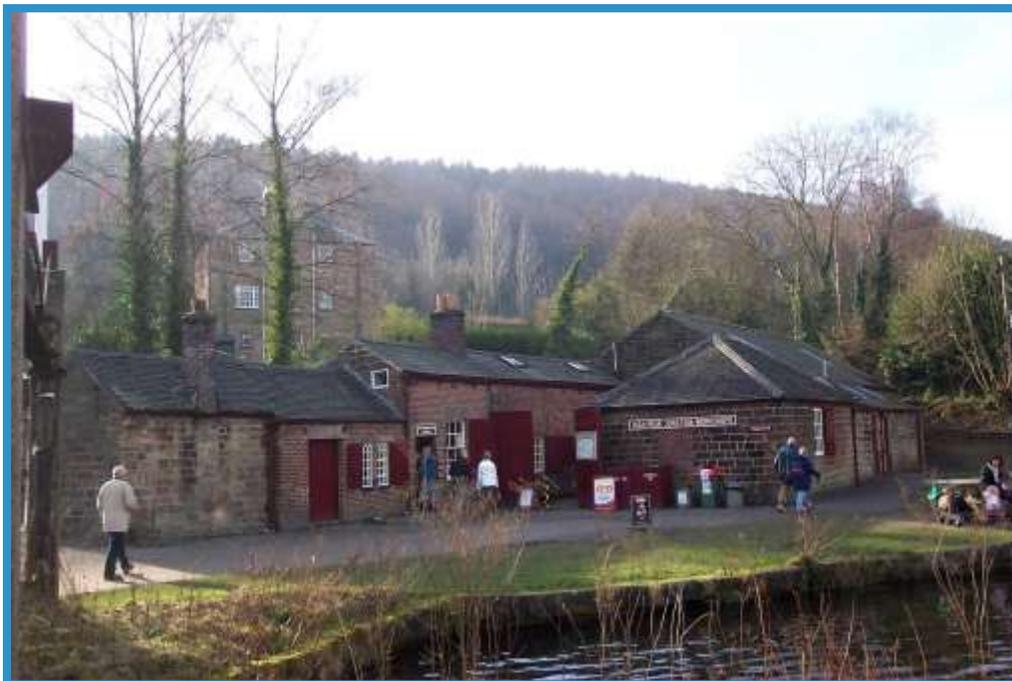
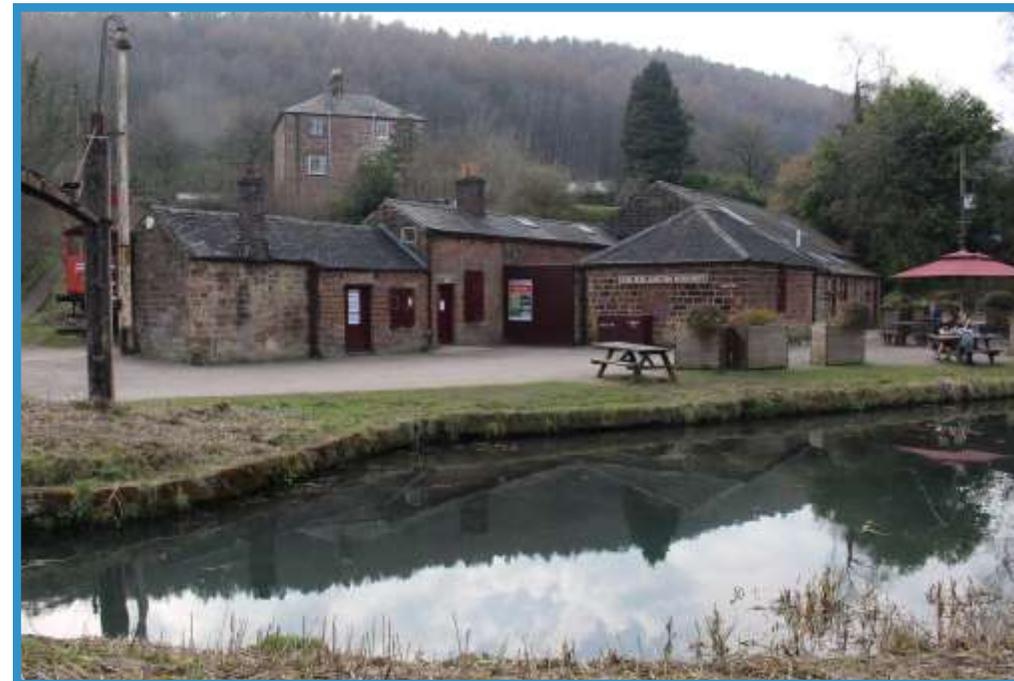
19 High Peak Junction from the canal

Additional outside seating provision has been introduced to meet measures to reduce Covid-19 transmission.

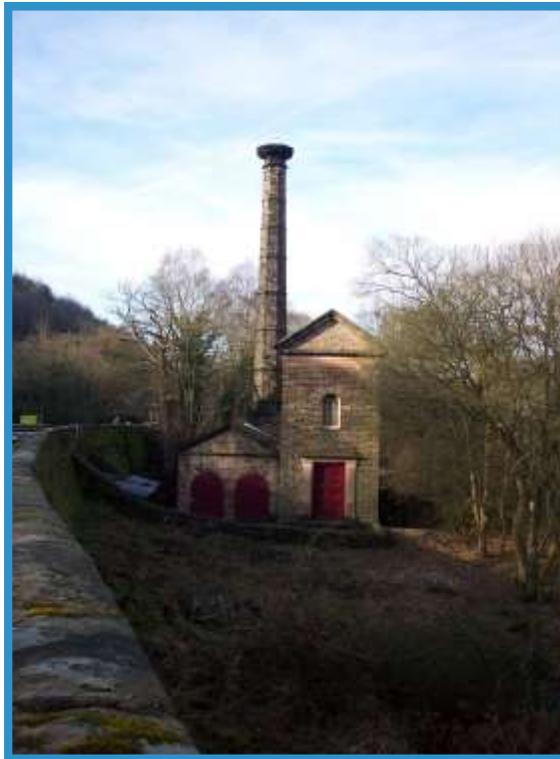
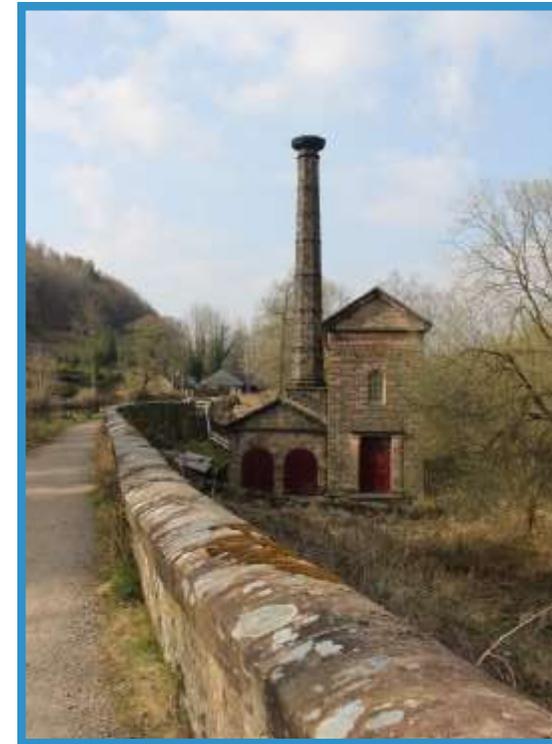
20 Leawood Pumphouse

Tree growth continues to increase.

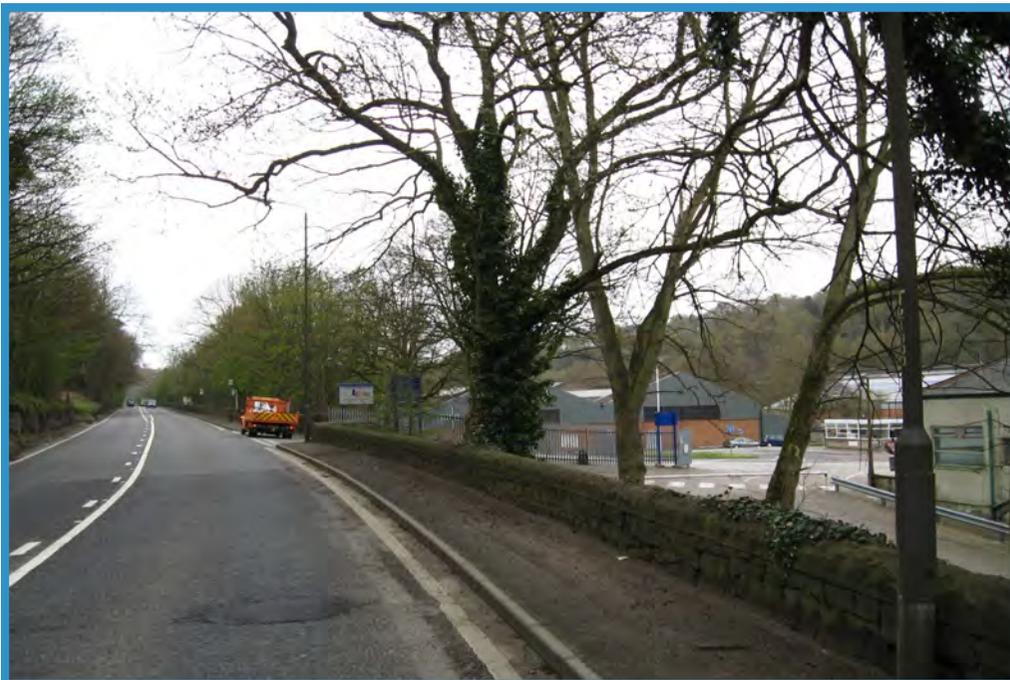
21 Entrance to former wireworks on A6 near Ambergate

The re-use of buildings for a motor museum has improved the site overall. The modern building on the right has been removed, creating a more open space at the museum entrance, with no loss to historic fabric. A section of the stone wall on the south side of the main entrance has been removed and replaced with steel fencing to improve visibility for vehicle drivers, with no WHS consultation.

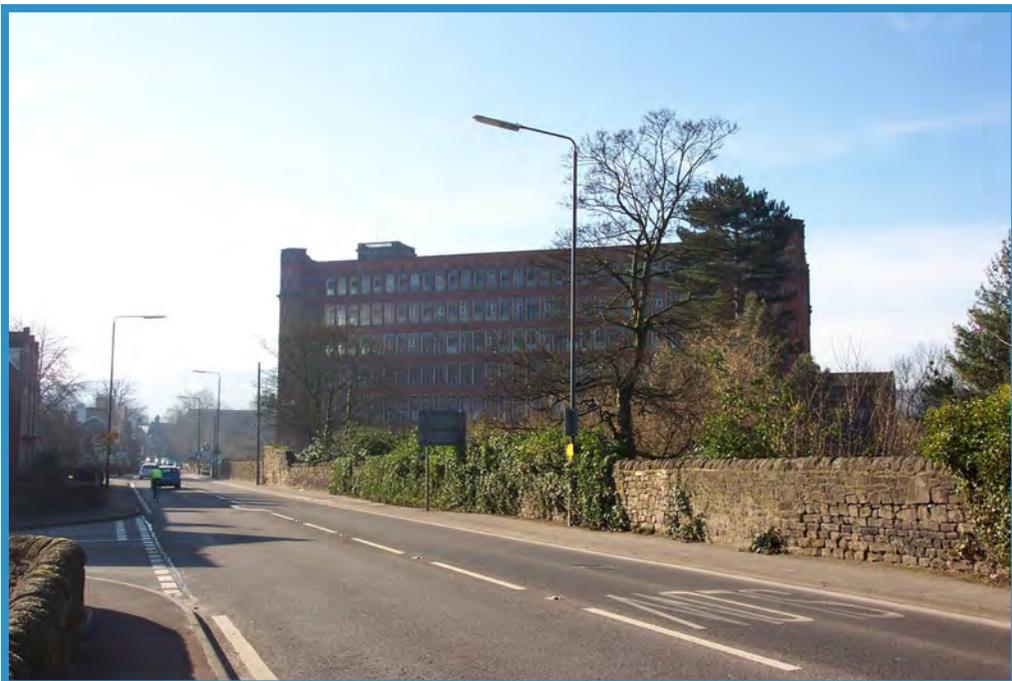
22 Belper's East Mill from the A6 looking south

The East Mill is a major landmark within the World Heritage Site. Its present condition is a matter of great concern. From this viewpoint its setting is largely as it was when built. The wall predates the mill and forms the boundary of the River Gardens. It was raised in the winter of 1905/6 to reduce the risk of falling for onlookers leaning over the wall. Vegetation has penetrated and damaged this wall.

2010 – Although no significant change is visible to this landmark mill it continues to deteriorate. Removal of trees as part of the River Gardens renovations has improved the view of the East Mill.

2017 – The building continues to deteriorate with an increase in vegetation growth.

The empty building continues to deteriorate, with more vegetation growth and no reparation work evident.

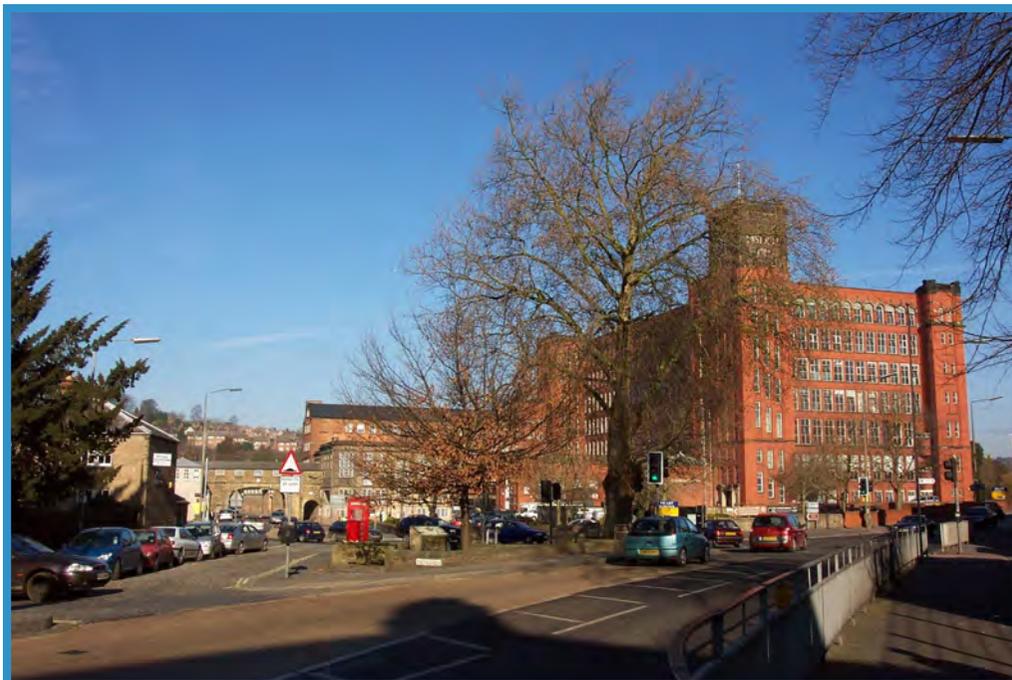
23 Belper Mills from The Triangle

The empty building continues to deteriorate, with more vegetation growth and no noticeable care of the building evident.

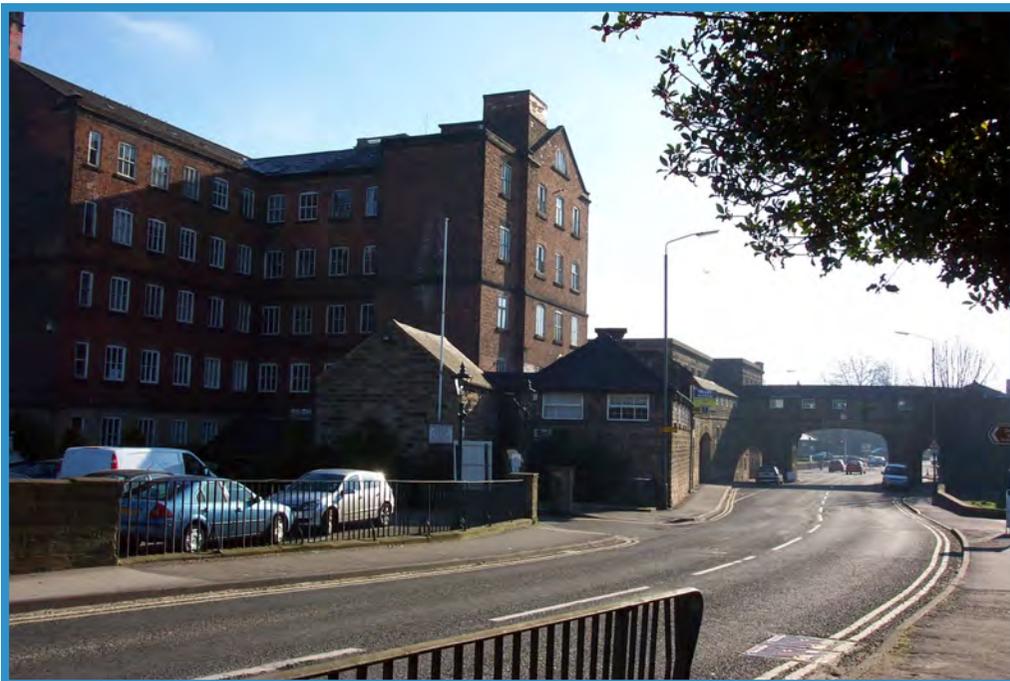
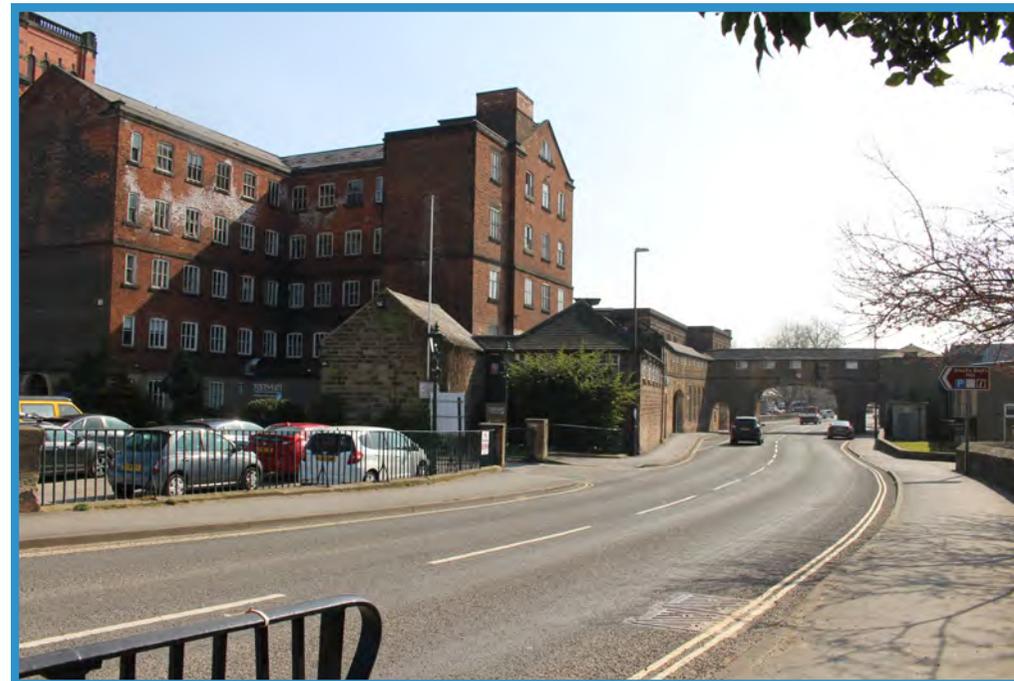
24 Gangway and North Mill

From this viewpoint the Gangway (footbridge) of c.1795 and the North Mill of 1804 are seen well together. Their setting is damaged by undistinguished 20th century industrial buildings and plant just out of sight on the right. The footbridge has suffered extensive damage from tall vehicles. Bridge collision warning signs were installed in 2007 to reduce the risk of further damage, but whilst a busy A-road continues to go under the bridge, the risk remains.

- 2009 – No significant change.
- 2010 – The scaffolding facilitated some very limited repairs, but the need for major repairs remain a Management Plan priority.
- 2012 – No significant change.
- 2017 – No significant change.

The scale of efflorescence on the upper floors of the Listed Grade One North Mill is likely to indicate significant damp issues leading to potential structural problems for one of the most important – and most neglected – buildings in the World Heritage Site. Several collisions by high vehicles have chipped away further at the fabric of the Grade II* Gangway, a possible indicator that drivers are not seeing the temporary warning signs now those installed in 2007 no longer work.

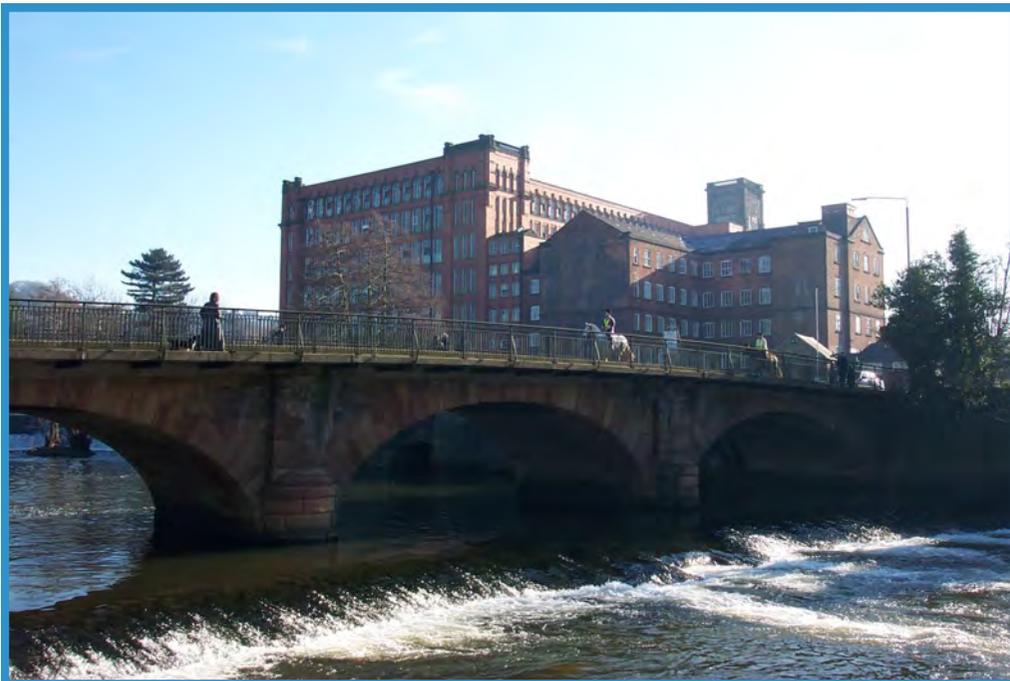
25 North and East Mills with river bridge in foreground

From this viewpoint the river bridge of 1797, the weir of 1797, North Mill of 1804 and the East Mill of 1912 are seen together. The poor condition of both mills and the weir are causes for concern.

2017 – No visible significant changes but the rock weir continues to deteriorate and may collapse in a future flooding event.

The scale of efflorescence on the upper floors of the Listed Grade One North Mill are also noticeable from here. Despite several significant flooding events the rock weir has not yet collapsed, but no repair work has taken place and it continues to deteriorate. Collapse could significantly change this important view.

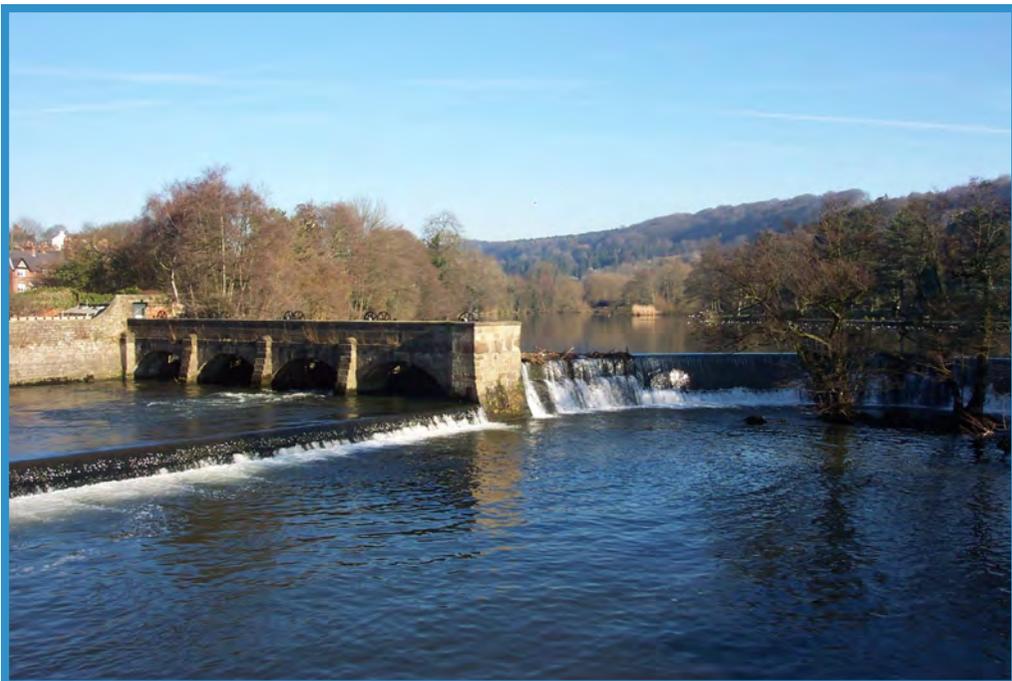
26 Belper weir from river bridge

The magnificent Horseshoe Weir of 1797 is seen best from the river bridge. The River Gardens beyond provide a pretty background, as does the rising woodland beyond. The gardens of Wyver Lane also provide a pretty backdrop. Debris frequently collects at the weir, necessitating close management to prevent damage and ensure this iconic Belper view remains pleasing to visitors and residents.

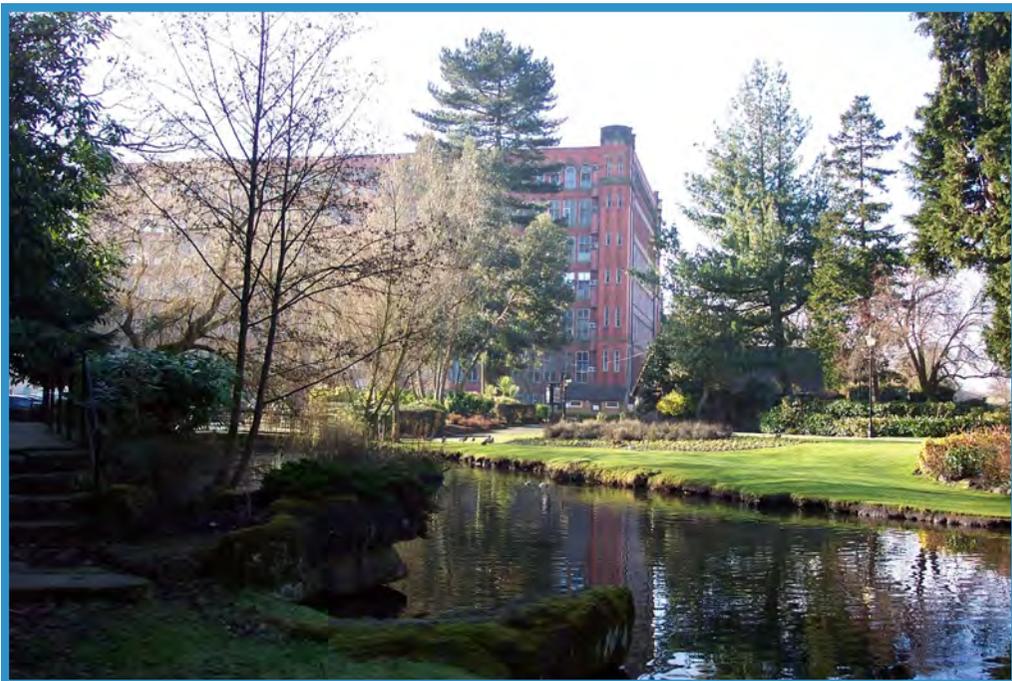
27 East Mill from River Gardens

Some management of the vegetation in the gardens has restored a clearer view of the mill building. The mill itself continues to deteriorate.

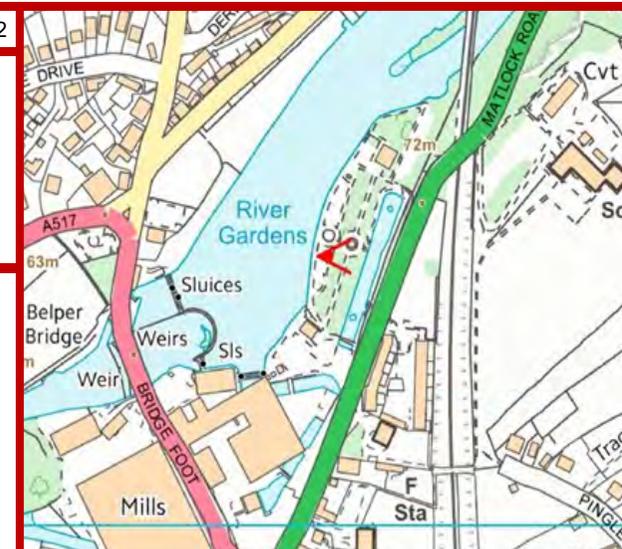
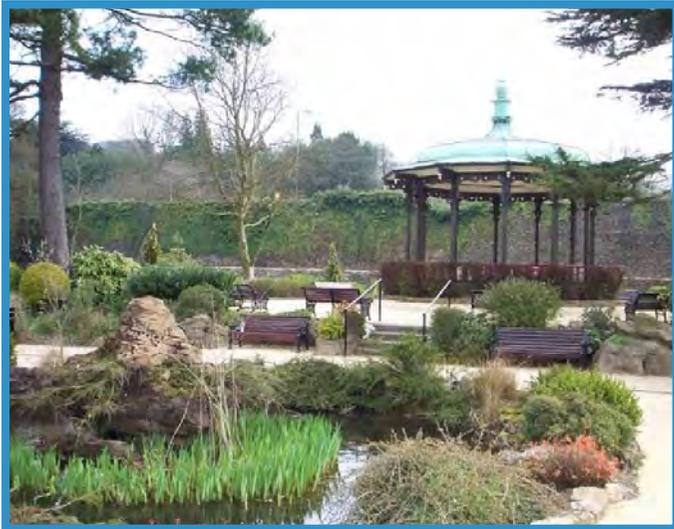
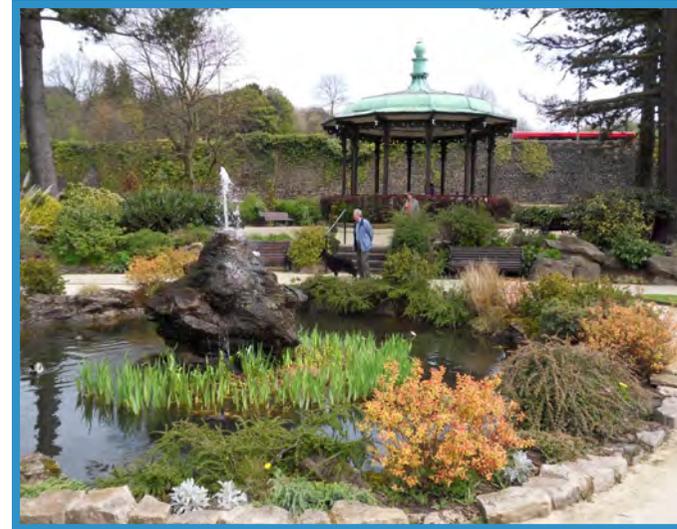
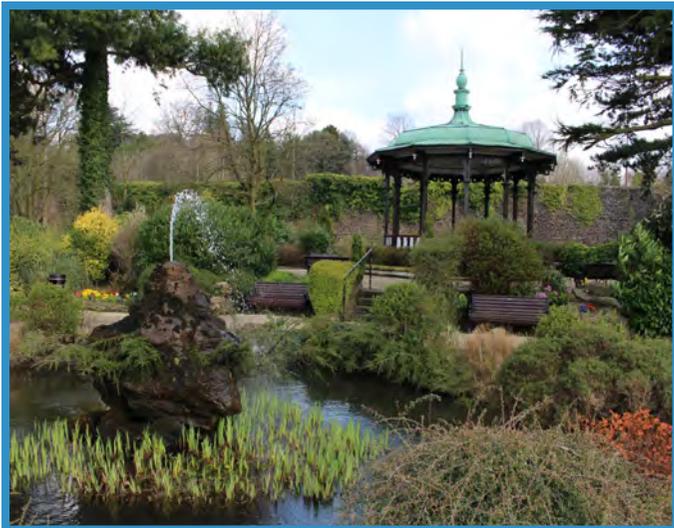
28 River Gardens fountain and bandstand—interim years

Vegetation growth on the wall continues unchecked. Newer planting has become more established.
