Derwent Valley Mills World Heritage Site Monitoring Views 2022

Appendix 20

Images from North to South

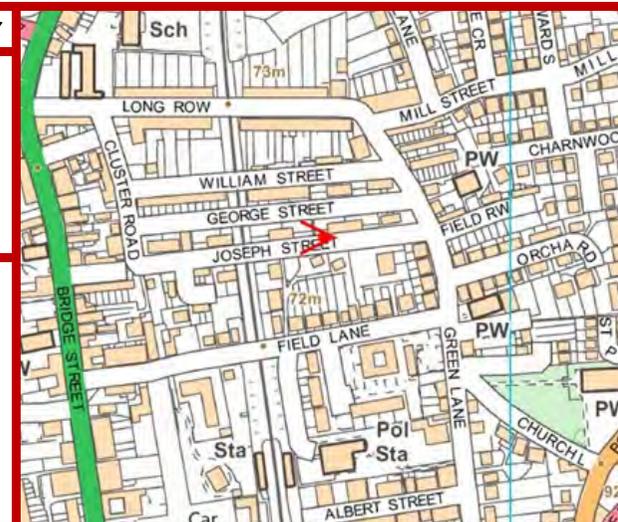
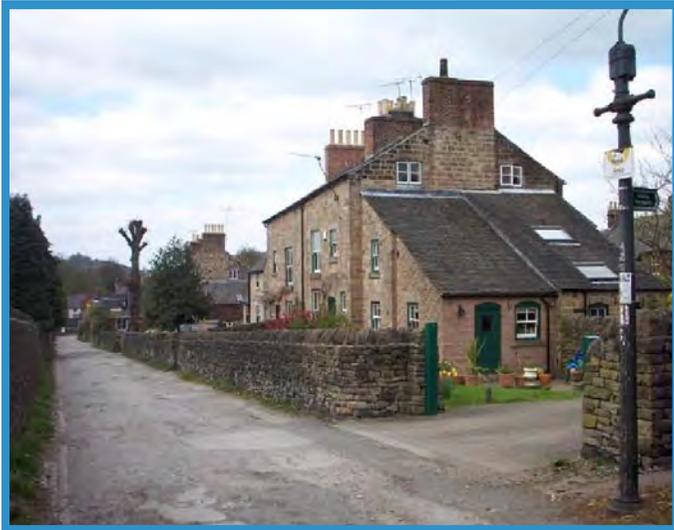
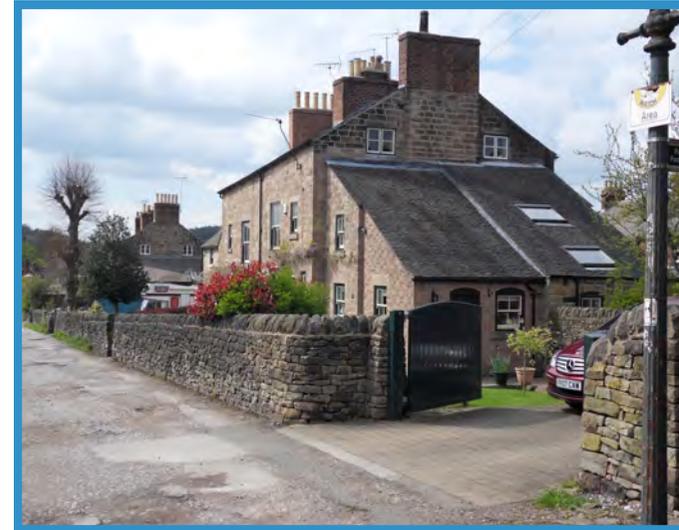
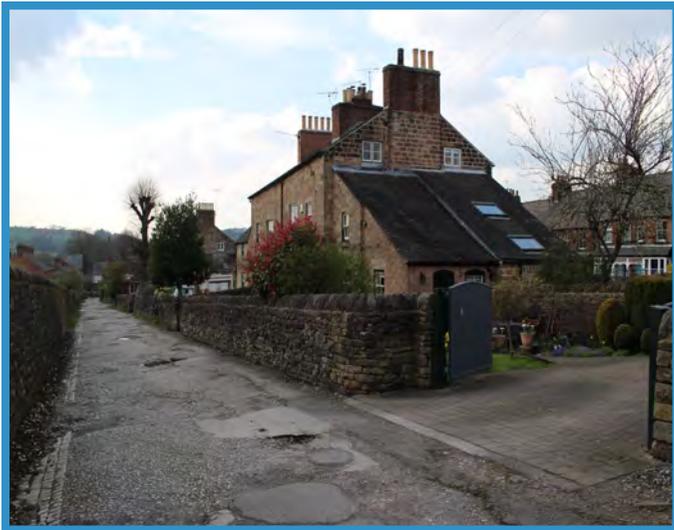
31 Cluster Houses on Joseph Street, Belper—interim years

The historic setting of these distinctive houses of 1805 is important, namely stone boundary walls and a Telford-like road construction. The latter is in a poor state and is vulnerable to further deterioration. A World Heritage objective is the repair of the best surviving areas of road surface and the restoration of the remainder. An important characteristic of this historic scene is the absence of kerbs, street signs and other modern street clutter.

- 2009 – No significant change.
- 2010 – No significant change.
- 2012 – No significant change.
- 2017 – No significant change but the road continues to deteriorate.

The road continues to deteriorate, but residents have cleared out the gutters along the northern edge of the road, aiding drainage.

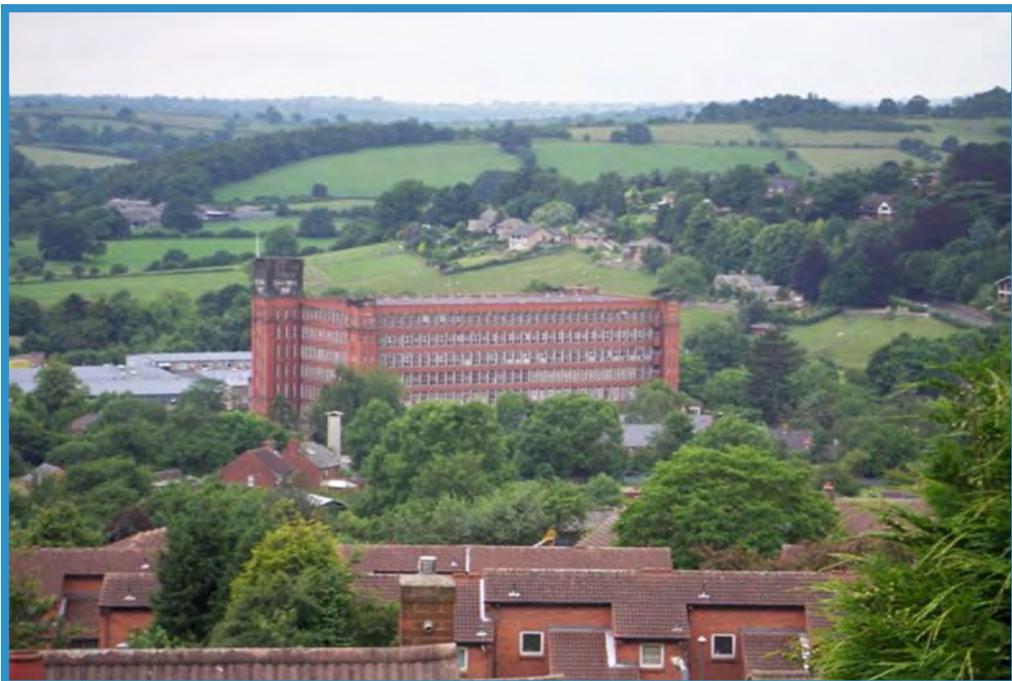
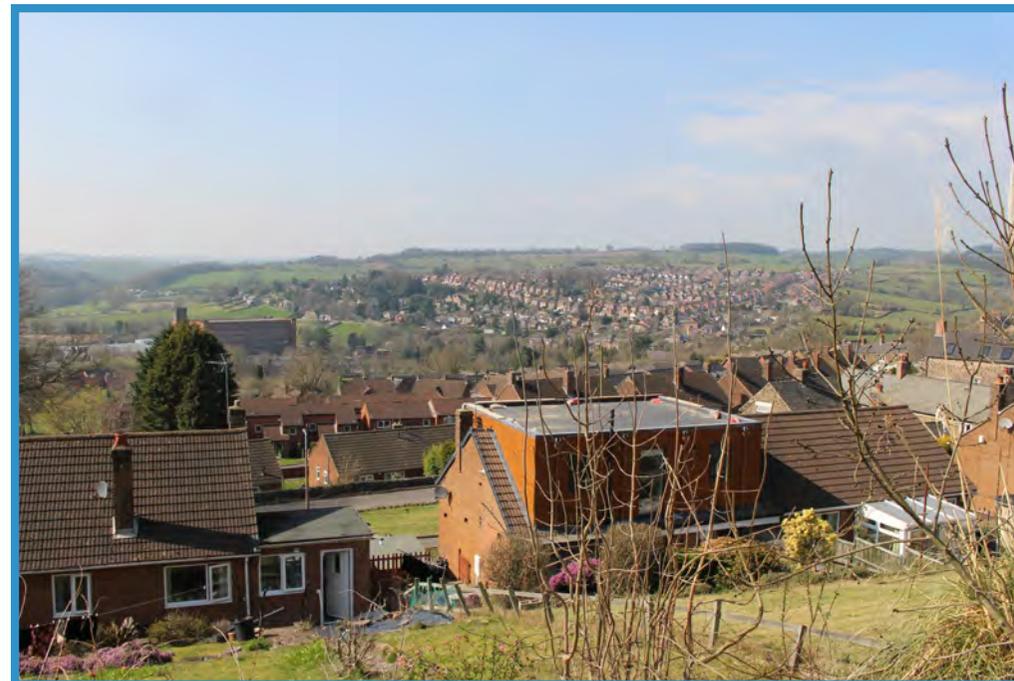
32 East Mill and Bridge Hill from Chesterfield Road, Belper

A large first-floor extension to the bungalow in the foreground has affected appreciation of this view – the WHS coordination team were not consulted on this development. More serious impacts will be felt with the permission, by the Secretary of State, for 118 houses within the landscape setting on the hillside to the right, above the present community boundary, on which work has now begun.

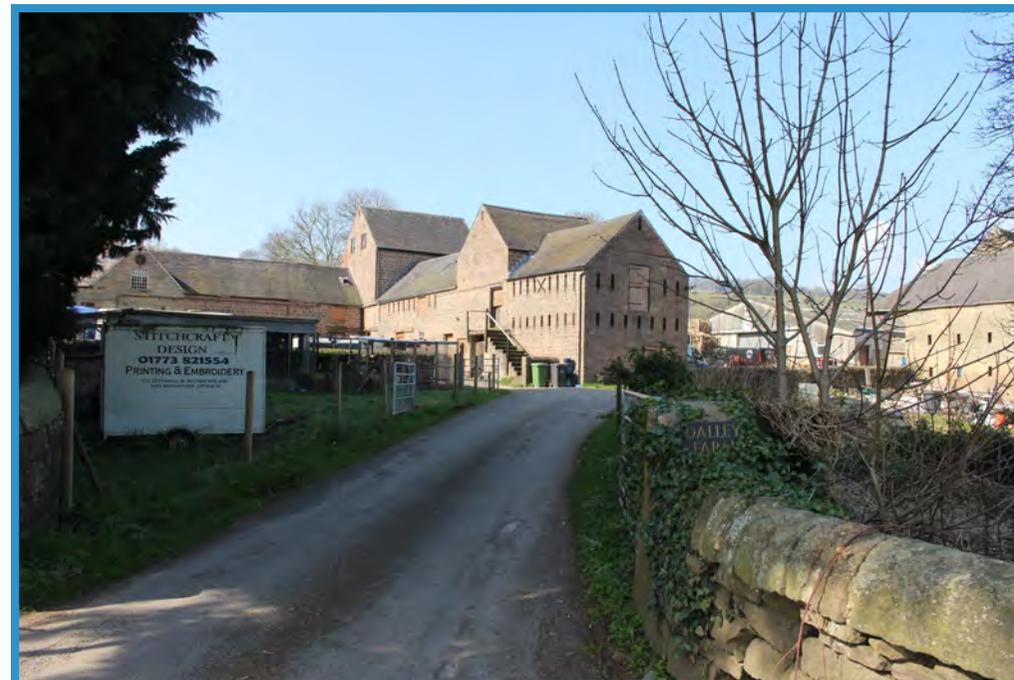
34 Dalley Farm

No significant changes. Planning permission has been granted for the removal of the 20th century shed glimpsed behind the barns, and creation of low-impact holiday lets, designed in consultation with the WHS Partnership.

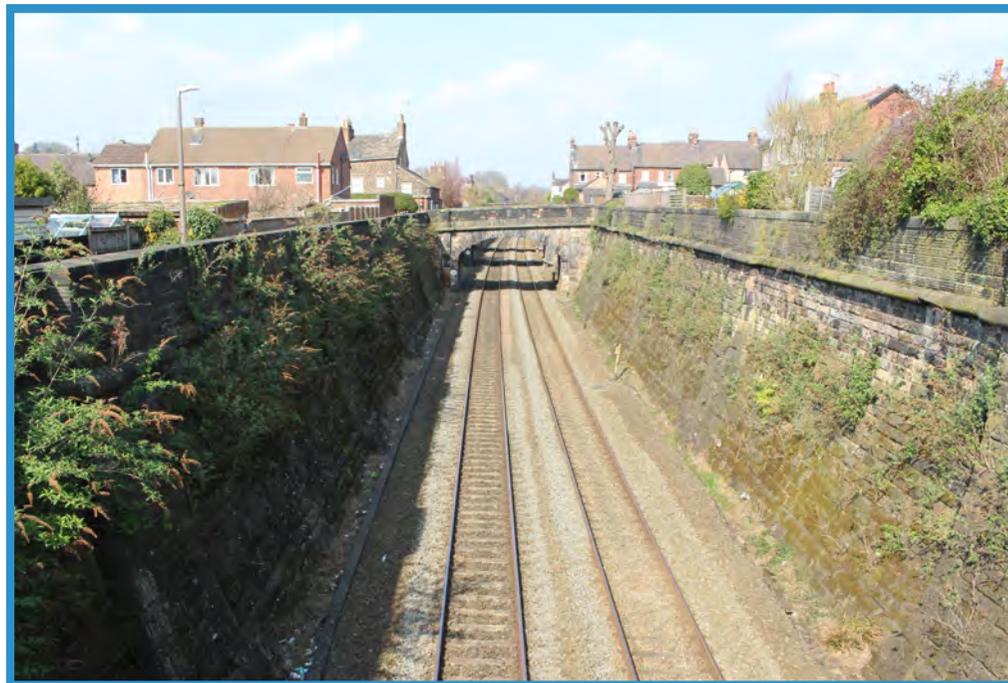
35 Rail cutting and bridges from Field Lane, Belper

This impressive engineering structure designed and built by George and Robert Stephenson needs regular and careful maintenance to prevent damage resulting from vegetation getting established in masonry joints.

No de-vegetation work has taken place, impacting on the view of this important cutting and raising concerns over the masonry.

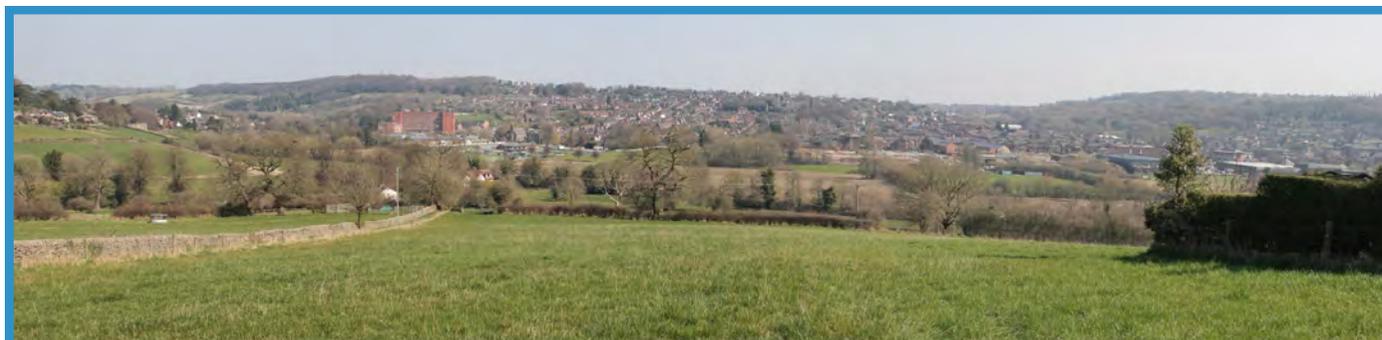
36 Belper and the Derwent Valley from the north end of Chevin Road

Re-development has begun on a large area of brownfield land on Derwent Street, on the edge of the floodplain. The WHS Partnership was consulted, and it is hoped the landscape impacts will be minor.

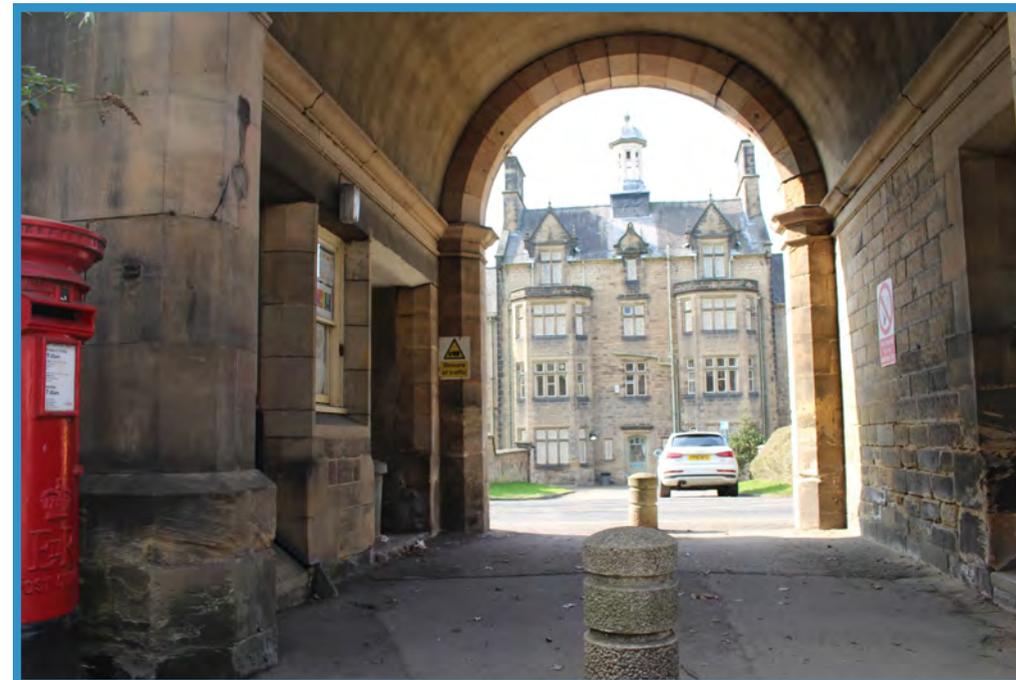
37 Belper Workhouse (Babington Hospital) from A6

No significant change. The sale of the buildings and subsequent change of use are still expected.

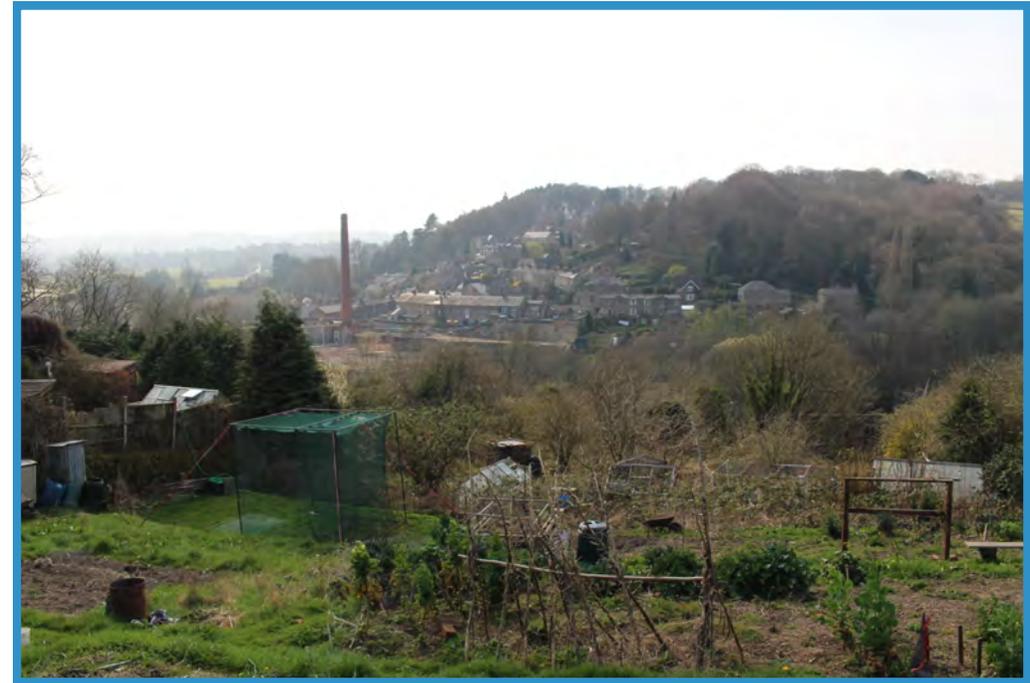
38 Milford from the east

The former bleaching and dyeworks site on the valley floor is being redeveloped. The derelict c.1964 sheds on site have been removed, but the chimney and older structures have been kept. The WHS Partnership was consulted and it is expected the new development will be an improvement on the previous state of the site.

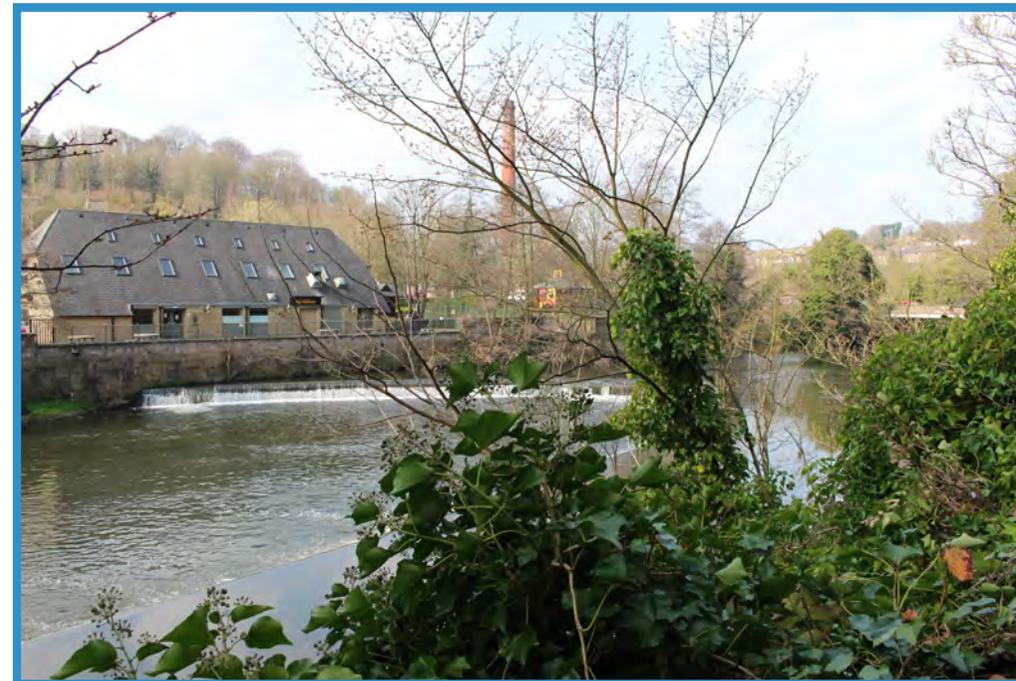
39 The weir at Milford

As the vegetation removal was part of a one-off project, it has not taken long for it to grow again and obscure this important view.

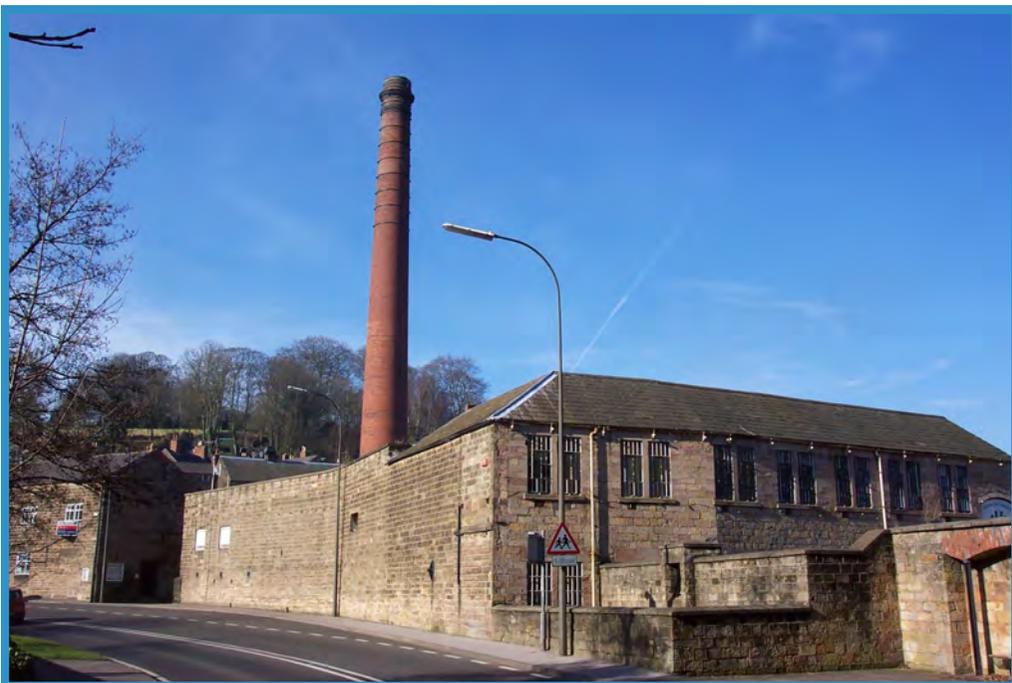
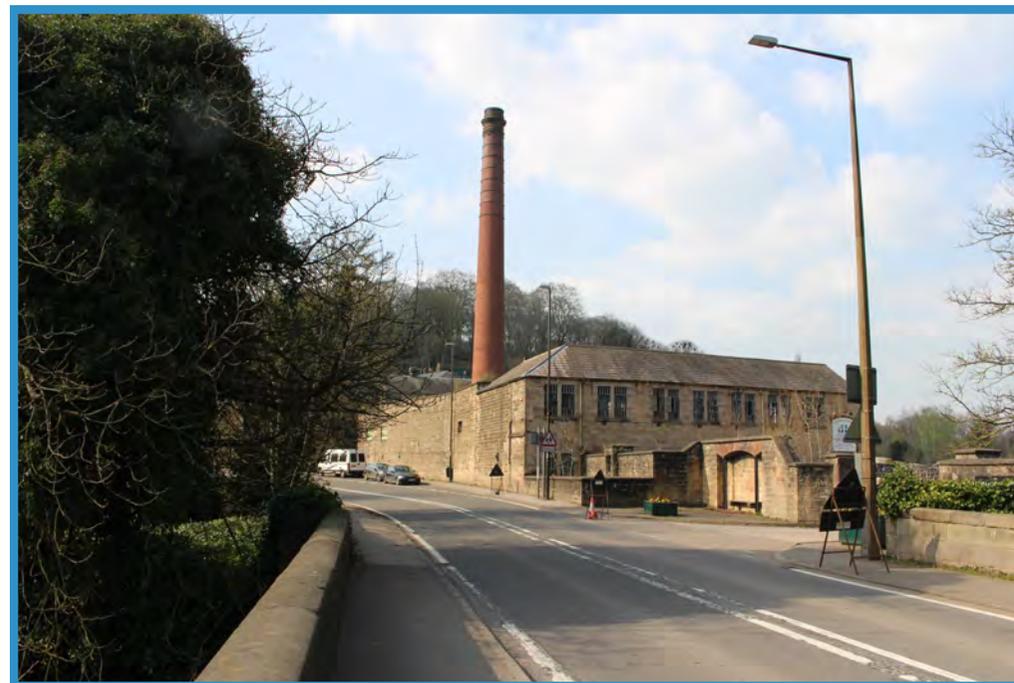
40 Chimney and mill remnants from road bridge, Milford

Work has begun on the redevelopment of the site, with little impact, as yet, on this view. Proposals for lowering the historic wall between the site and the road, which helps define the traditional relationship between the mills and road, have been resisted.

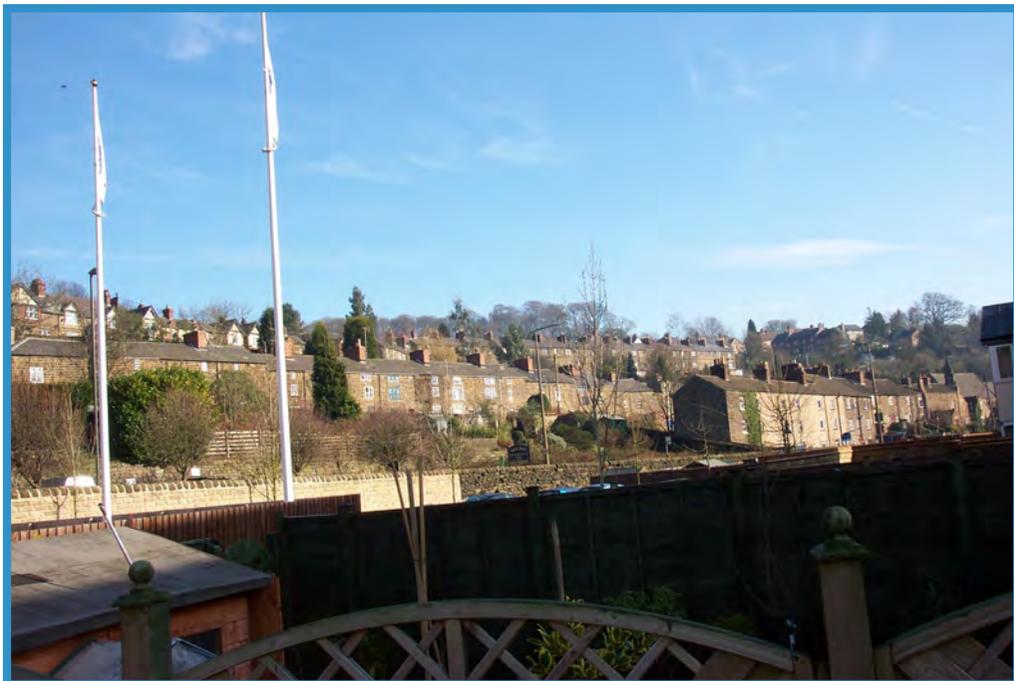
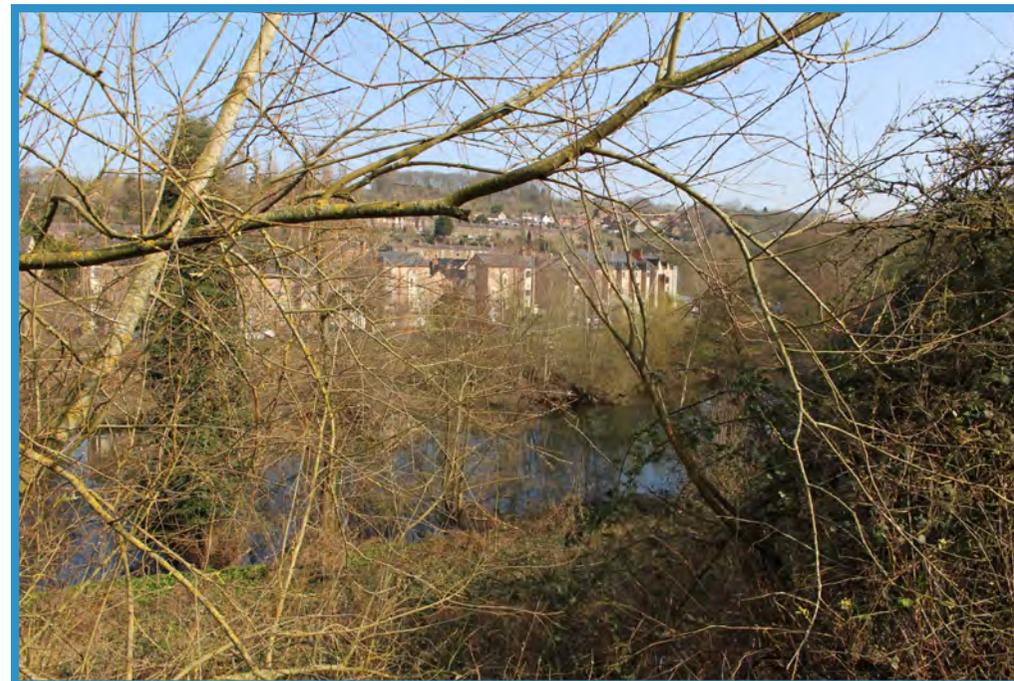
41 Hopping Hill terraces, Milford

Vegetation growth continues to reduce opportunities for appreciating the Milford terraces from across the valley.

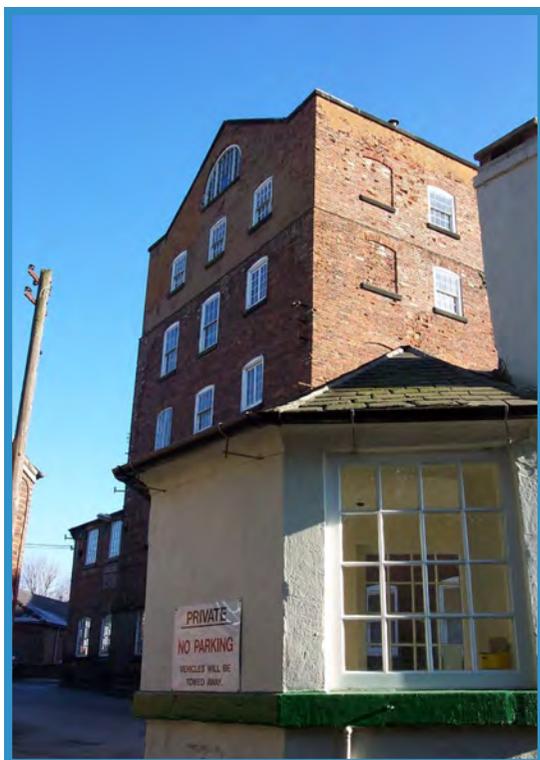
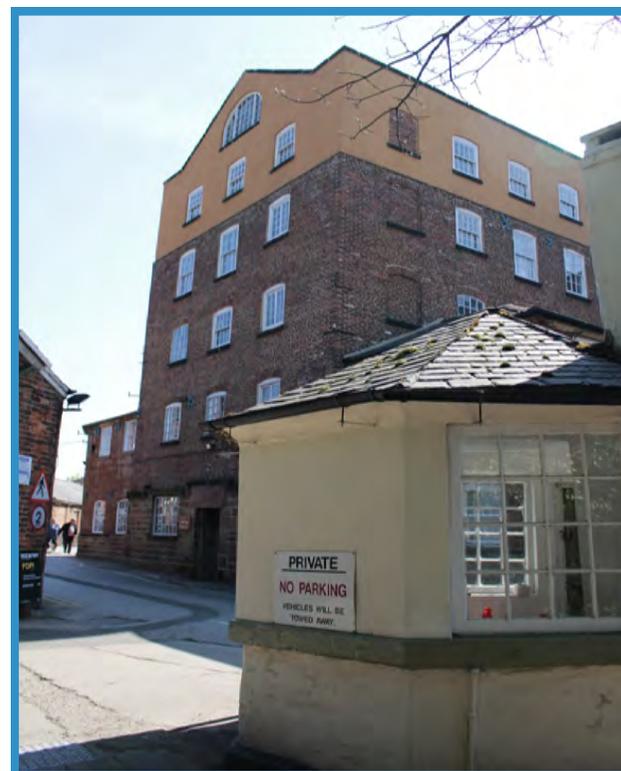
43 Toll booth, and gable end of Boars Head Mill

The mill has fresh render and buildings have been repaired and repainted to a high standard.

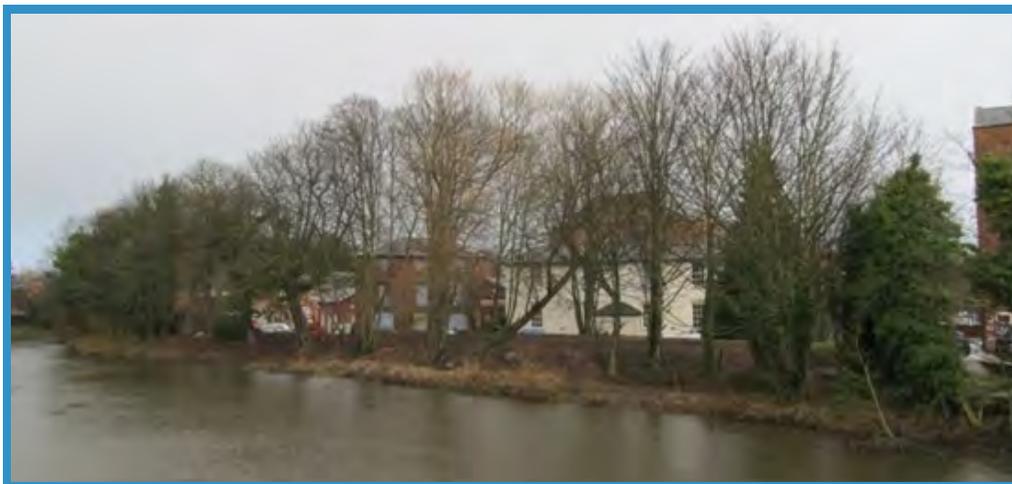
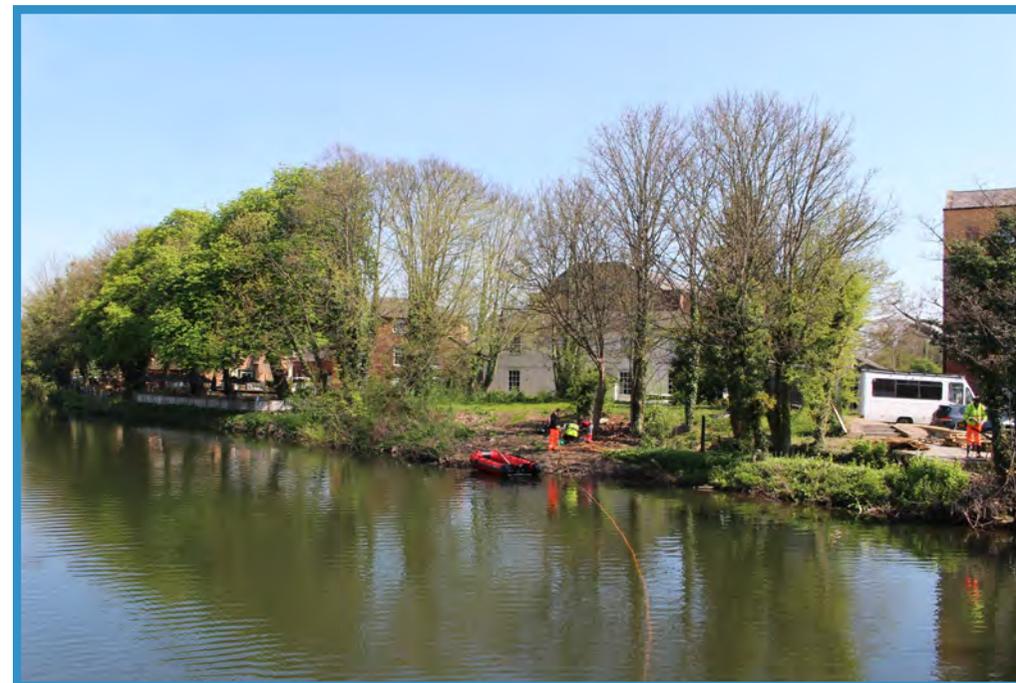
44 Darley Abbey Mills from the west (added 2014)

Outside riverside seating serviced by cafes on the mill site has been added as businesses adapted to Covid-19 regulations. A survey of the bridge, from which this view was taken, has resulted in its full closure to pedestrians and vehicles, severing the mills from the mill community. Unless the bridge is restored before 2027, the view cannot be replicated.

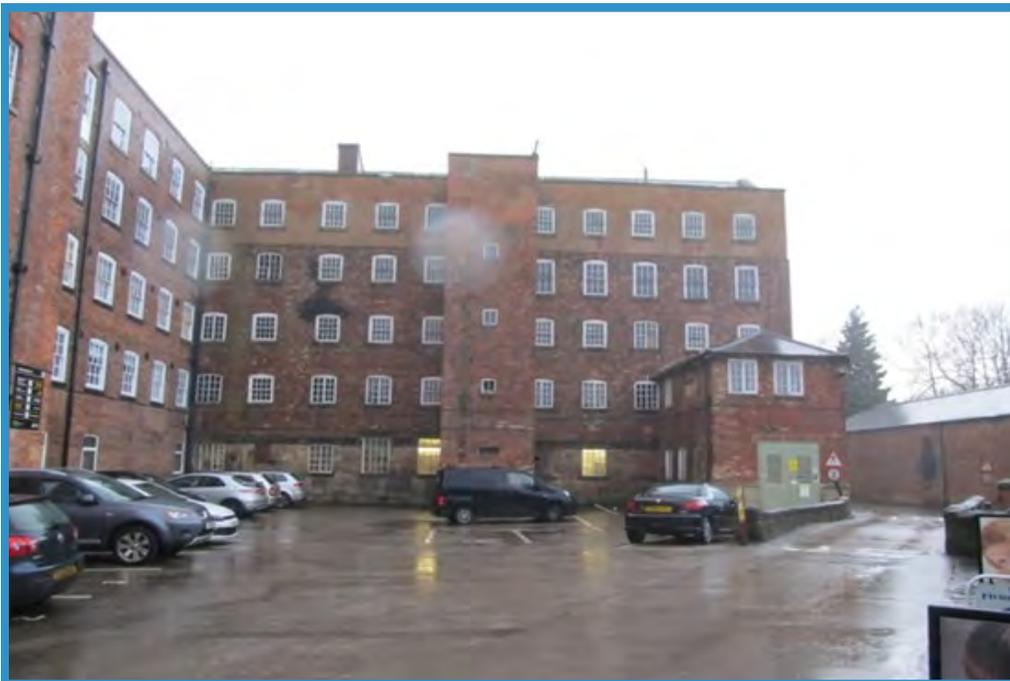
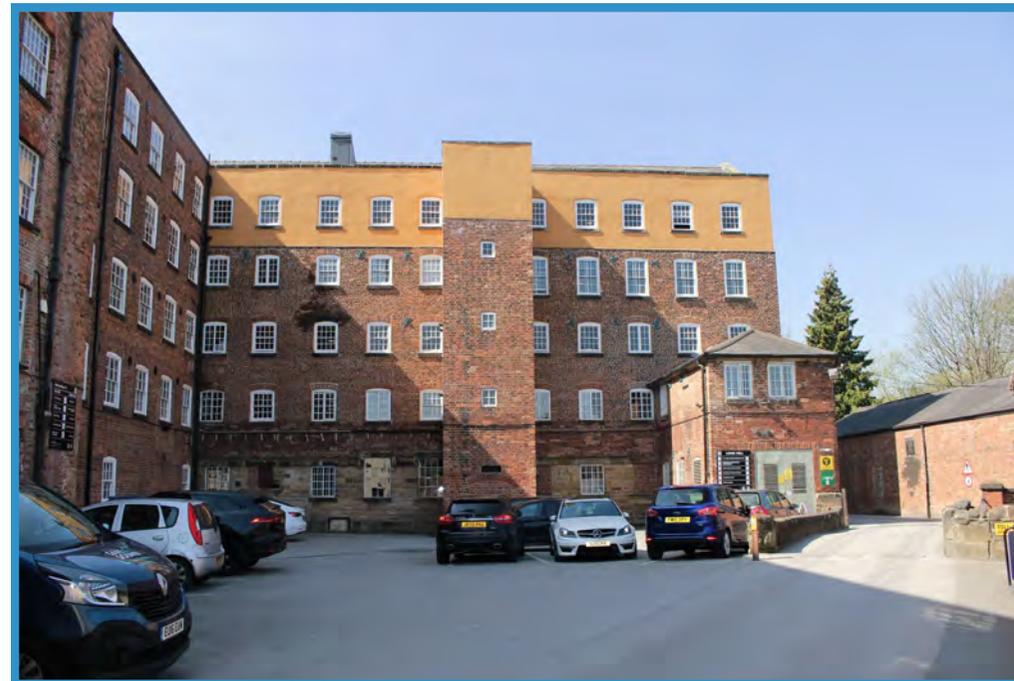
45 Long and Middle Mill, Darley Abbey (added 2014)

New render on the Long Mill has much improved this important space at the centre of the mill complex.

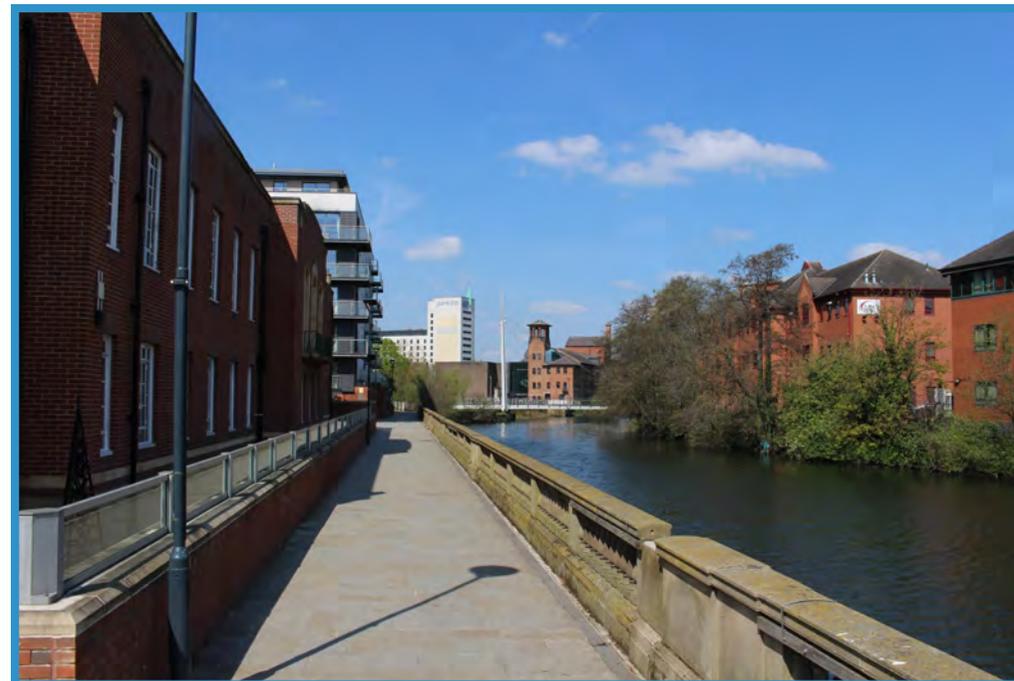
2022

No significant change.

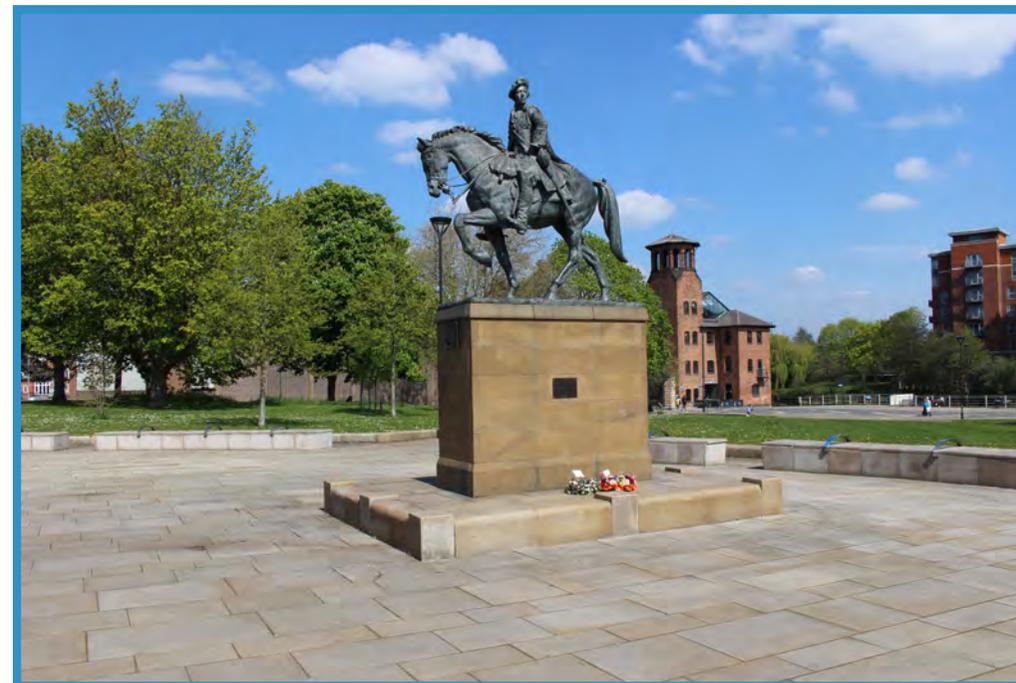
2022

The roofline of the Silk Mill has changed with the introduction of the new Museum of Making, and one of the recreated posts for the original Silk Mill gates can be seen in this view.

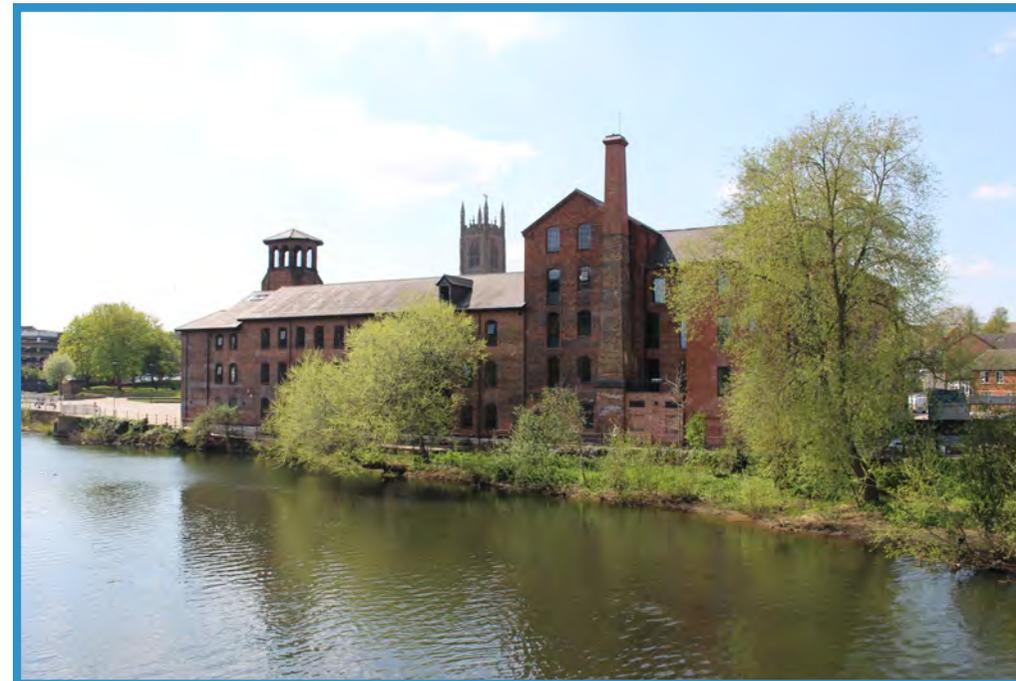
2022

No significant change. The changes made to accommodate the new Museum of Making are harder to discern from this view.
